MEMORANDUM

SUBJECT: Timber Harvesting Plan 1-88-011 MEN  
Barton Gulch, Navarro River, Mendocino County

An on-site inspection was conducted on February 1, 1988. Participants were Lee Susan, RPF; Jim Purcell, CDF; Tom Spittler, Geologist; Tom Schultz, LP; Bill Stancer, LTO; and Dick Moore, DFG.

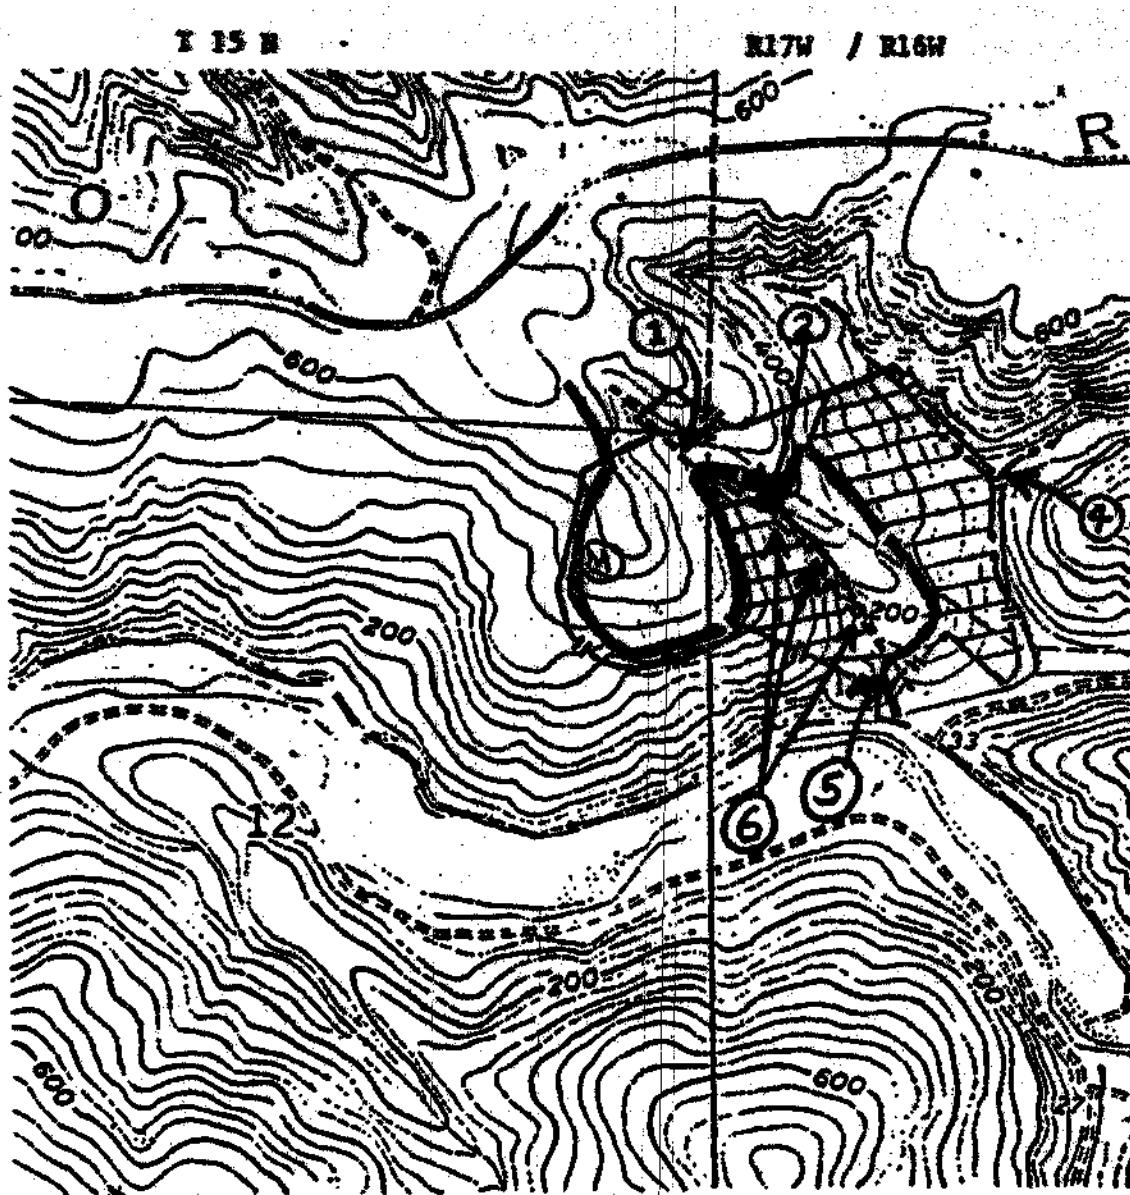
MAP TO ACCOMPANY  
TIMBER HARVESTING PLAN  
Giacomini - West Barton Gulch - Louisiana Pacific

1. Portions of the seasonal road (above Point M) contained waterbreaks that had been breached by traffic. They had remained in this condition after the most recent rainfall. This included at least one weekend. The RPF indicated these waterbreaks would be reinstalled or repaired following the on-site inspection on February 1, 1988.

2. At Area 1, the Class II watercourse extends upslope to this point approximately 200 feet upslope of the existing truck road. There is a six foot "nick point" at this location. At present-flow begins at this point. Pools and vegetation remain dense downstream past the slide. At the slide flow is underground surfacing at the base of a ten foot plus falls in the watercourse near the slide at Point 2. Several large second growth Redwood have fallen across the watercourse at Point 2. These can be removed by cable machine. There is access on benches for tractors north and east of the watercourse downstream from the slide at Point 2. The watercourse is deeply incised in this area. The incised slopes will not require tractor operations other than end-lining from the WLPZ.

3. The KPF indicates a Class I watercourse up to Point 4. No fish were observed in this area, however, fish have access to this area during the winter period. The area upstream of Area 4 contains meandering channels where gravel has settled. The source of this gravel was not located during this inspection, however, some stream meandering and sidecutting was observed upstream of Area 4. Extensive erosion on the public road north of this area (Navarro Ridge Road) has been noted in the past. It is not known if this erosion has contributed to erodible materials mentioned above.

4. A wet area with a one to two foot scarp was noted at Area 5. The RPF has this flagged off of the THP area, however, It appears as indicated on the attached map. Point 5 should either be shown on the map or the map changed to reflect conditions as flagged on-site.

5. Point 6 indicates areas, northeast of the added Class II watercourse, where steepness of slope indicates this is a moderate erosion hazard rated area. The watercourse is deeply incised in some areas (10+ feet) and contains a lens shaped channel with underground flow in other areas. The channel transports bedload soil downstream of Point 1 with considerable materials transported downstream of the slide at Point 2. Almost all of the gravel settles on the flat in a delta at the edge of the flood plain. Extreme high water has flooded Highway 128 in the past. The culvert under Highway 128 is accessible to fish during normal winter flows.

6. Between Points 2 and 5, concentrated surface flow was carried in the inside road ditch and along the road surface for extended distances without the benefit of relief. This will be addressed by the Geologist and/or CDF in their- reports.

1. Extend the Class II watercourse up to Point 1.
2. Trees marked for leave shall be marked at the base of the tree.
3. Either map wet area and scarp at Area 5 or change map to reflect flagged area on-site.
