Stream Inventory Report

Hare Creek

Jackson Demonstration State Forest
Mendocino County

California Department of Fish and Game

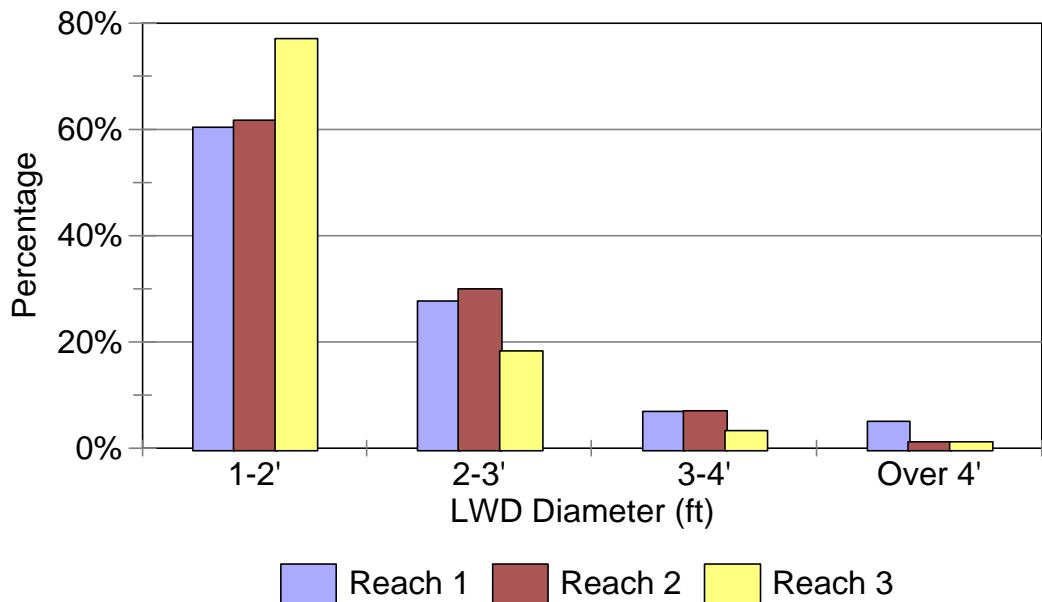
FIGURE 1. Percentage of LWD in each diameter size category found for each reach surveyed.
