**Analysis of the
1997 Garcia River Cross Sections**
by
Dennis Jackson

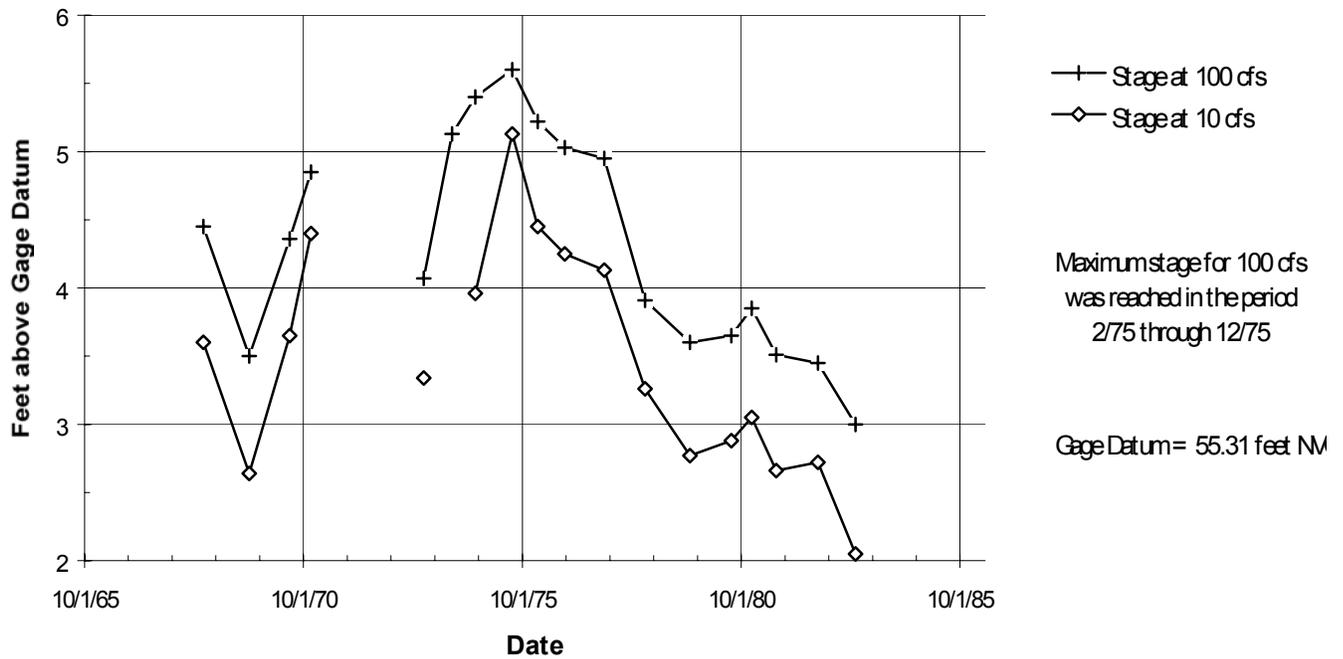
**Figure 1. Garcia River, USGS Gage at Conner Hole
Stage Required for 100 cfs and 10 cfs of Flow.**

Any single event may result in scour or deposition in a reach. However, net fill or scour, in a reach, would have to occur over a period of several years before the reach could be said to be aggrading or degrading. Figure 1 shows the passage of a bed material wave at the USGS gaging station at Conner Hole (details of the graph are discussed on page 2). Figure 1 provides evidence that the riffle crest below the gage rose from 1969 to 1975 and eroded from 1976 to 1983. Figure 1 shows that a period of fill was followed by a period of scour demonstrating Leopold's assertion that equilibrium acts on an intermediate time scale. It is my opinion that the mainstem of the Garcia River is in equilibrium with a time scale of approximately 10 years.

Figure 1 shows that equilibrium can be achieved, over a decade, by alternating scour and fill. The processes of aggradation and degradation require different management responses. If the river is incising into its bed it would be prudent to curtail all gravel extraction from the main stem in order to protect the aquatic habitat and the bridges that cross the river. If the river is aggrading steps should be take to decrease the amount of sediment being delivered to the river.

In April of 1991, Jackson prepared a graph of the stage for 100 cfs at the Conner Hole gaging station (see Figure 1). The data for the graph were obtained by looking at all of the available rating curves and reading the stage which was required for 100 cfs of flow and for 10 cfs of flow. The graph shows that the case for 10 cfs mirrors the 100 cfs case. Figure 1 shows that during the period, January 1969 to December 1969, the stage required for 100 cfs of flow was 3.5 feet. By February 1975 the required stage to produce 100 cfs flow had risen to 5.6 feet, a 2.1 foot increase in six years, for an average rate of 0.35 foot per year. The increase in stage required to produce 100 cfs of flow indicates

that the downstream control (riffle crest) for the gaging pool must have risen. This implies that the low water channel of the reach below the gaging station aggraded relative to its 1969 condition. By December 1982 the stage required for 100 cfs of flow had dropped to 3.0 feet, a drop of 2.6 feet in seven years, for an average rate of 0.37 feet per year. The decrease in stage required for 100 cfs of flow implies that the riffle crest below the gage eroded, relative to its 1975 condition. Figure 1 indicates that a wave of bed material passed the USGS gaging station during the period January 1969 to September 1983, when the record ended because the station was closed.

It is strongly recommended that a low flow rating curve be developed for Conner Hole. This was attempted in 1992-1993 but soil creep disturbed the lowest staff gage at the station. A new staff was installed in the fall of 1995. The new staff is in a protected location and should not be subject to further soil creep. The development of a new low flow rating curve would relate the present conditions in the river to the graph of stage for 100 cfs of against time. This would indicate whether the river has incised relative to its 1983 condition. Besides developing a new low flow rating curve it is recommended that the elevation of the present gage datum be confirmed by surveying the staff gages and USGS benchmark. USGS records give the gage datum as 55.31 feet NVGD and that the bronze marker on the right bank is 18.82 feet above the gage datum or 74.13 feet NVGD. The 1992 survey of the river, associated with the bentonite clean up, indicated that the elevation of the benchmark at the gaging station reported by the USGS was 0.59 feet lower than reported by the 1992 survey. However, all the cross section surveys have used the 74.13 feet elevation for the bronze marker, as reported by the USGS.

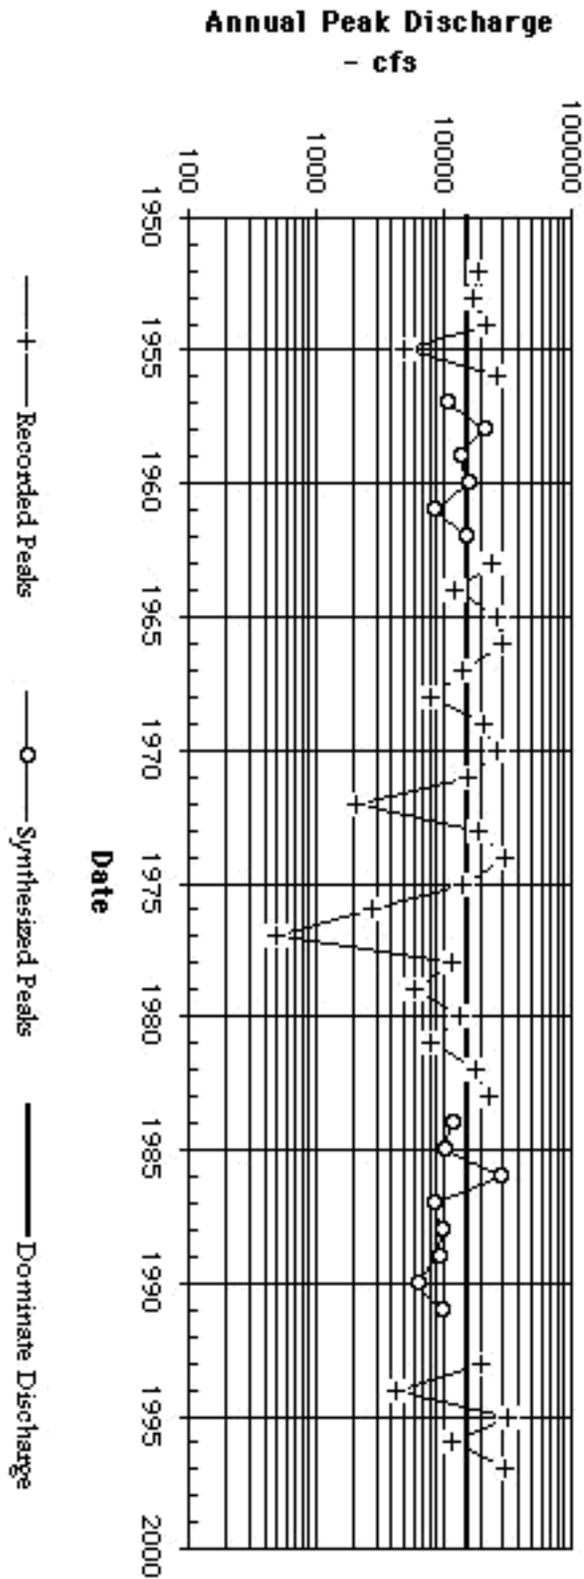
Figure 2. Annual Peak Floods on the Garcia River at the Conner Hole Gaging Station.

Figure 2 shows that the twenty-four year period from 1954 to 1975 had a total of sixteen years with annual peak discharges greater than the dominate discharge (66%), indicating that the period probably had a large input of material into the channel and the power to transport the material. Figure 2 also shows that the twenty-one year period from 1976 to 1996 had a total of five years with annual peak discharges greater than the dominate discharge (25%), indicating that very little new coarse material was delivered to the channel.

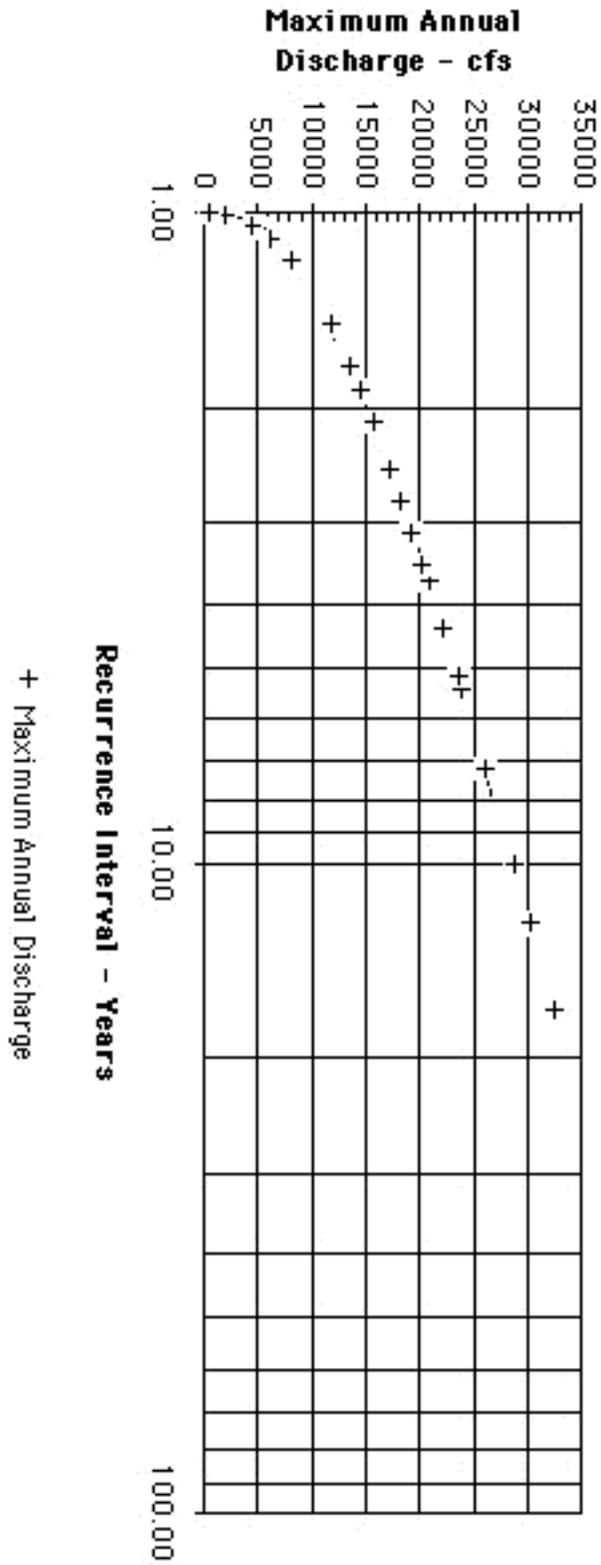
Figure 3. Annual Peak Flood Recurrence Interval for Garcia River Former USGS Gage No. 11467600, Based on 31 Years.

The force of the flowing water and transported sediment works to shape the bed and banks of the river. The greater the flow of water the more energy is available to alter the channel. Figure 2 shows the recorded and synthesized annual peak flood discharges for Conner Hole. Table 1 lists the magnitude and frequency of the annual peak discharge since 1991. The flood frequency was recalculated using all available observed data, including the 1997 event. None of the synthesized data were used in recalculating the flood frequency. The flood frequencies shown in Table 1 were calculated by the Gumbel Extreme Value method. Figure 3 shows the recalculated flood frequencies.

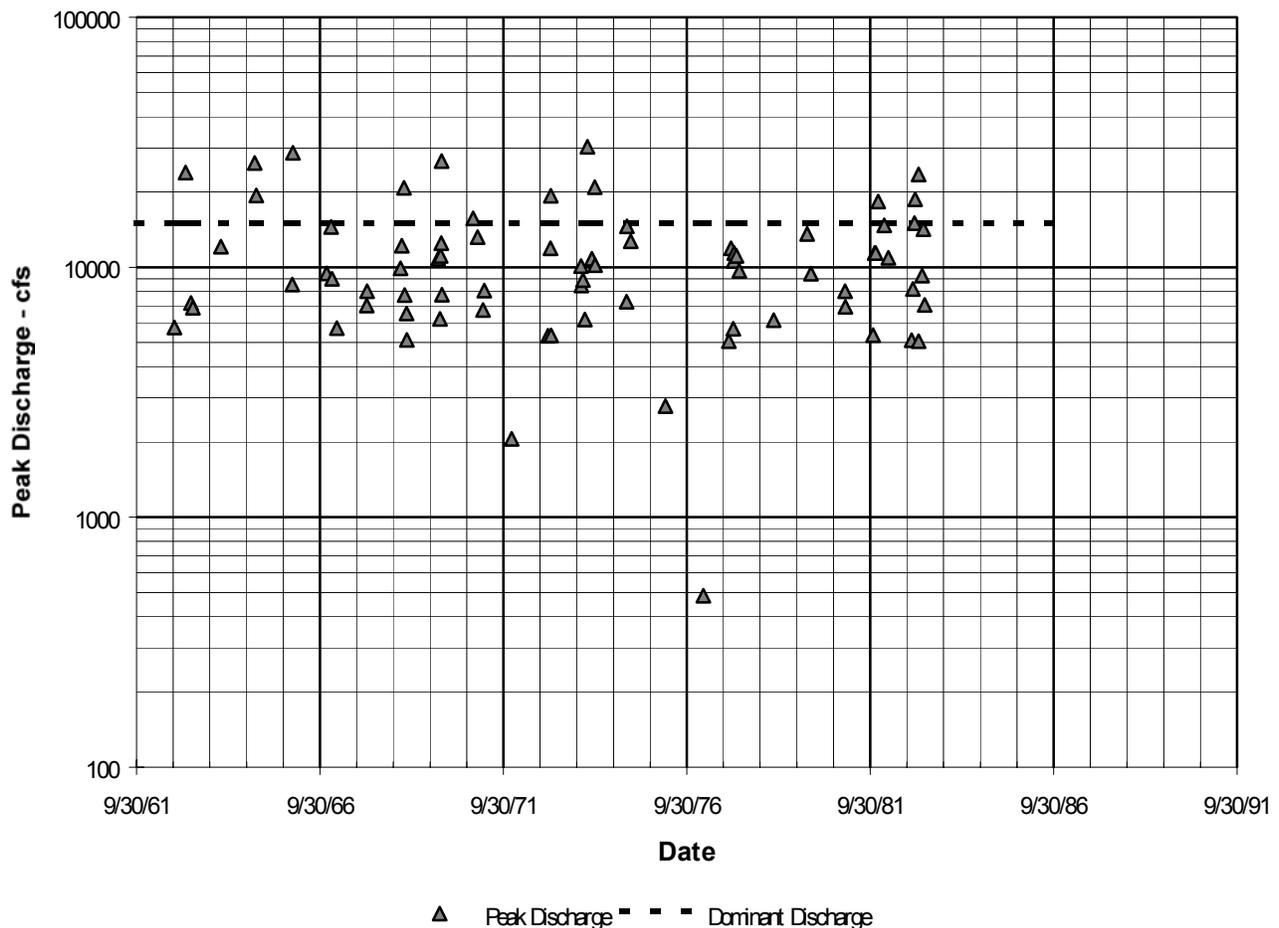
Figure 5. USGS Peak Discharges for Garcia River at Conner Hole for Water Years 1963-1983

The graph of *Stage Required for 100 cfs of Flow* (Figure 1) suggests a wave of sediment past the Conner Hole Gaging station between 1968 and 1983. Figure 5 is a graph all of the peak discharges recorded at the Conner Hole gaging station. Figure 5 suggests the cause of the sediment wave. The graph of the sediment wave, Figure 1, shows that the rise of the sediment wave started in 1969 and crested in 1975. Figure 5 shows that only two of the eight years between 1968 and 1975 had peak discharges less than the dominant discharge of 15,000 cfs. However, for the next eight years only two years had peak discharges greater than the dominate discharge. (These observations do not imply that there is an eight year weather cycle on the Garcia).

The occurrence of peak discharges equal to or greater than the dominant discharge implies above average rainfall and saturated conditions in the watershed. The prime cause for a slide to occur on steep topography is saturated soil. Saturated conditions also increase the occurrence of debris flows. Slides terminating in a watercourse are an important means of delivering coarse and fine sediment to the channel. Debris flows are slurries of earth and water that travel at high speed down steep (slope > 8%) canyons. Overland flow, on the other hand, delivers only fine material to the river system, assuming that an adequate vegetated buffer exists. The steep topography of the upper watershed suggests that debris flows can occur on the smaller steep tributaries. Personal observation of the mainstem of the Garcia River between Voochris Grove and the Eureka Hill Bridge revealed several large slides that terminate directly in the river. Many of the bars above the bridge had an abundance of cobble size material on the surface. Below Eureka Hill Bridge there are fewer slides terminating in the river and cobble is less abundant.

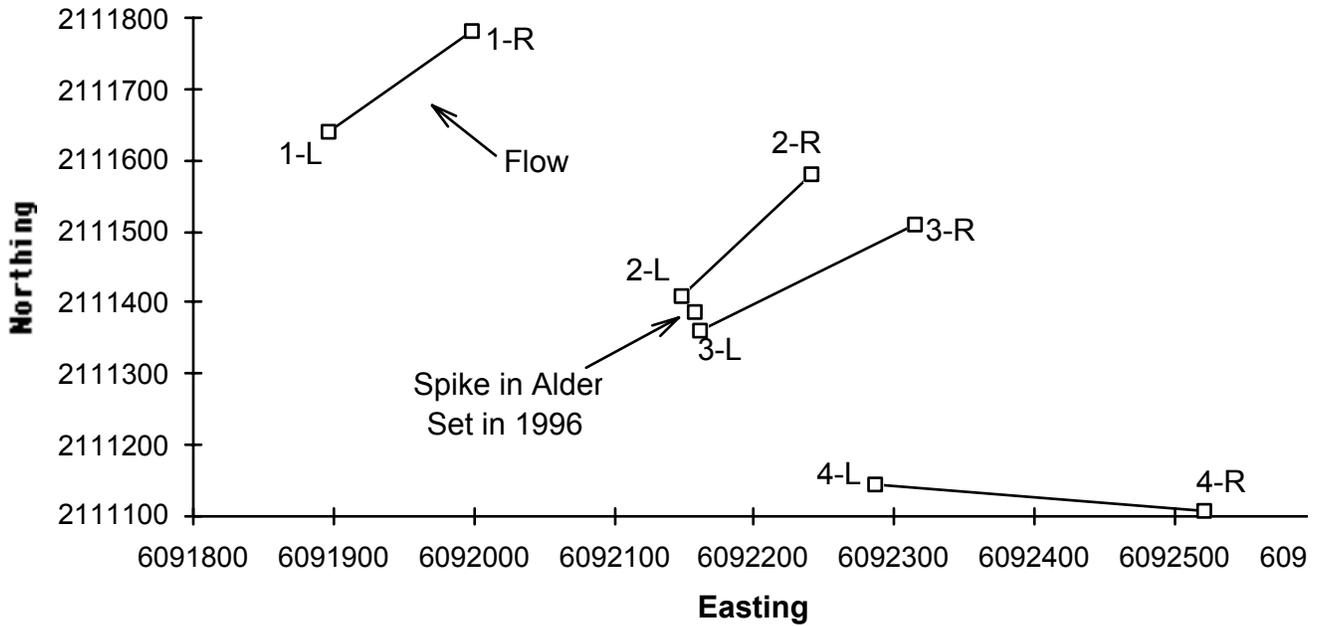
Hooper Cross Sections

At cross section 1 clay was visible on the left bank during the original survey in 1991 but not on the right margin of the low water channel. The 1991 survey notes make no mention of clay being

visible in the thalweg of the channel in 1991. The clay on the margin of the bar first became visible during the winter of 1994. The clay in the left bank may be related to the San Andreas fault and may have been visible for a very long time. The layer of clay that was exposed in 1996 does not necessarily mean that the river just cut through the clay. It is possible that the river cut into the clay layer in the past and material was deposited on top of the eroded surface. The recent floods may have just re-exposed a previously eroded surface. This idea is supported by the filling of the low water channel in 1997.

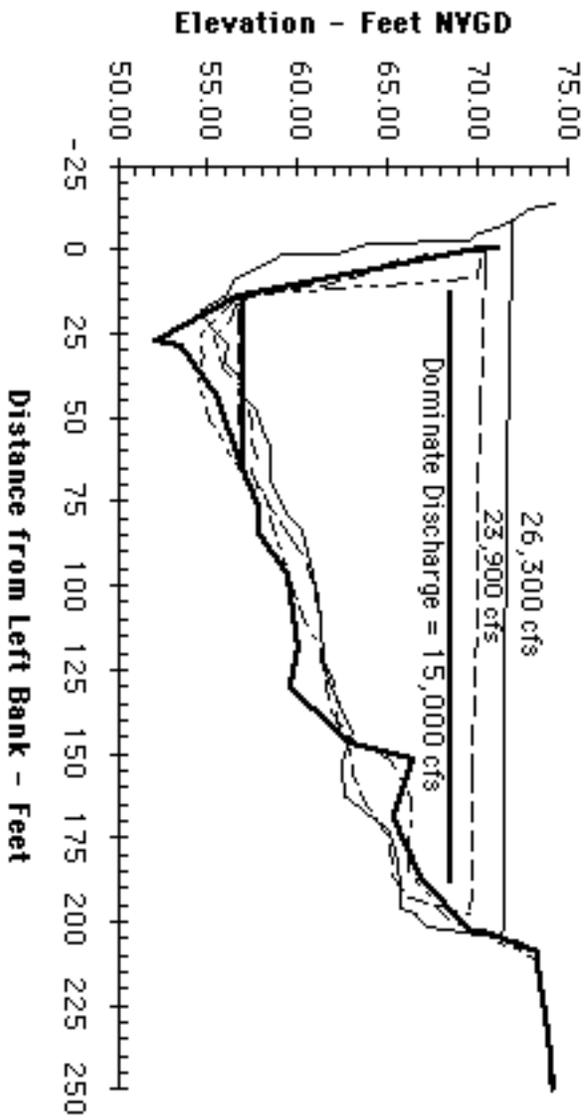
**Figure 9. Garcia River at Conner Hole, USGS
Slope-Area Cross Sections at Cableway**

The upstream MCWA cross section is located at the site of the USGS cableway. The right bank endpoint is the USGS benchmark on the A-frame anchor block. The benchmark is 18.82 feet above the gage datum which has an elevation of 55.31 feet NVGD. Thus, the NVGD of the benchmark is 74.13 feet NVGD. The left bank endpoint is a piece of rebar located near the stage recorder. Both of the endpoints were found to be in good condition, in 1997.

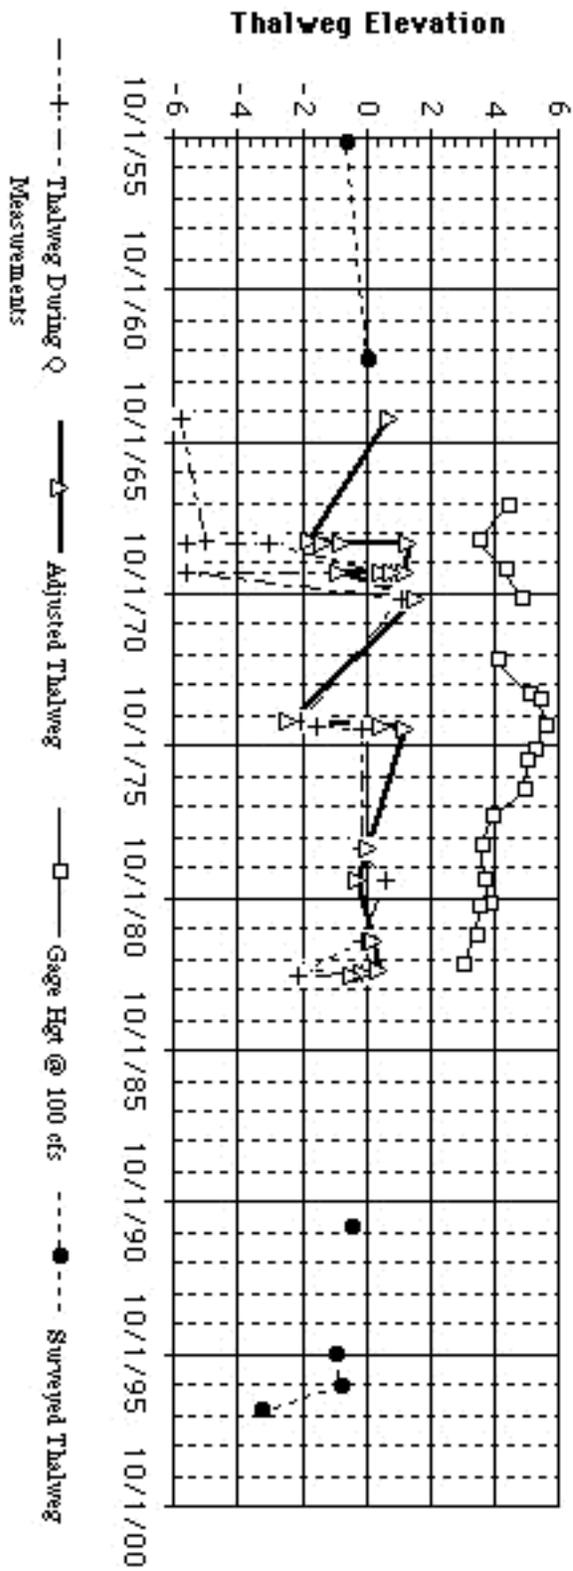
Figure 10. Garcia River, at Conner Hole Thalweg Elevation
Derived from Cableway Discharge Measurements

magnitude of the discharge being measured. Jackson developed the following regression equation to estimate the thalweg based on the log of the discharge,

$$\text{Thalweg (relative to gage datum)} = 20.234 - 6.713 * \text{Log(Discharge)}.$$

The above regression explains 78.8% of the variation ($R^2 = 0.788$) in the thalweg elevation observed during discharge measurements. The effects of the magnitude of the discharge were accounted for by subtracting the predicted thalweg elevation from the observed thalweg elevation. The adjusted thalweg elevation is shown in Figure 10 along with the thalweg elevation observed during the discharge measurements.
