**CALIFORNIA DEPARTMENT OF FISH AND GAME
STREAM SURVEY**

NAME BARTON GULCH COUNTY Mendocino

STREAM SECTION _____ FROM HEAD WATERS TO CONFLUENCE WITH NAVARRO RIVER LENGTH 2 mi.

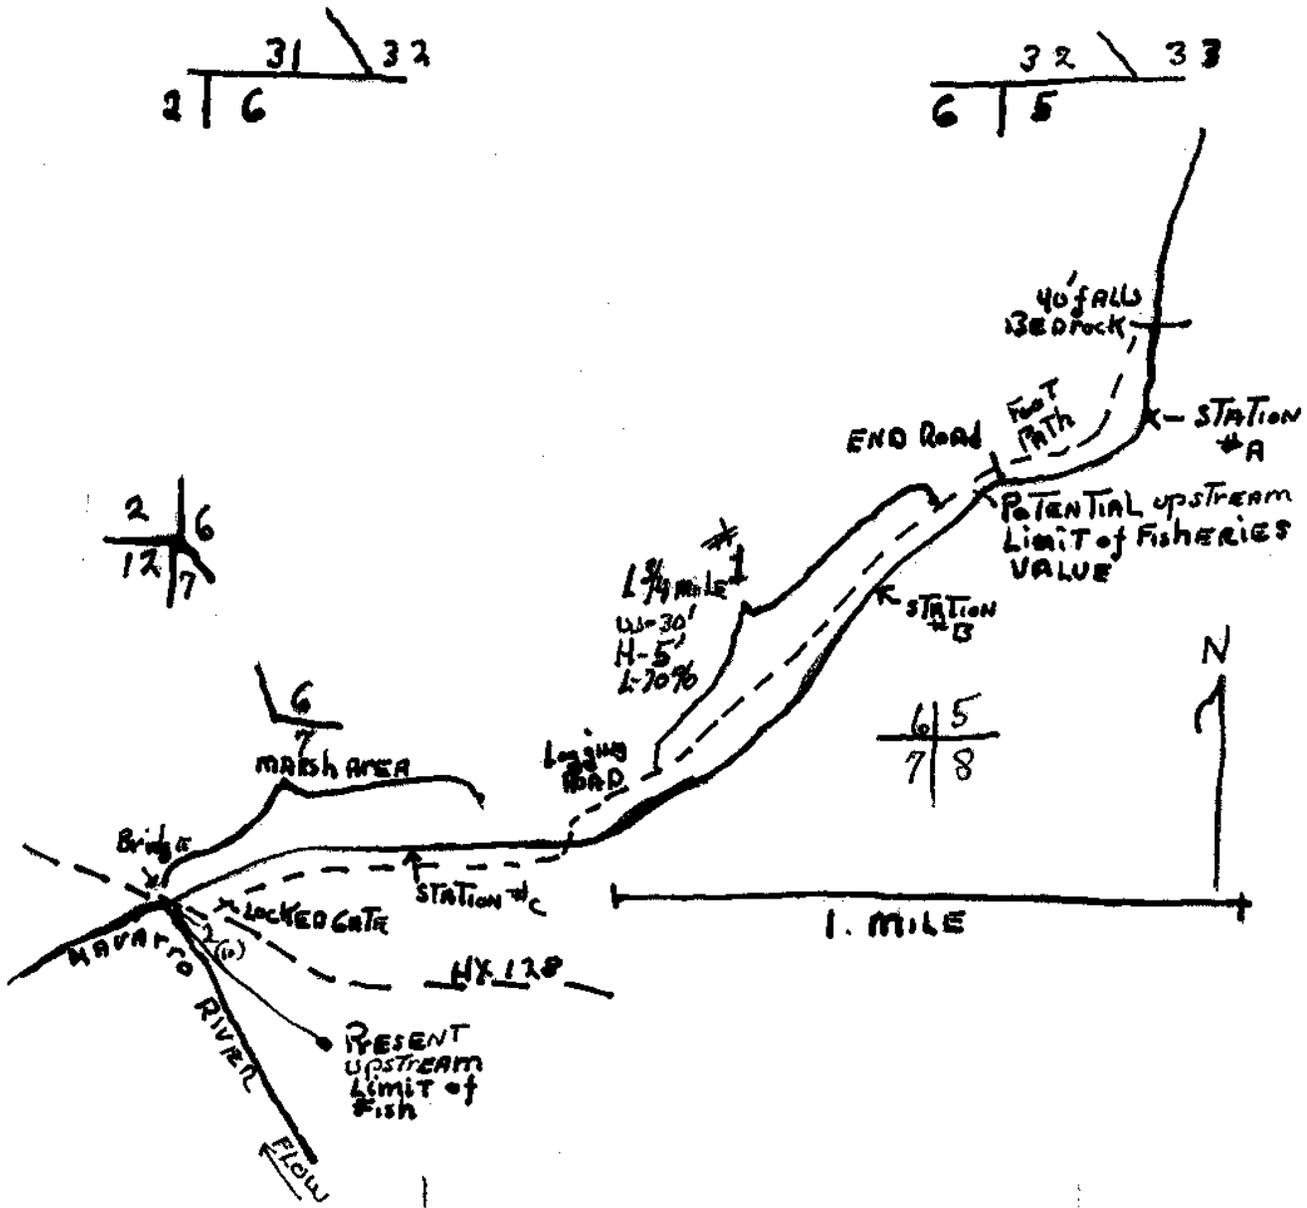
Barton Gulch

Spawning and Nursery Area in miles

1. Now satisfactory for SH & SS 0
2. To be improved 1 1/4 miles
3. Available after improvement 1 1/4 miles

ADD 15% FOR DEBRIS
NOT LISTED BETWEEN
NUMBERED JAMS
