**CALIFORNIA DEPARTMENT OF FISH AND GAME  
STREAM SURVEY**

NAME COLD SRINGS CREEK COUNTY Mendocino

TRIBUTARY TO Rancheria Creek TWP 14N R 15W SEC 35

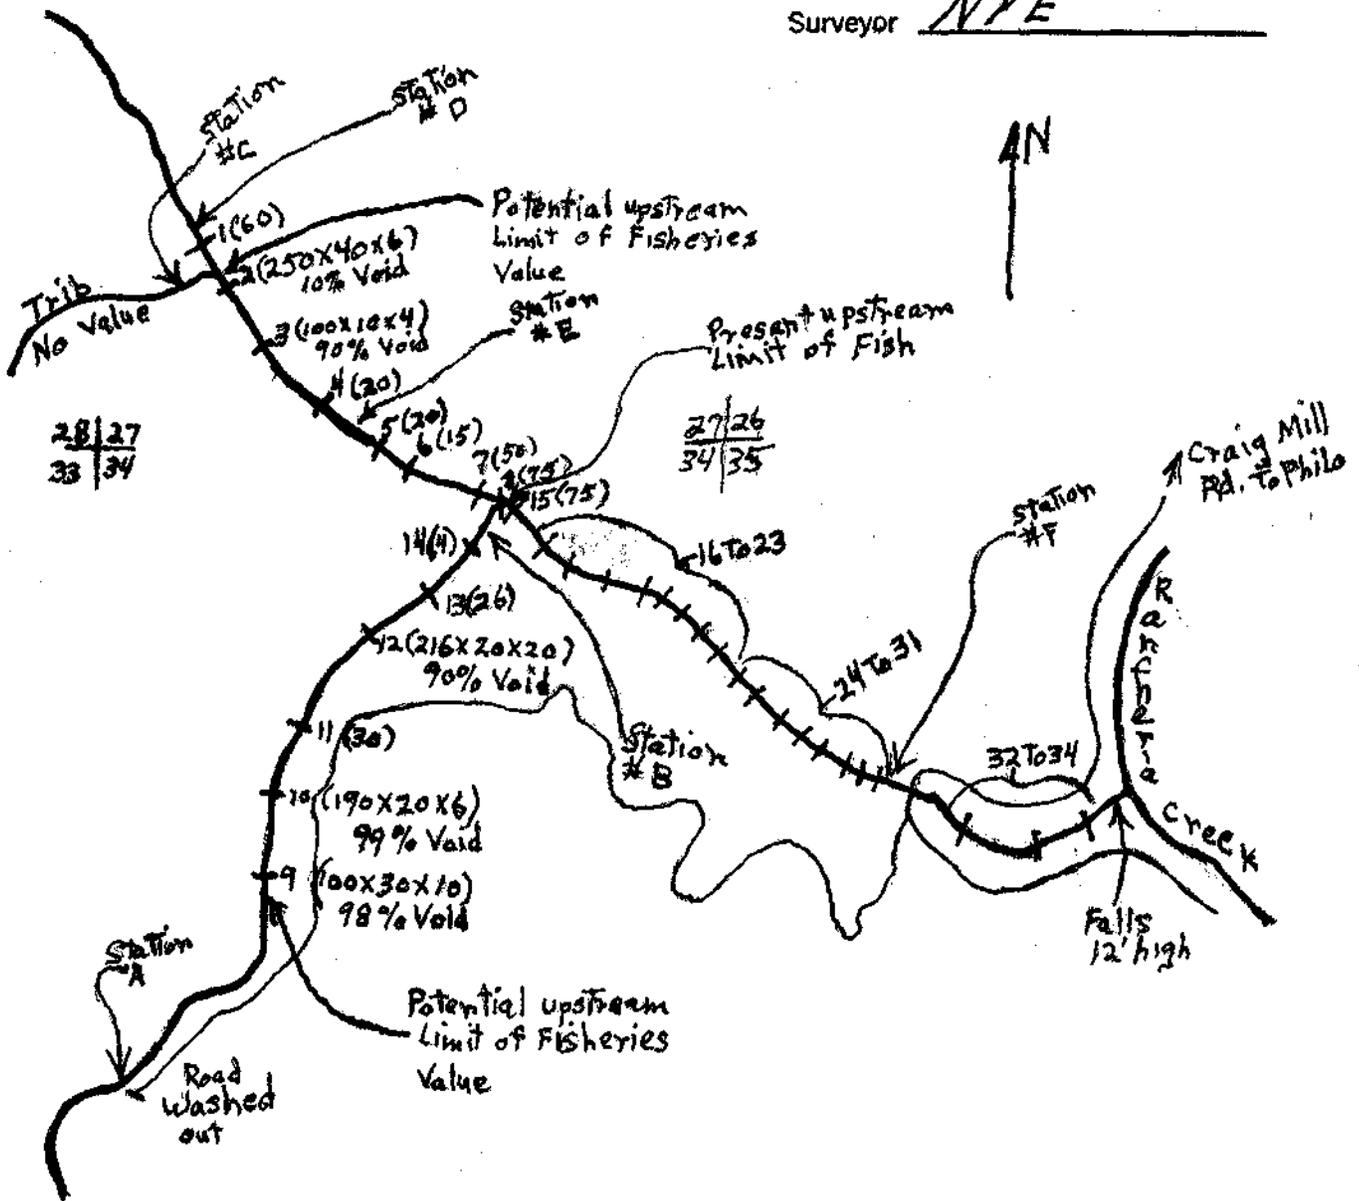
# Cold Springs Creek

- 16. (20)
- 17. (6)
- 18. (120x20x10)  
90% Void
- 19. (210x15x15)  
95% Void
- 20. (60)
- 21. (40)
- 22. (25)
- 23. (125x15x12)  
90% Void
- 24. (210x20x10)  
95% Void
- 25. (30)
- 26. (120x12x6)  
95% Void
- 27. (60)
- 28. (50)
- 29. (25)
- 30. (145x15x5)  
95% Void
- 31. (60)
- 32. (300x10x6)  
90% Void
- 33. (20)
- 34. (60)

1. Now satisfactory for SH & SS 0
  2. To be improved 2.6 MILES
  3. Available after improvement 2.6 "
- Surveyor NYE

Add 2% for debris between Jams not listed.

RECOMMENDED MANAGEMENT - First step, clean up and remove all wooded material and allow siltation problem to clean out. Second, continue to manage as a resident trout spawning and nursery area,
