RESOURCE PROJECT
STREAM SURVEY

FILE FORM No.....
Date April 15, 1979

NAME.....Thompson Gulch.....COUNTY.....Mendocino.....

STREAM SECTION.....FROM.....mouth.....TO.....head of nav.....LENGTH.....2 mi.....

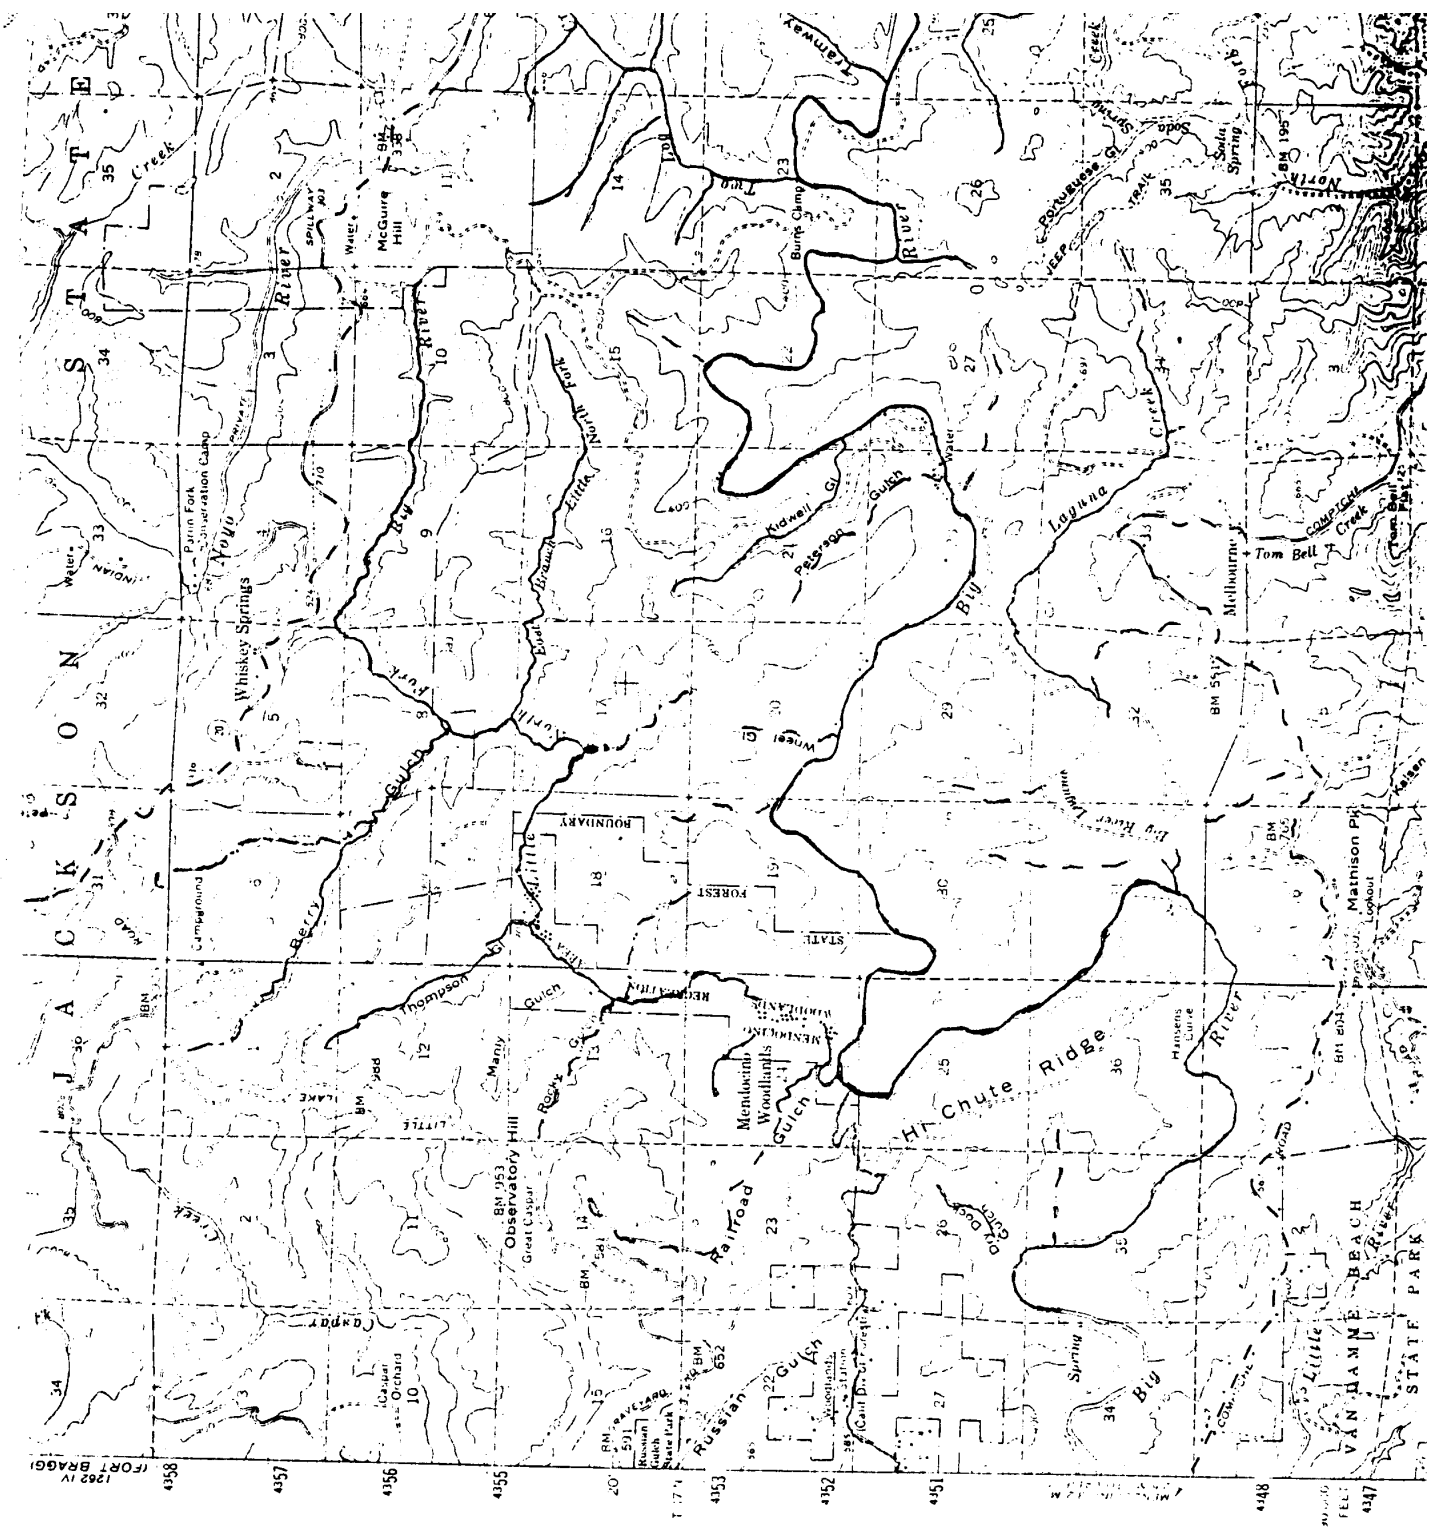
sketch map- attached

Barriers- There were 7 log jams noted and 6 main falls. Log; jam # 1- At 100 ft. from mouth the was 6 ft, in diameter trunk laying across stream causing virtually NO passage except some seepage through debris. Jam # 2 passable at high water, 6' w X 2 1/2' H X 15' L. (50 ft. past 2nd bridge). Jam # 3- At 1 mi. in narrow basin with stream diversions during high water. At present impassable although during high water, probably passable. Jam # 4- At 1 1/2 mi. upstream is a complete blockage with small seepage at present. Jam cemented with silt and moss; 2 1/2 X 3' w X 6'1. Jam #5-100 yards past Jam 4; 3' h X 5' w X 4' l with limited passage. Jam #6 with canyon erosion on sides of jam at 1 2/3 mi. upstream. Passable at present. Jam # 7- dam creates a 3 ft. fall through logs. and debris which make it impassable to migraters 10' w X 12' 4 at 1 3/4 mi. upstream.

There were also 6 falls noted. The first three were in the first 1/2 mi. of stream and all are passable at high water. The 3rd was a series of 6 smaller falls

each about 1' to 2' tall with some debris & clutter. The 4th fall at 1/2 mi. was 4' 4 X 3'1 (pool beneath) and impassable at present because of debris overhang and depth of pool, although with further bank erosion the fall could change shape and become passable. 5th fall could possibly be natural barrier at

5 1/2' 4 X 2 1/2 w with 1 1/2' deep pool underneath. (200 yards past Jam 7)

It is impassable at present for migrators and as there is no resting pool at the top and some debris jamming, it would be a difficult barrier even at high water. The 6th fall is a definite natural barrier with a height of 14 ft, with 5 levels of shallow pools and one jump of 8 ft. at 2 mi. up stream.

Recommended management- Suggest removal of log blockage at mouth, and jams 4, 5 & 6.

Also overall debris cleanup of stream would help further blockage from occurring so that spawners could have access to this stream.
