CALIFORNIA DEPARTMENT OF FISH AND GAME

STREAM SURVEY

NAME..... RUSSELL BROOK CREEK.....COUNTY.....Mendocino.....
 STREAM SECTION.....FROM.....mouth.....TO.....extreme headwaters.....LENGTH.....4-1/2 mi.
 TRIBUTARY TO.....Big River.....Twp.....17N.....R.....15W.....Sec.....26
 OTHER NAMES.....Unknown.....RIVER SYSTEM.....Big River
 SOURCES OF DATA.....personal observation.....

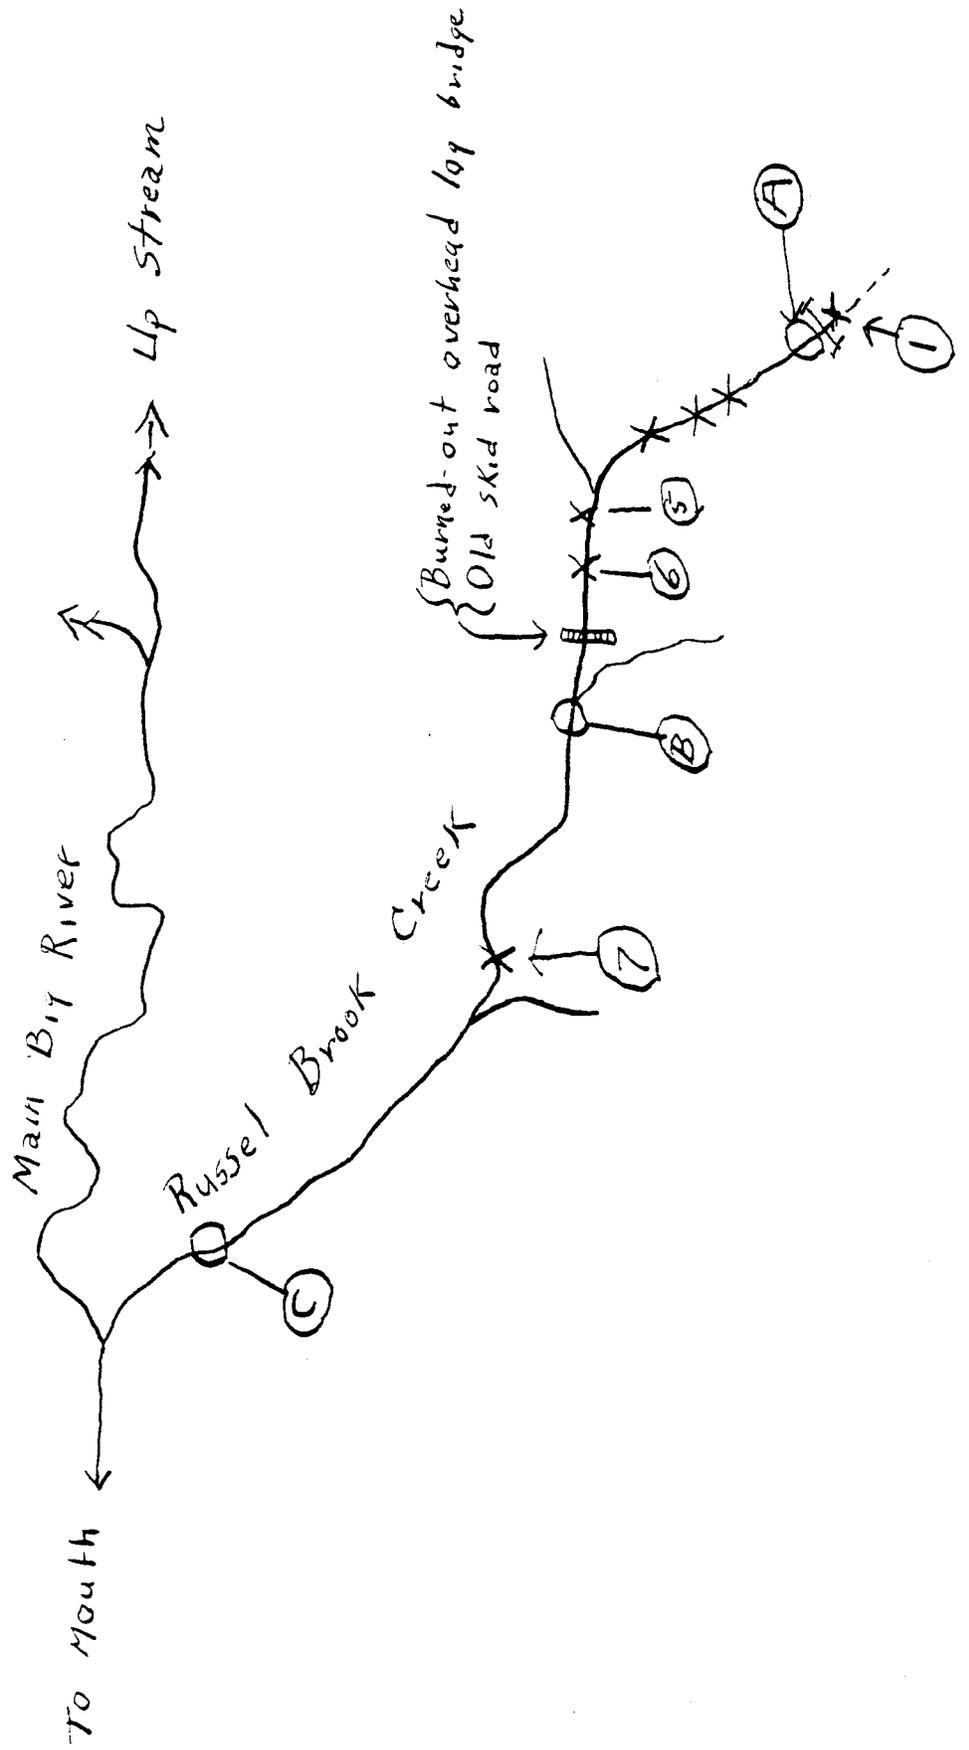
SKETCH MAP - See attached.

Log jams and barriers

1. Log jam - 1/4 mile above last upstream- tributary - 10 ft wide 5 ft long 4 ft high - 75% void area.
2. Log jam and barrier - 150 yards below #1 - intermittent flow - silted in-bed drop 2 ft - 15 ft wide 10 ft long 5 ft high - 90% void area.
3. Log jam - 100 yards below #2 - 15 ft wide 5 ft long 4 ft high - 85% void area.
4. Log jam and barrier - silted in-bed drop 3 ft. - 200 yards below #3. 25 ft wide 5 ft long 4 ft high - 90% void area.
5. Log jam and barrier - silted in-bed drop * 3 ft - 200 yards below uppermost east tributary - 15 ft wide 5 ft long 4 ft high - 75% void area.
6. Log jam - 100 yards below #5 - 30 ft wide 10 ft long 6 ft high -90% void area.
7. Log jam - 100 yards above lowest downstream south tributary -25 ft wide 10 ft long 6 ft high - 75% void area.

I would not recommend the removal or disturbance of these log jams.
