GARCIA RIVER WATERSHED ENHANCEMENT PLAN

The Garcia River Watershed Enhancement Plan

Prepared for California State Coastal Conservancy

Mendocino County Resource Conservation District
Ukiah, California

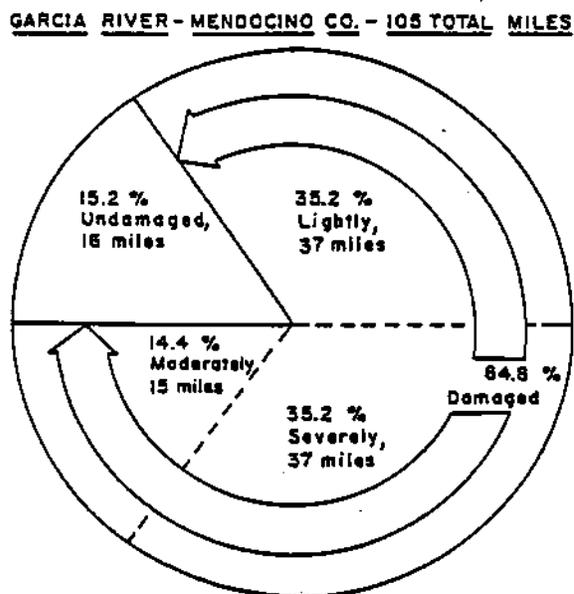
FIGURE 1: STATUS OF FISHERY HABITAT IN GARCIA RIVER-1966
(FISK ET AL., 1966)

Status of Fishery Habitat in Garcia River (1966):

Historic damage caused by road building, logging, overgrazing and poor land management practices, aggravated by the 1964 flood.

California Department of Fish and Game (DFG) and the Salmon and Steelhead Advisory Committee have done studies that support this observation. Although efforts to locate raw data and field notes in agency files have been generally unsuccessful, results such as the following chart indicate damage to fishery habitat in the Garcia (Fisk et al, 1966).

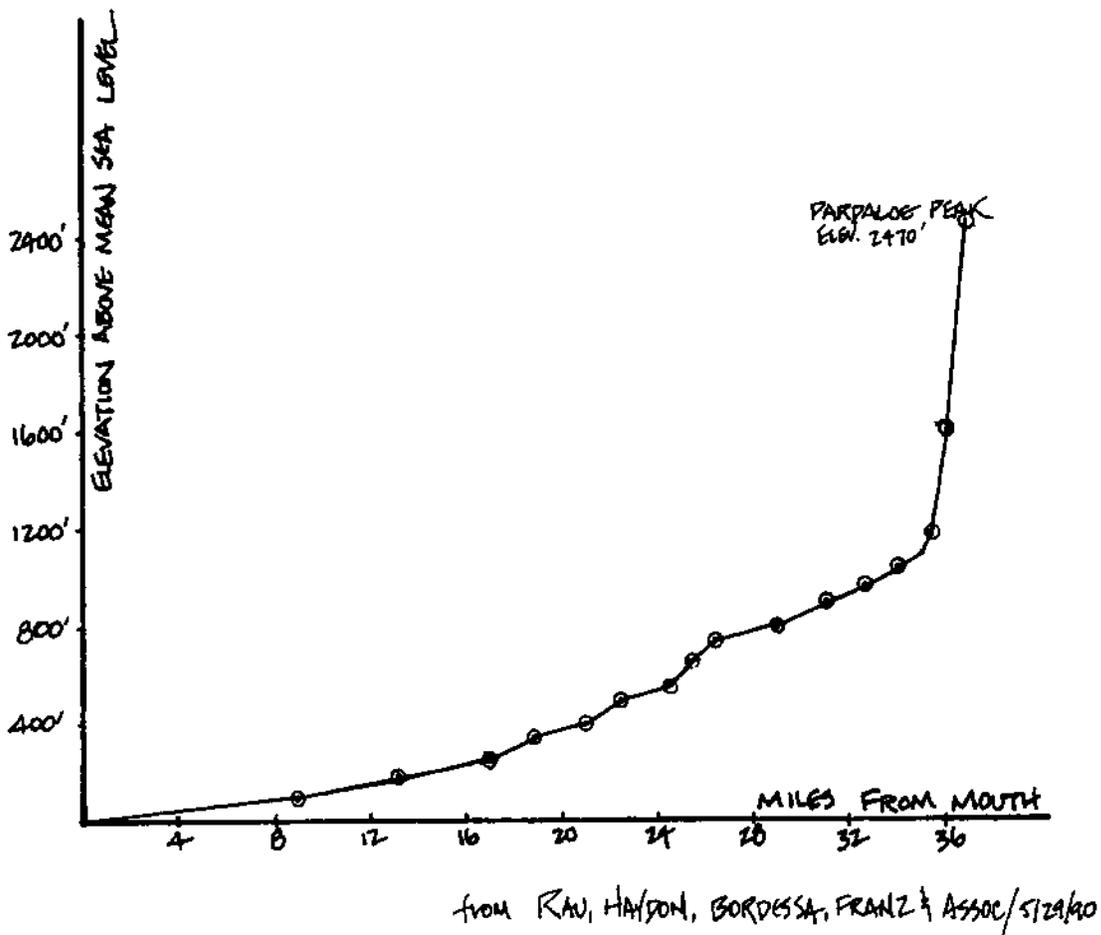
FIGURE 4: PROFILE OF GARCIA RIVER

A LONGITUDINAL PROFILE is a diagram of the slope of a stream or river. It shows the change in slope of the river as it travels its course downstream from the headwaters. Topographic maps and surveying equipment are used to gather the information necessary to develop a longitudinal profile. The profile helps to understand the energy that the stream flow produces. The steeper the stream, the faster and more powerful the flows. A steeper elevation along the profile means the river has more power to move larger debris and rocks as well as more soil or sediment. It is also possible to observe waves of sediment moving through a watershed system if profiles are repeated over time. Figure represents a rough profile of the Garcia River.

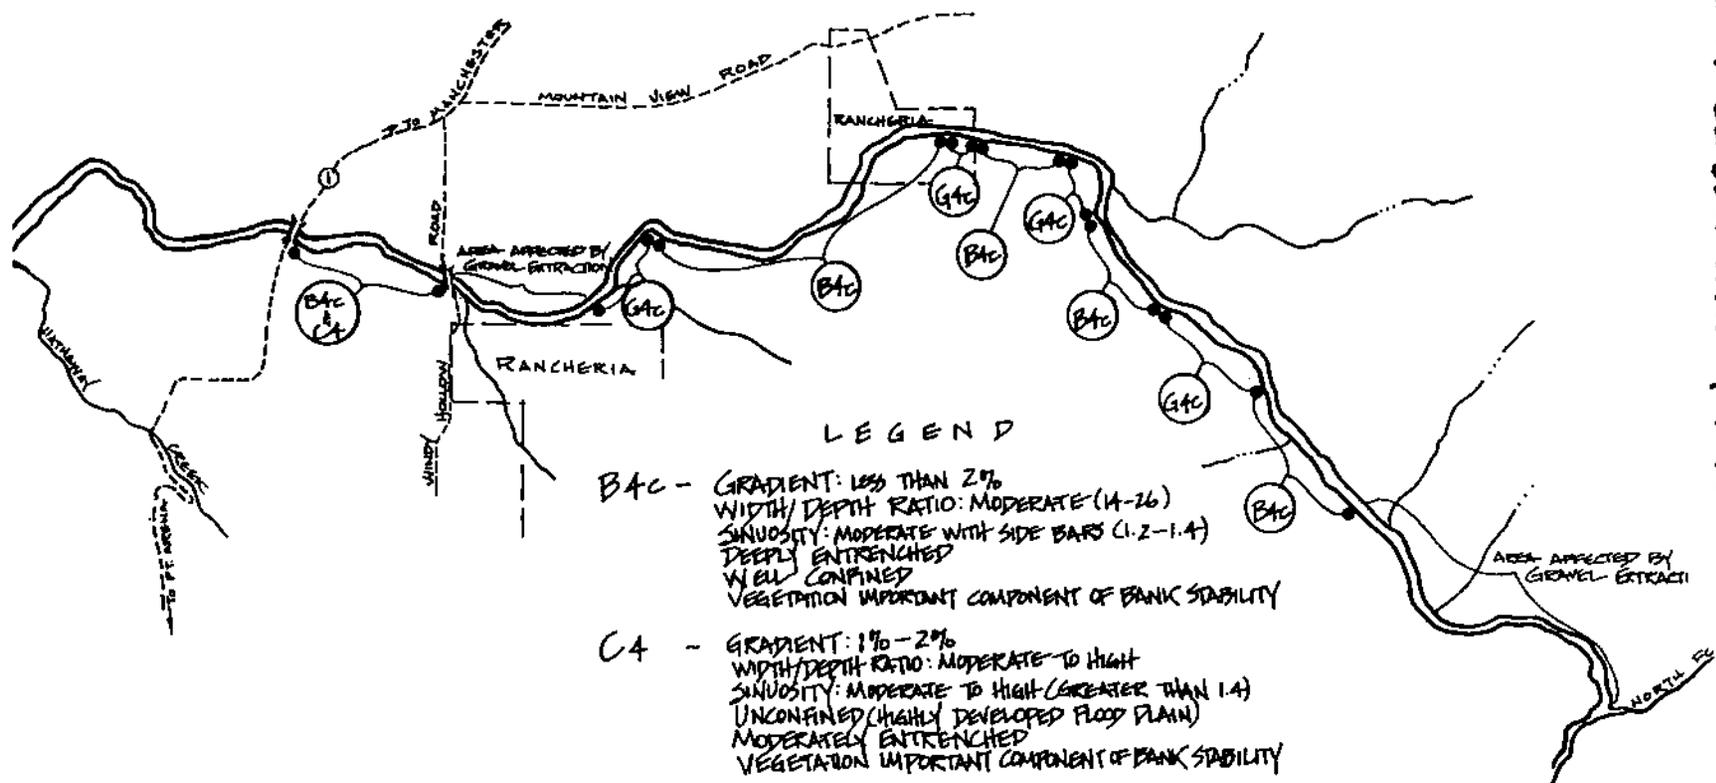
MAP F: LOWER 7-MILE REACH □
 ROSGEN CLASSIFICATION SYSTEM
 GARCIA RIVER - LOWER 7 MILES

- LEGEND
- B4c - GRADIENT: LESS THAN 2%
 WIDTH/DEPTH RATIO: MODERATE (1.4-2.6)
 SINUOSITY: MODERATE WITH SIDE BARS (1.2-1.4)
 DEEPLY ENTRENCHED
 WELL CONFINED
 VEGETATION IMPORTANT COMPONENT OF BANK STABILITY
 - C4 - GRADIENT: 1% - 2%
 WIDTH/DEPTH RATIO: MODERATE TO HIGH
 SINUOSITY: MODERATE TO HIGH (GREATER THAN 1.4)
 UNCONFINED (HIGHLY DEVELOPED FLOOD PLAIN)
 MODERATELY ENTRENCHED
 VEGETATION IMPORTANT COMPONENT OF BANK STABILITY
 - G4c - GRADIENT: LESS THAN 2%
 WIDTH/DEPTH RATIO: LOW (LESS THAN 1.2)
 SINUOSITY: MODERATE (1.2-1.4), GENERALLY MORE
 SINUOUS THAN B4c
 FAIRLY DEEPLY ENTRENCHED
 TOTALLY CONFINED
 VEGETATION IMPORTANT COMPONENT OF BANK STABILITY

insight for recommendations for appropriate enhancement measures. (See Appendix II for further explanation of the Rosgen Stream Classification System.)

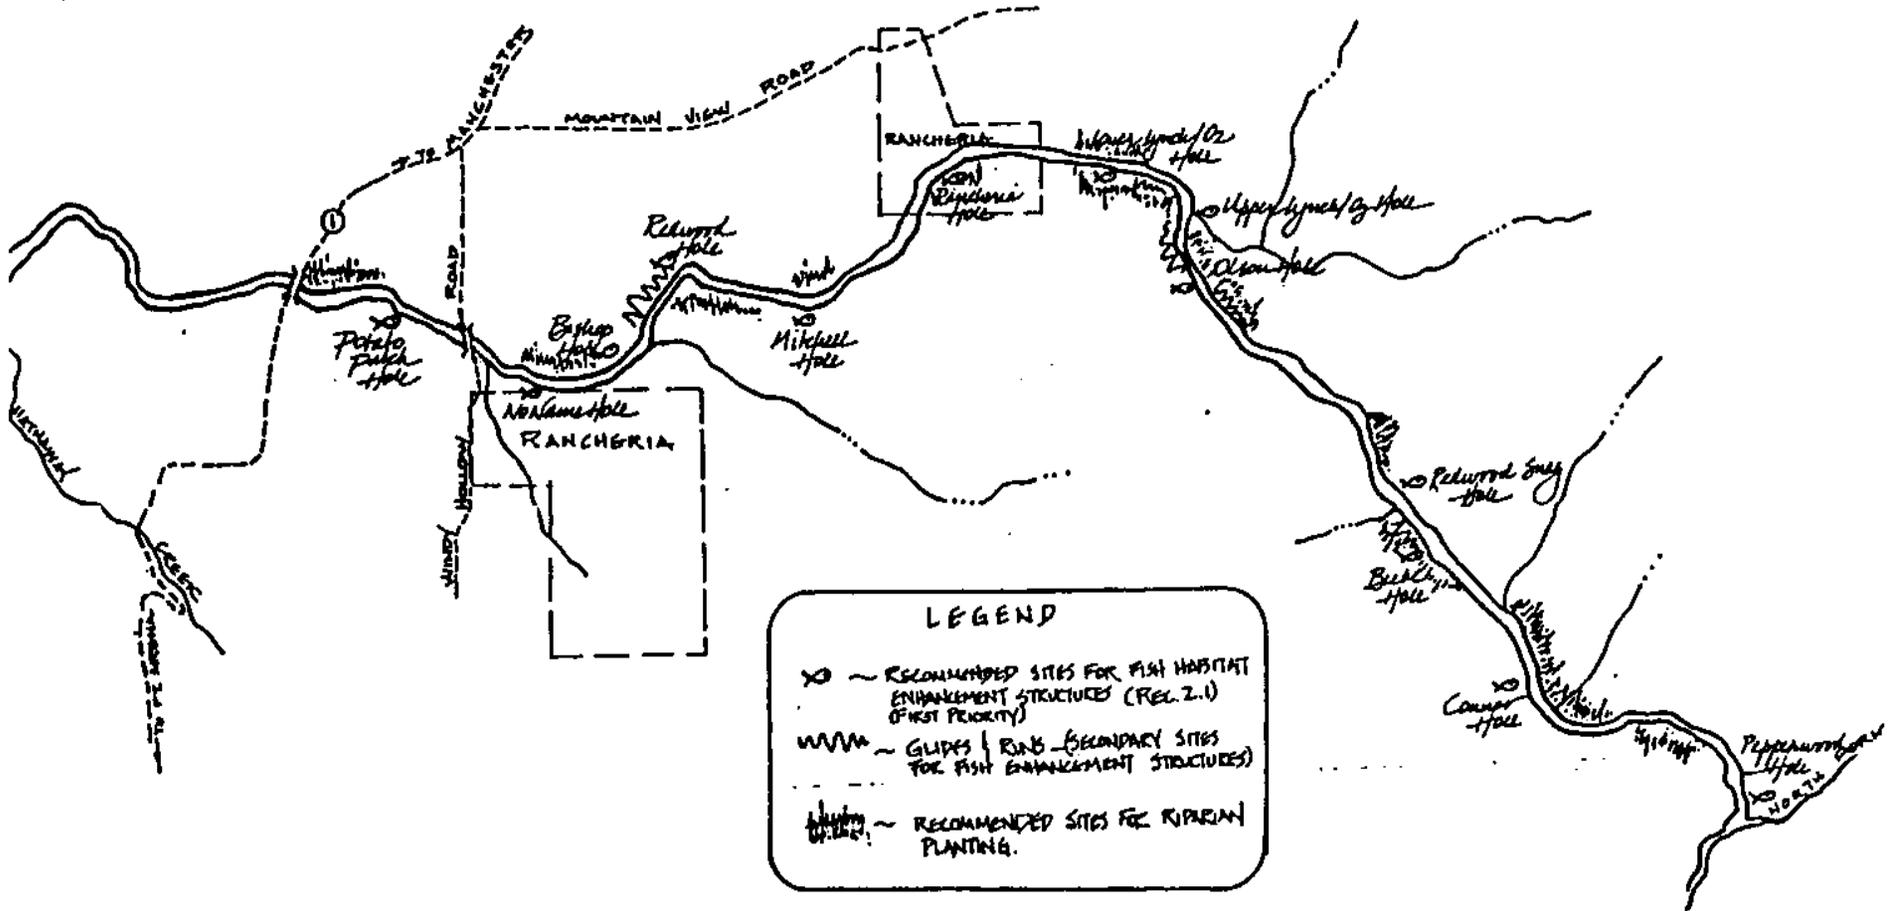
GARCIA RIVER - LOWER 7 MILES
WORK SITE MAPS 2.1 & 2.2

PROPOSED FISH HABITAT ENHANCEMENT AND RIPARIAN PLANTING SITES

large organic debris in the future for habitat. Suggested sites for riparian planting are indicated on Work Site Map 2.1 and 2.2.

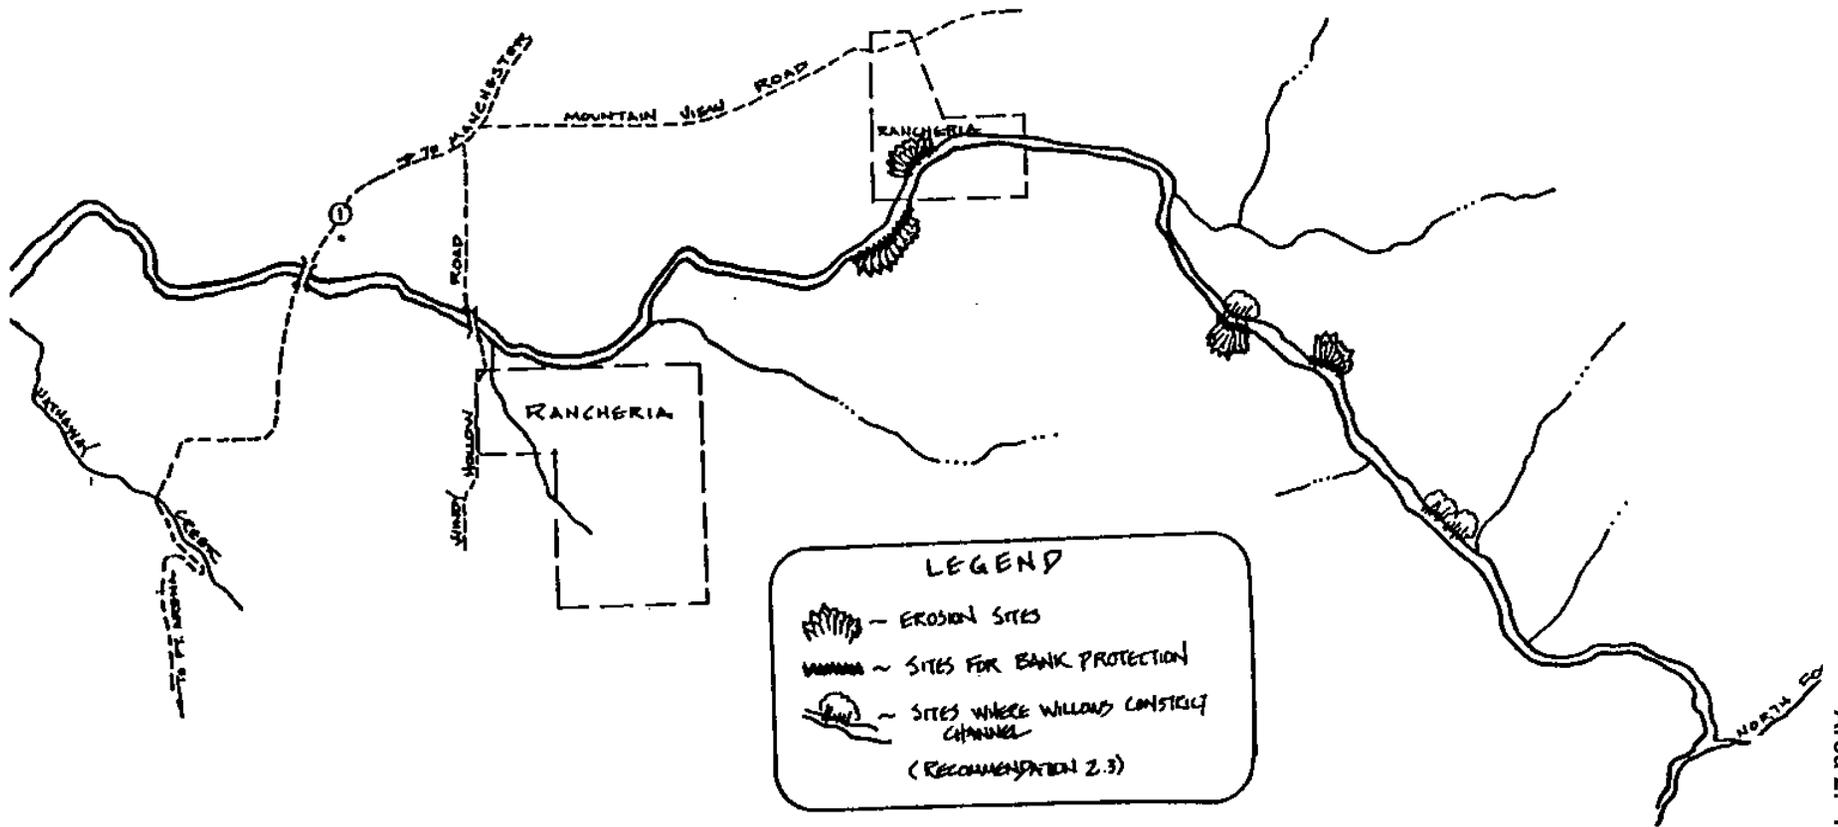
GARCIA RIVER - LOWER 7 MILES.
WORK SITE MAP 2.3

LOWER 7 MILES - PROPOSED BANK PROTECTION SITES |
 (INCLUDING SITES OF WILLOW CONSTRICTION) □

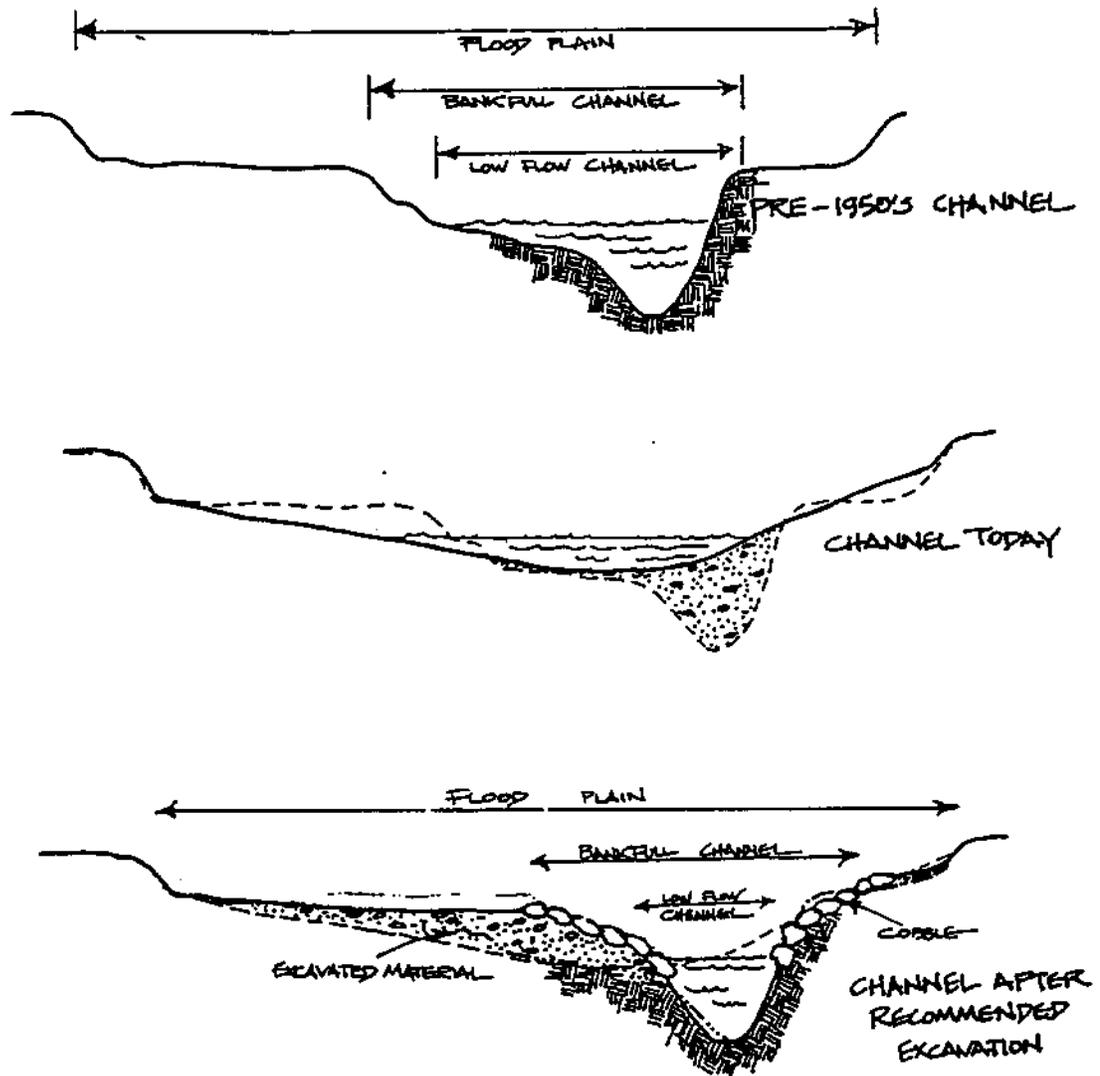
FIGURE 8: DIAGRAM SHOWING EXCAVATION OF A WELL-DEFINED CHANNEL AS RECOMMENDED IN 3.5.

All sound organic material removed by heavy equipment should be stockpiled in an accessible site for future instream structures. On inaccessible sites, hand tools and chainsaws can be used.

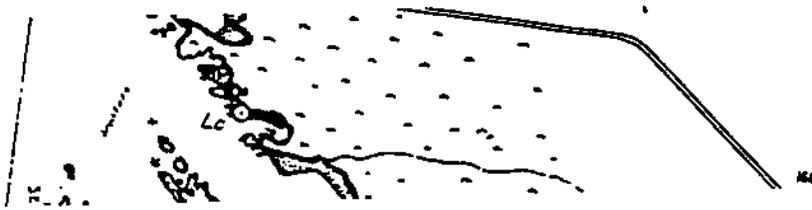
GARCIA RIVER ESTUARY

from U.S. COAST & GEODETIC SURVEY
TOPOGRAPHIC MAP T-4504
1929

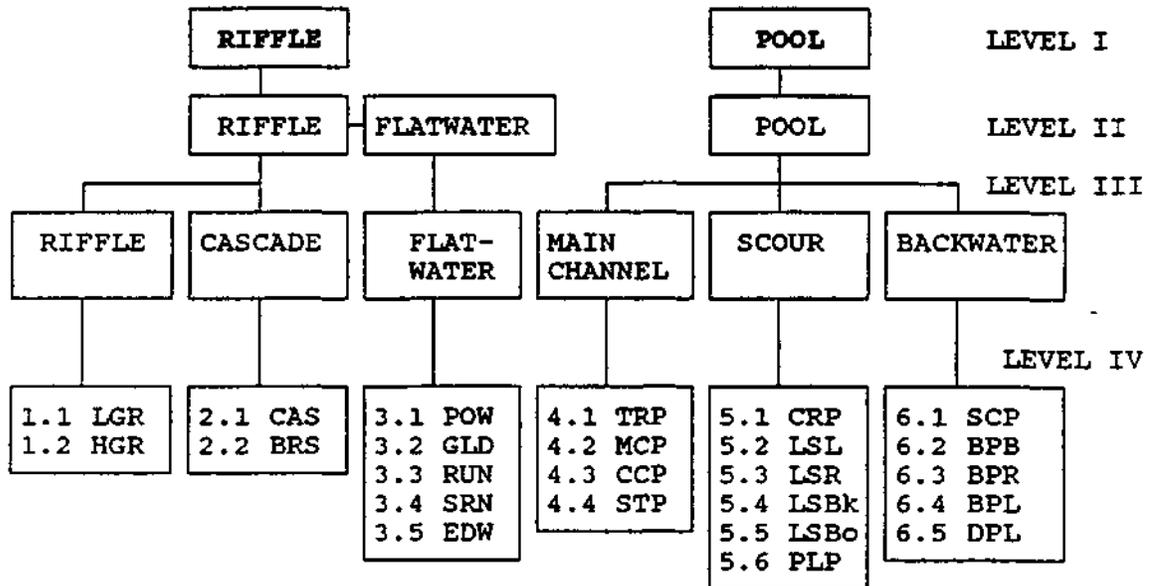
Figure 10. Habitat types hierarchy.

Prior to initiation of an inventory, the level of data collection necessary to meet the needs of the investigation should be established. Habitat typing at level IV will provide the greatest detail and the most complete description of existing habitat. This data can later be aggregated into broader levels of habitat classification if detail is found to be excessive.

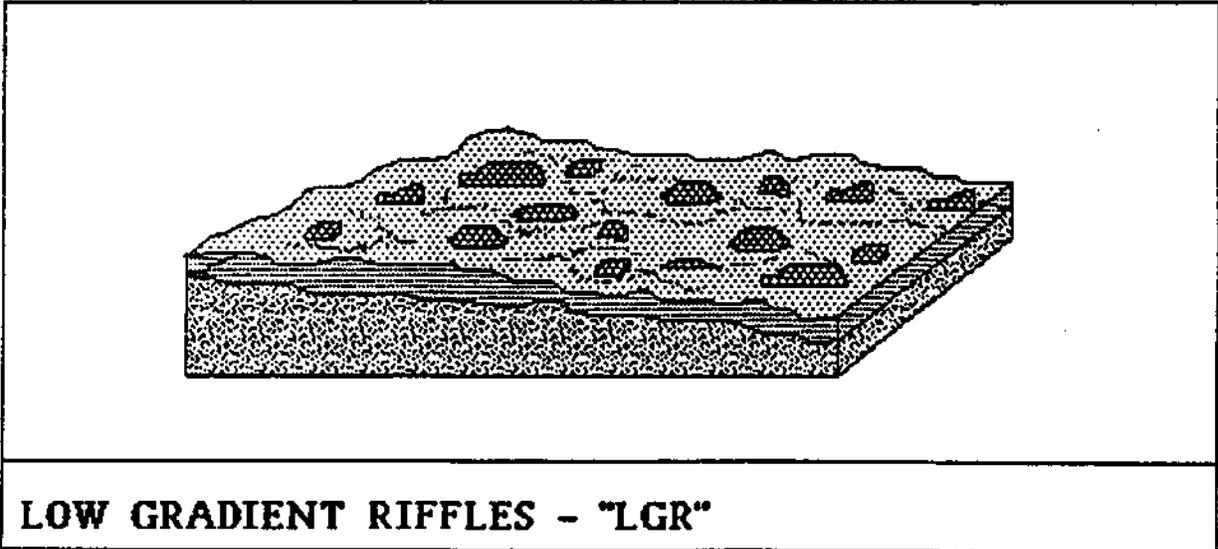
LOW GRADIENT RIFFLE (LGR) [1.1] {1}

Shallow reaches with swiftly flowing, turbulent water with some partially exposed substrate. Gradient $< 4\%$, substrate is usually cobble dominated.

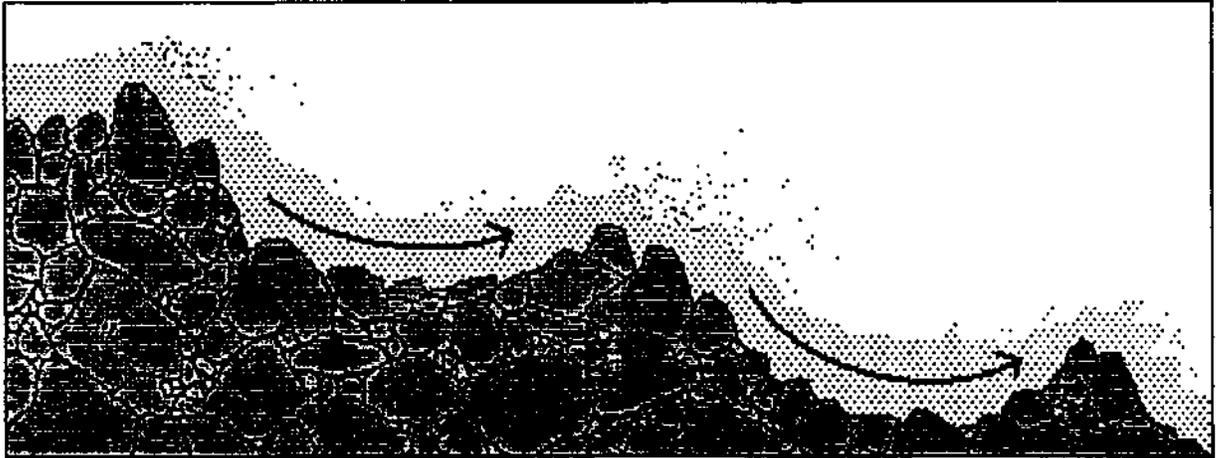
CASCADE (CAS) [2.1] {3}

CASCADE - "CAS"

The steepest riffle habitat, consisting of alternating small waterfalls and shallow pools. Substrate is usually bedrock and boulders.

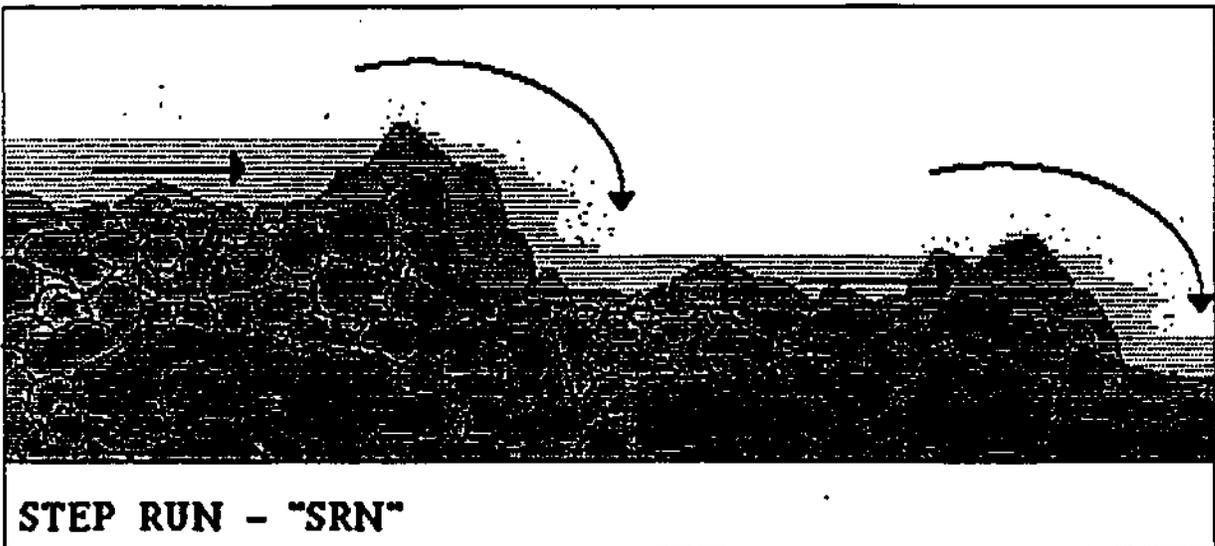
STEP RUN (SRN) [3.4] {16}

A sequence of runs separated by short riffle steps. Substrate is usually cobble and boulder dominated.

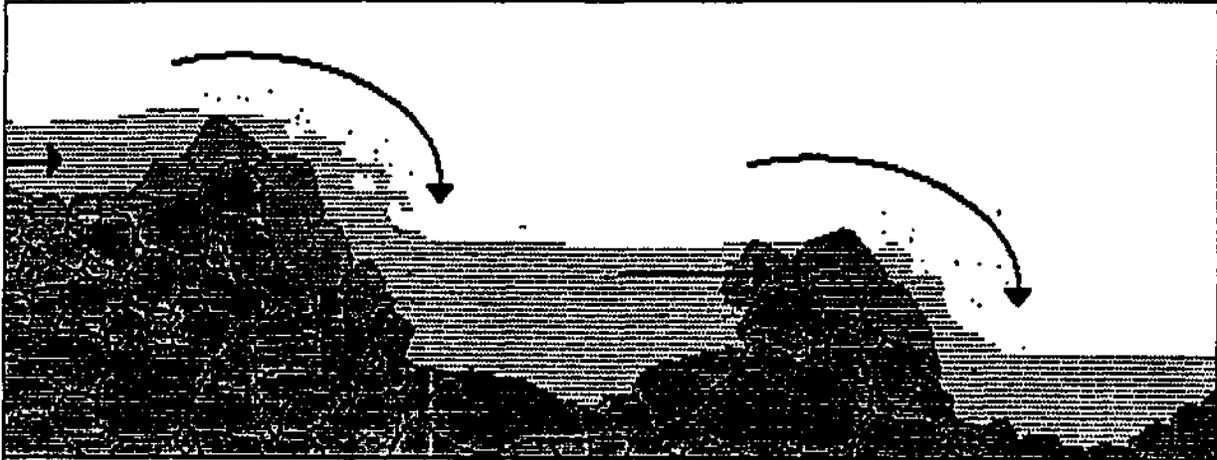
STEP POOL (STP) [4.4] {23}

STEP POOL - "STP"

A series of pools separated by short riffles or cascades. Generally found in high gradient, confined mountain streams dominated by boulder substrate.

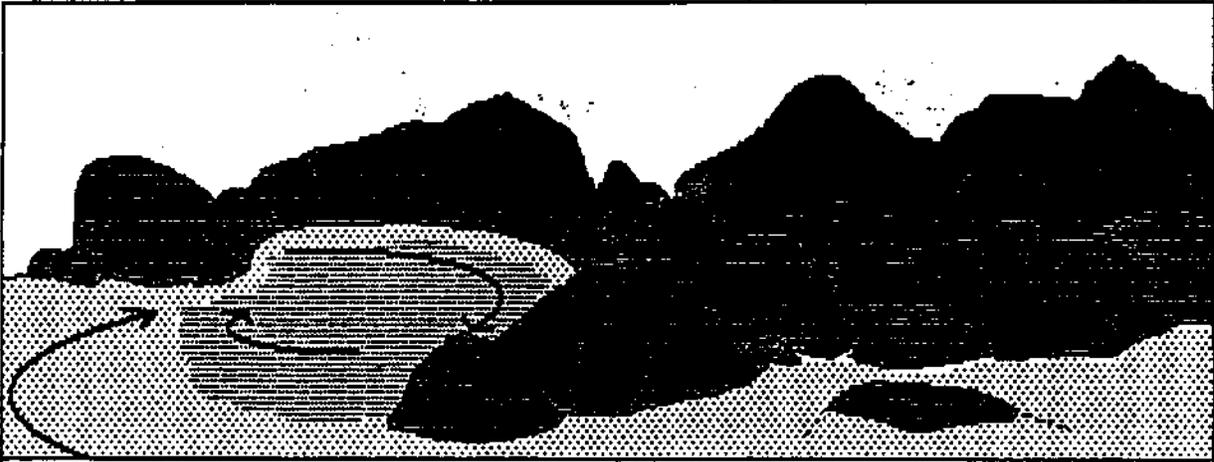
BACKWATER POOL - BOULDER FORMED (BPB) [6.2] {5}

**BACKWATER POOL - "BPB " BOULDER FORMED**

Found along channel margins and caused by eddies around a boulder obstruction. These pools are usually shallow and are dominated by fine-grain substrate. Current velocities are quite low.

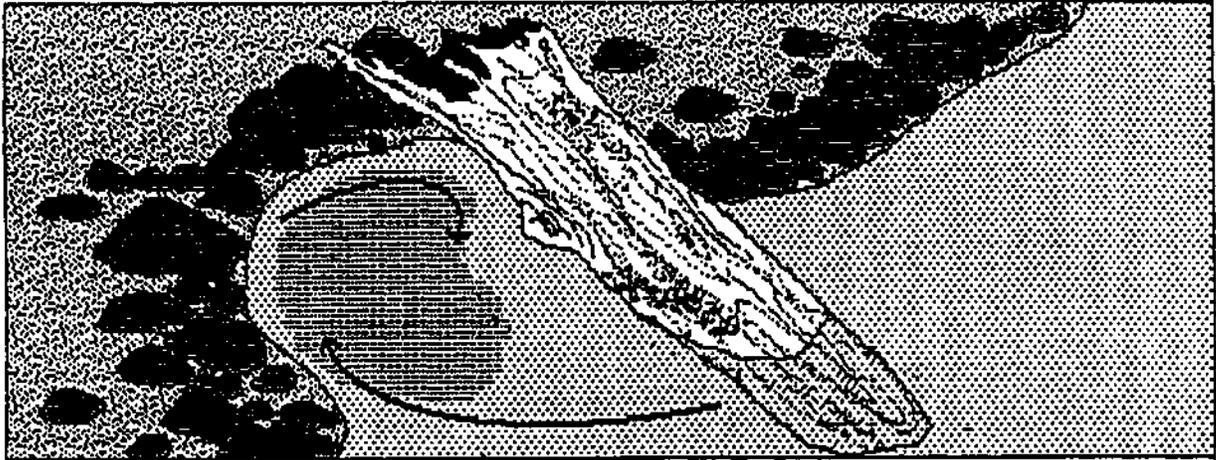
BACKWATER POOL - LOG FORMED (BPL) [6.4] {7}

BACKWATER POOL - "BPL" LOG FORMED

Found along channel margins and caused by eddies around a large woody debris obstruction. These pools are usually shallow and are dominated by fine-grained substrate. Current velocities are quite low.

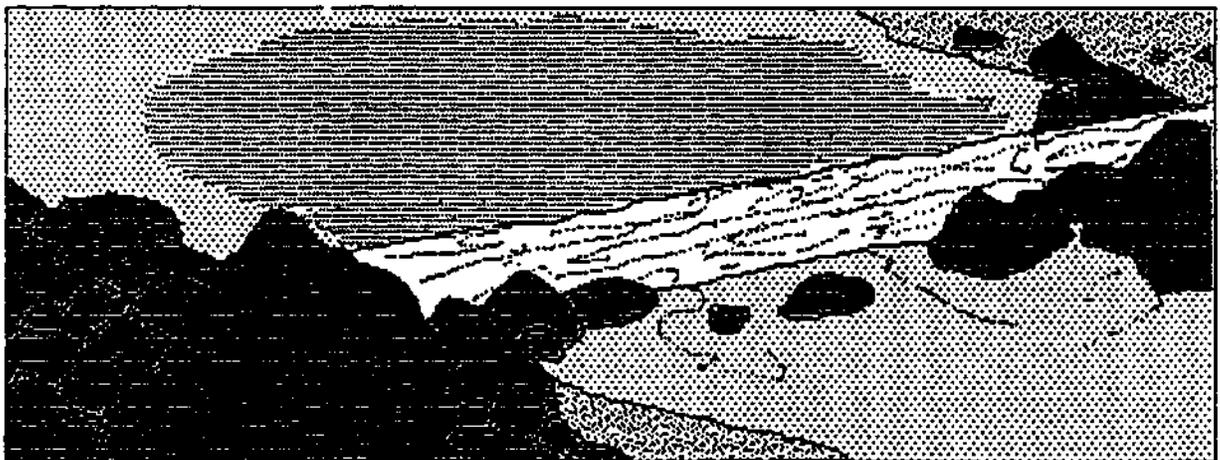
DAMMED POOLS (DPL) [6.5] {13}

DAMMED POOL - "DPL"

Water impounded from a complete or nearly complete channel blockage (debris jams, rock landslides or beaver dams). Substrate tend toward smaller gravel and sand.

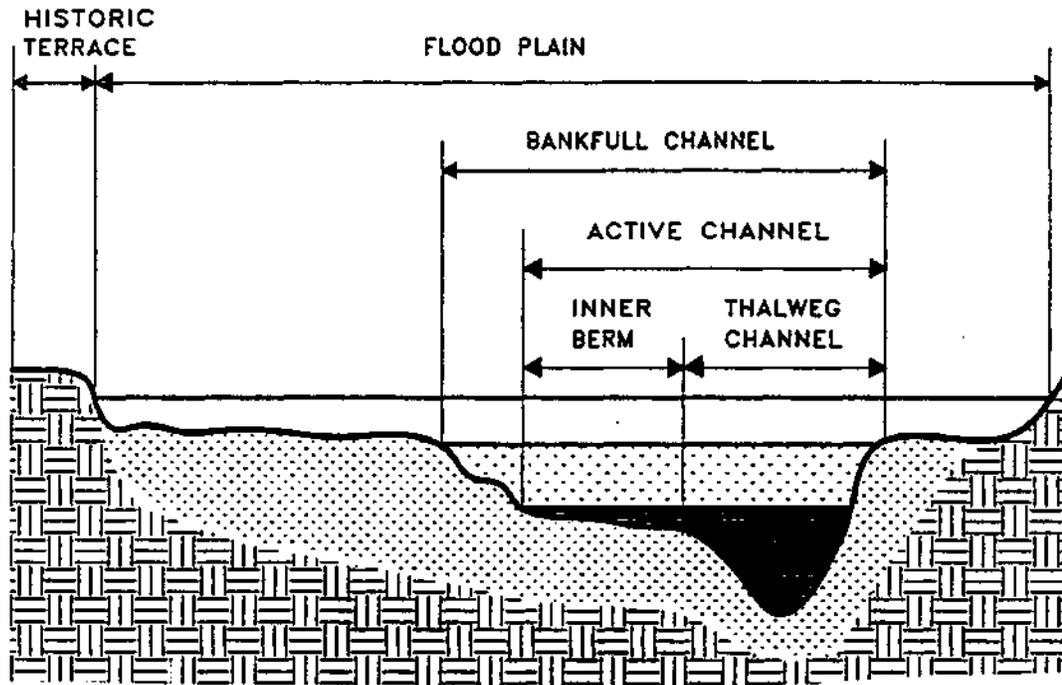
Figure 5. Channel cross section.

Stream gradient (water slope/energy gradient), entrenchment or the width/depth ratio, dominant substrate, and confinement are all determined from measurements taken in the field. Sinuosity can be determined from a 7 1/2 minute topographic map by measuring the lengths of the valley and the stream. Each measurement will be discussed later in Part III.

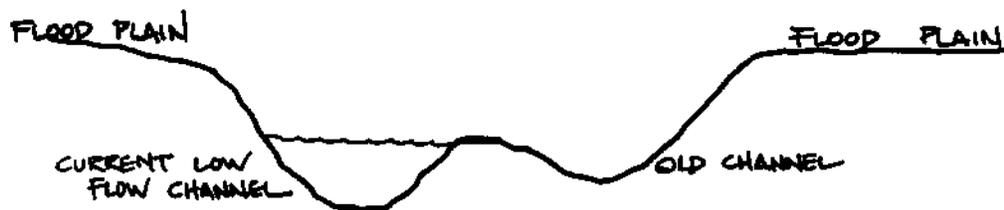
BEFORE:

CROSS-SECTION:

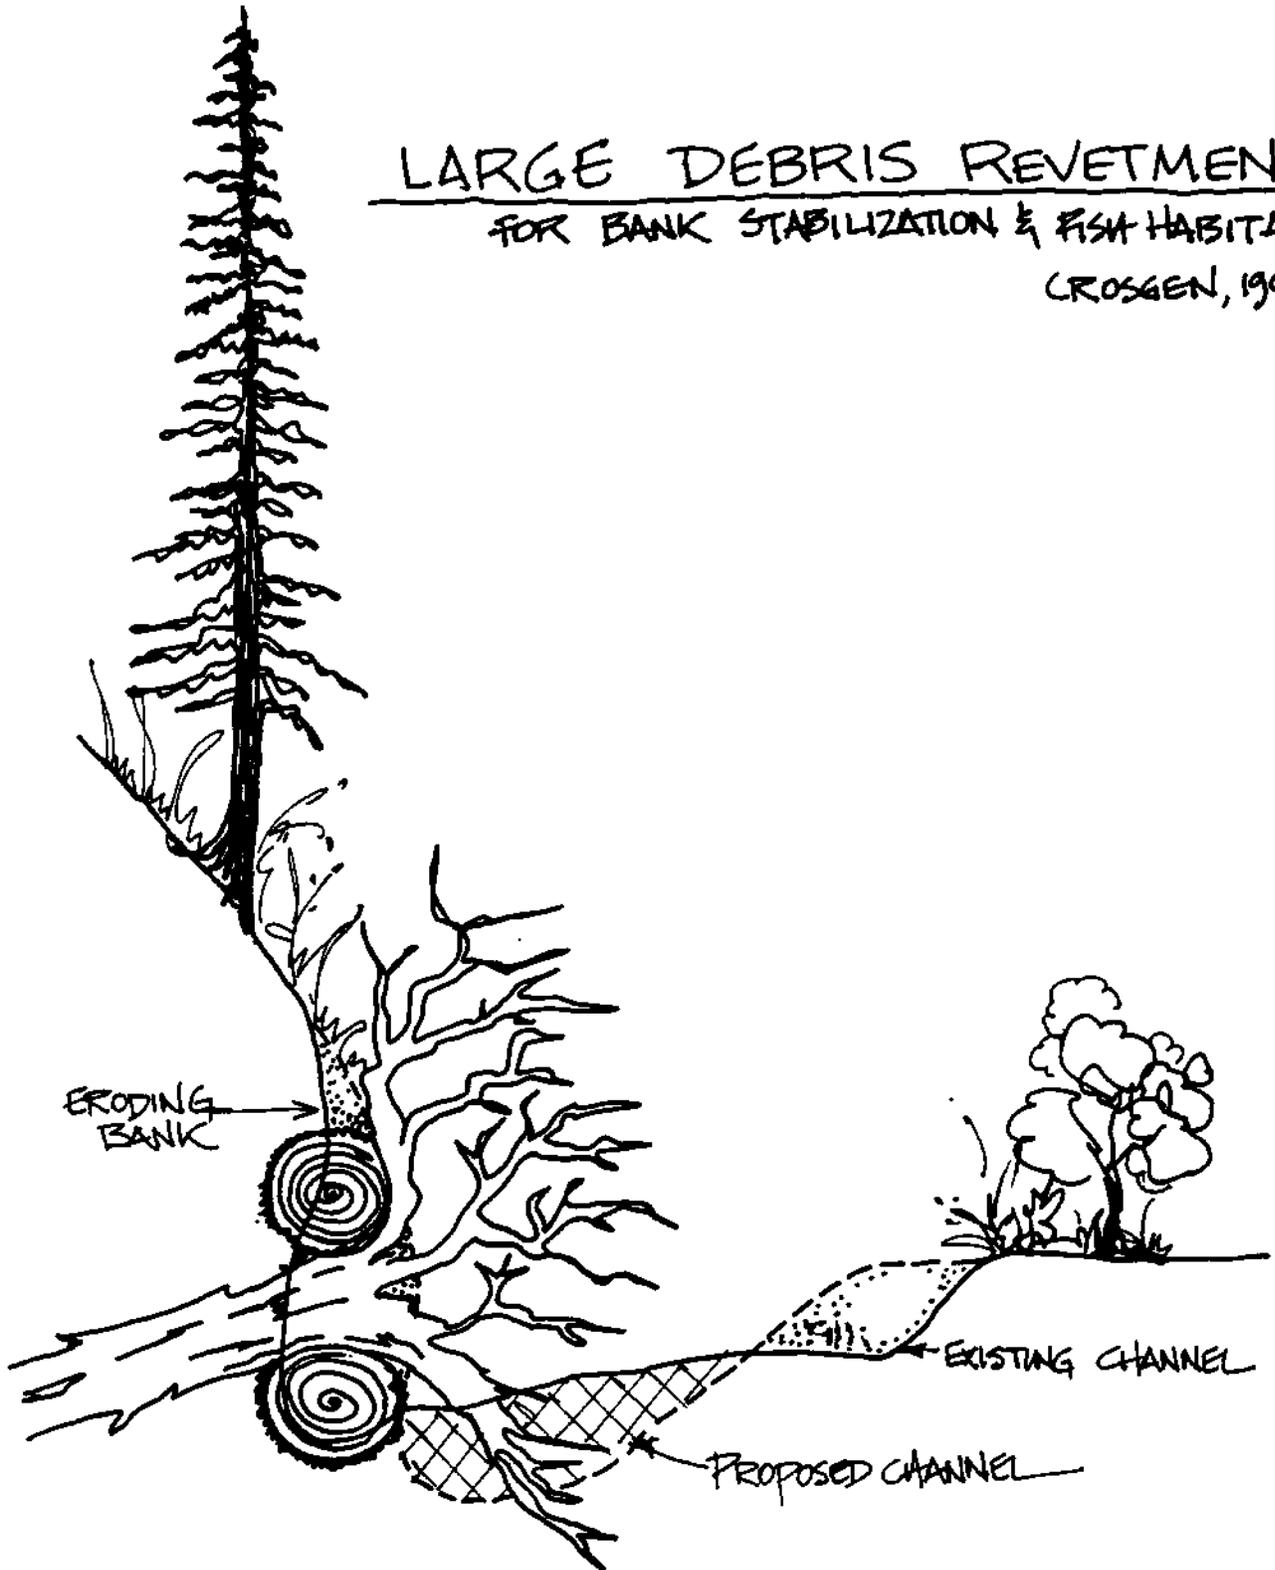
LARGE DEBRIS REVETMENT
FOR BANK STABILIZATION & FISH HABITAT
(CROSGEN, 1991)

imported material as necessary to stabilize the area. (See Appendix III, Large Debris Revetment Diagrams.) It may be necessary to use pilings in some places to secure debris. This bank protection should also create excellent fish habitat by providing complex cover as well as a solid surface for scour which should result in deeper pools. Planting of vegetation adaptable to estuarine environments should be used to help protect banks and provide habitat as discussed in Recommendation 1.1B.

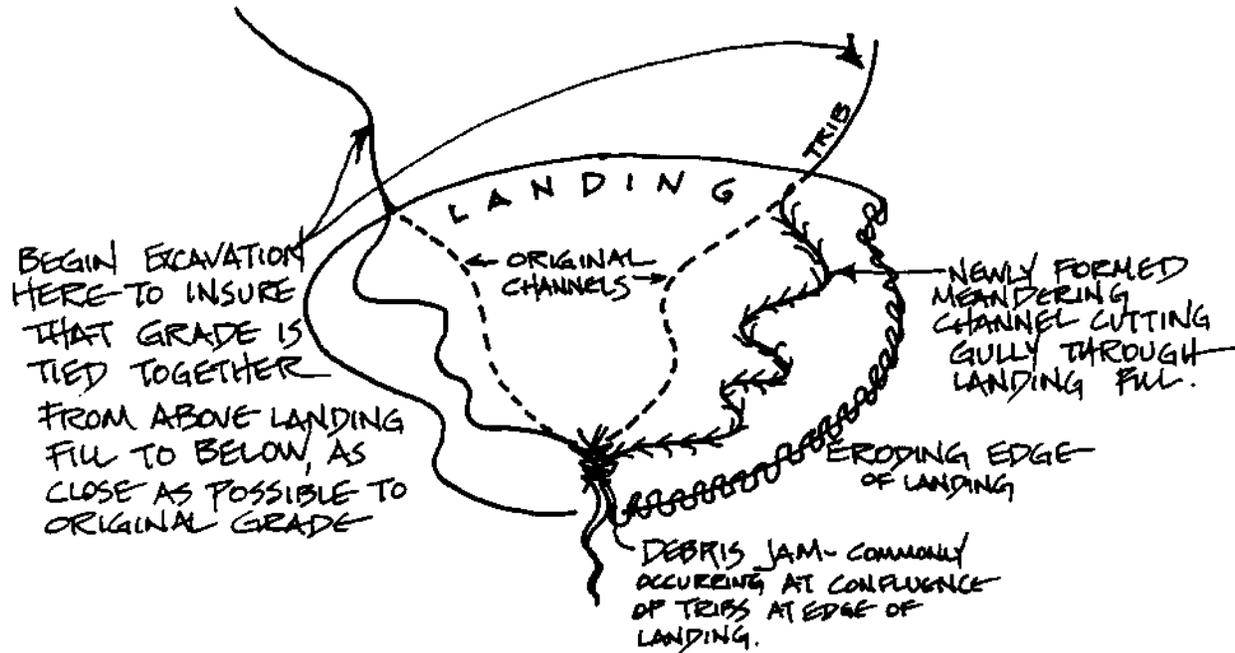
III-2: Diagram 3.3 (acc. Recommendation 3.3) — Recontouring

USE EXCAVATED MATERIAL TO RE-CONTOUR (RE-LANDSCAPE) LANDING SITE WITH OBJECTIVE OF RETURNING TO ORIGINAL GRADE & CONTOURS WHERE POSSIBLE.

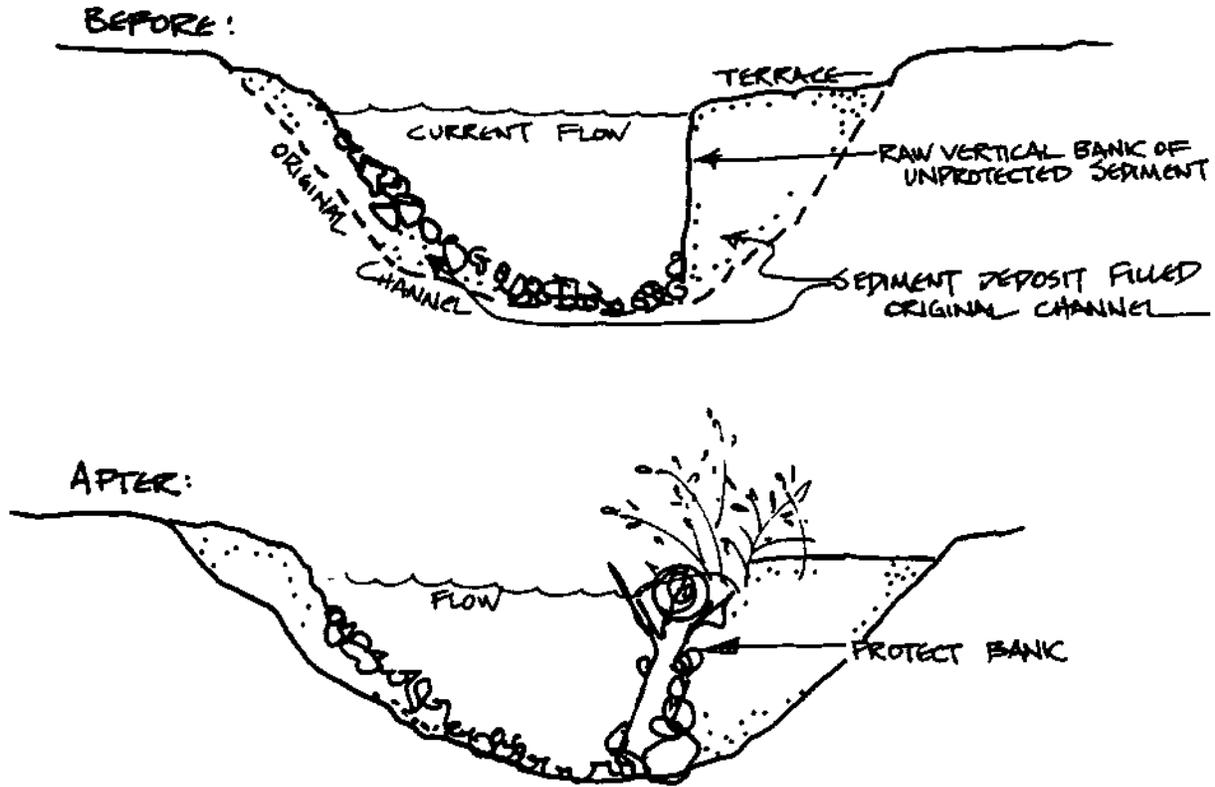
DIAGRAM 3.4
STABILIZATION OF SEDIMENT TERRACES

NOTE: THIS RECOMMENDATION APPLIES TO SMALLER UPSLOPE TRIBES, WHERE VOLUME OF FLOW AND GRADIENT ARE RELATIVELY LOW & SURFACE REVELTMENT IS ADEQUATE. EXACT TREATMENT IS ALWAYS SITE-SPECIFIC. BOTH ROCK & WOODY DEBRIS FOUND ON SITE CAN BE USED TO PROTECT BANKS. RECOMMENDED PLANTINGS/TRANSPLANTINGS INCLUDE BERGIES, JUNKUS, WILLOW, ALDER, CONIFERS, DEPENDING ON AVAILABILITY AND NATIVE SPECIES.

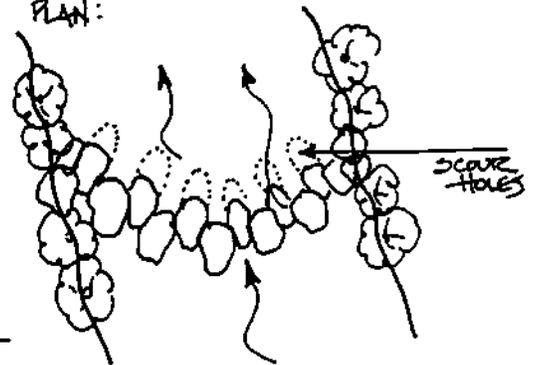
PLAN:

THE OBJECTIVE OF THIS STRUCTURE IS TO:

- 1) PROVIDE INSTREAM COVER IN THE RIFFLE REACH.
- 2) DEEPEN FEEDING AREAS IN THE RIFFLE REACH.
- 3) PROVIDE WIDER RANGE OF VELOCITIES FOR HOLDING WATER AT HIGH FLOW WITHOUT CREATING BACKWATER & SEDIMENT DEPOSITION.
- 4) ACT AS GRADE CONTROL STRUCTURE WITHOUT UPSTREAM LATERAL MIGRATION, BANK EROSION, & AGGREGATION.
- 5) MAINTAIN LOW WIDTH/DEPTH RATIO WHICH WILL REDUCE THE LIKELIHOOD OF BAR DEPOSITION & MAINTAIN SEDIMENT TRANSPORT CAPACITY OF THE STREAM.

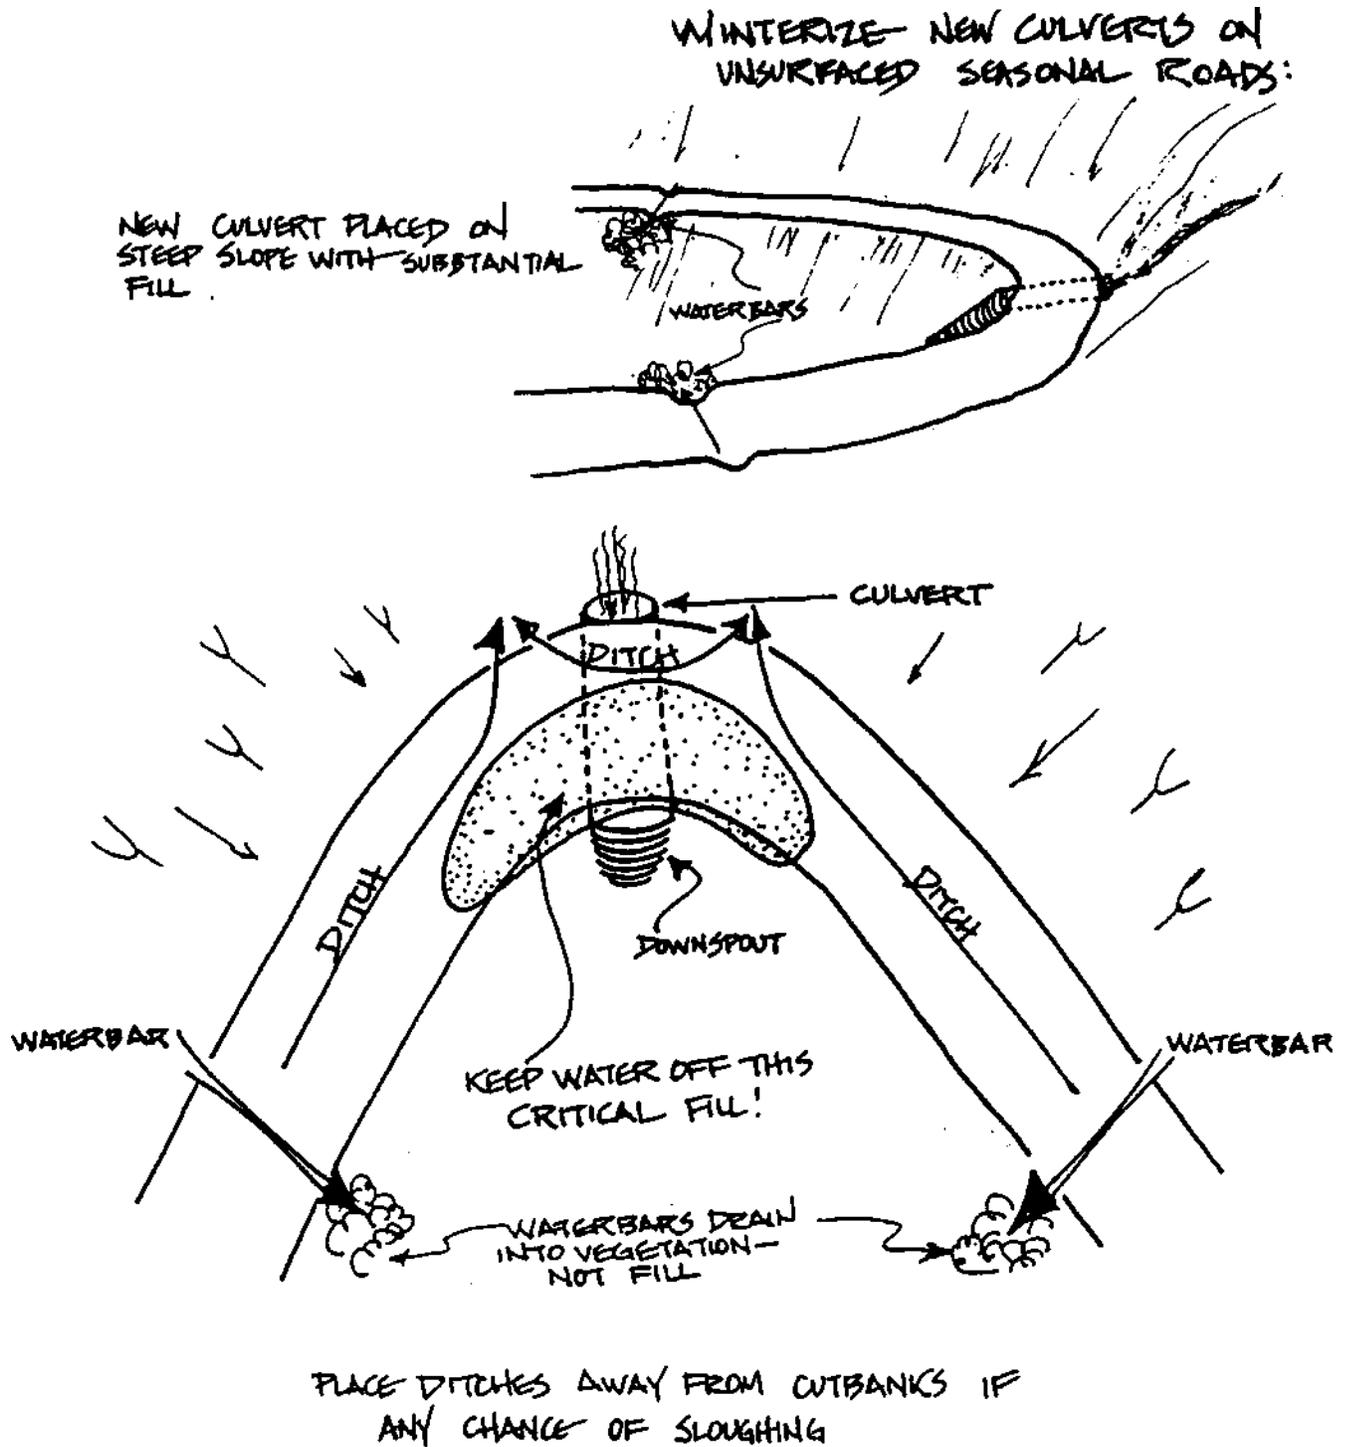
* Winterize new culverts on unsurfaced seasonal roads (such as haul and ranch roads) by protecting fill from surface erosion. This can be done by insloping road surface at crossing, or outsloping the road surface using a berm to channel the road surface runoff away from the fill. If there is a chance of bank sloughing, ditching can be done as shown in the diagram below:

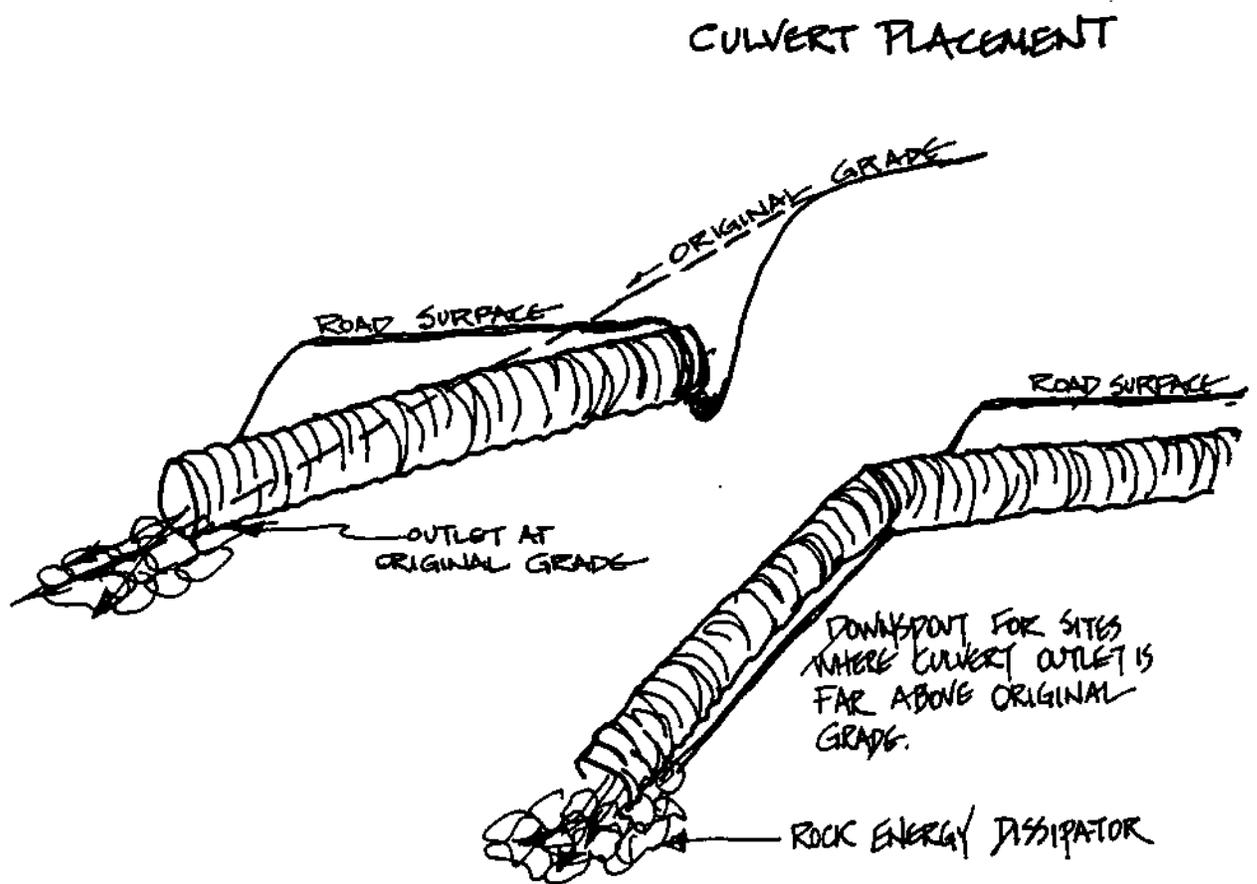
* Place culverts at grade of original drainage where possible. Where this is not possible, provide downspout or enery dissipator to return water from sulvert outlet to drainage at original grade. (See diagram.)

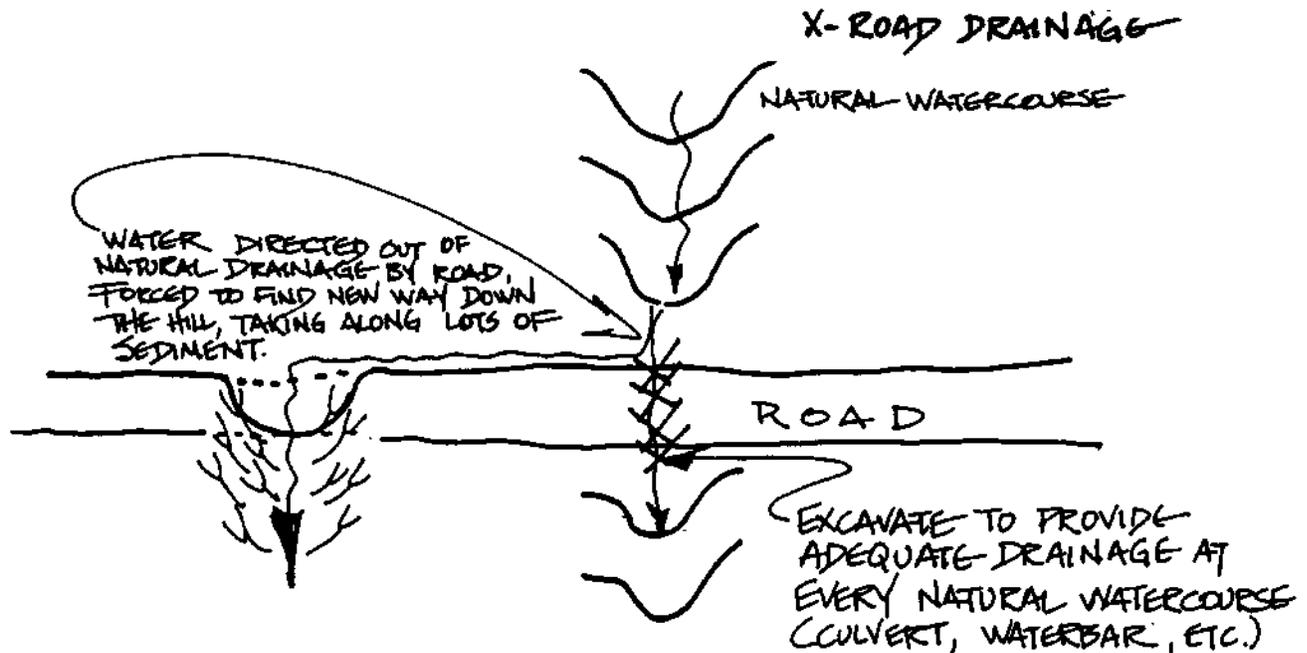
- * Provide cross-road drainage at every natural watercourse. (See diagram.)
