GARCIA RIVER WATERSHED ENHANCEMENT PLAN

The Garcia River Watershed Enhancement Plan

Prepared for California State Coastal Conservancy

Mendocino County Resource Conservation District
Ukiah, California

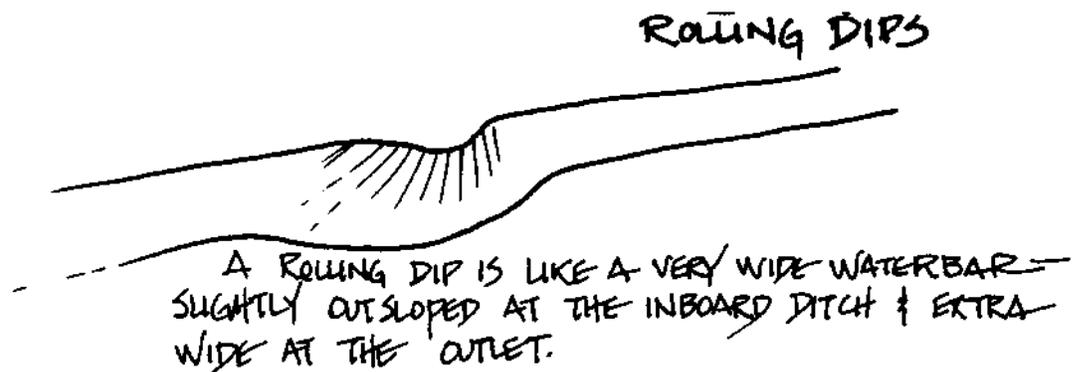
- * Construct new roads during dry season, but early enough that soil moisture is still adequate for compaction. Water road for compaction if necessary.
- * Build smallest road possible to meet the objective.
- * Provide road surface drainage by a combination of the following: outsloping, utilizing natural variations in grade, and rolling dips. (See diagram.)

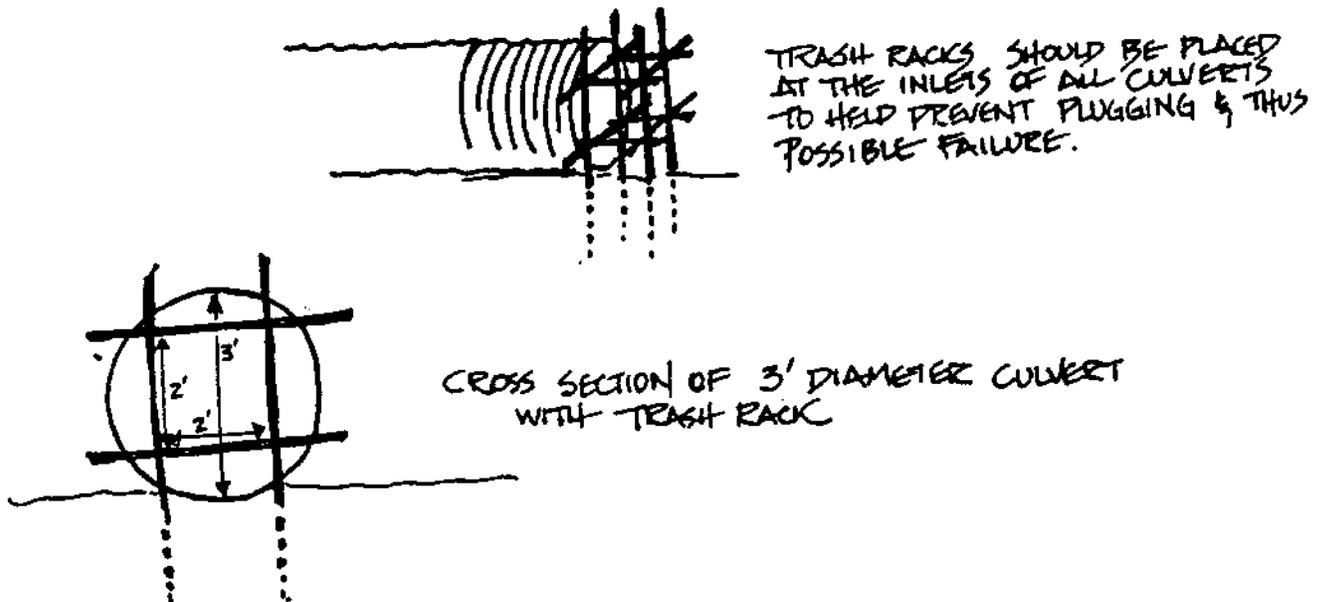
* Place effective trash racks at all culverts. (See diagram.)

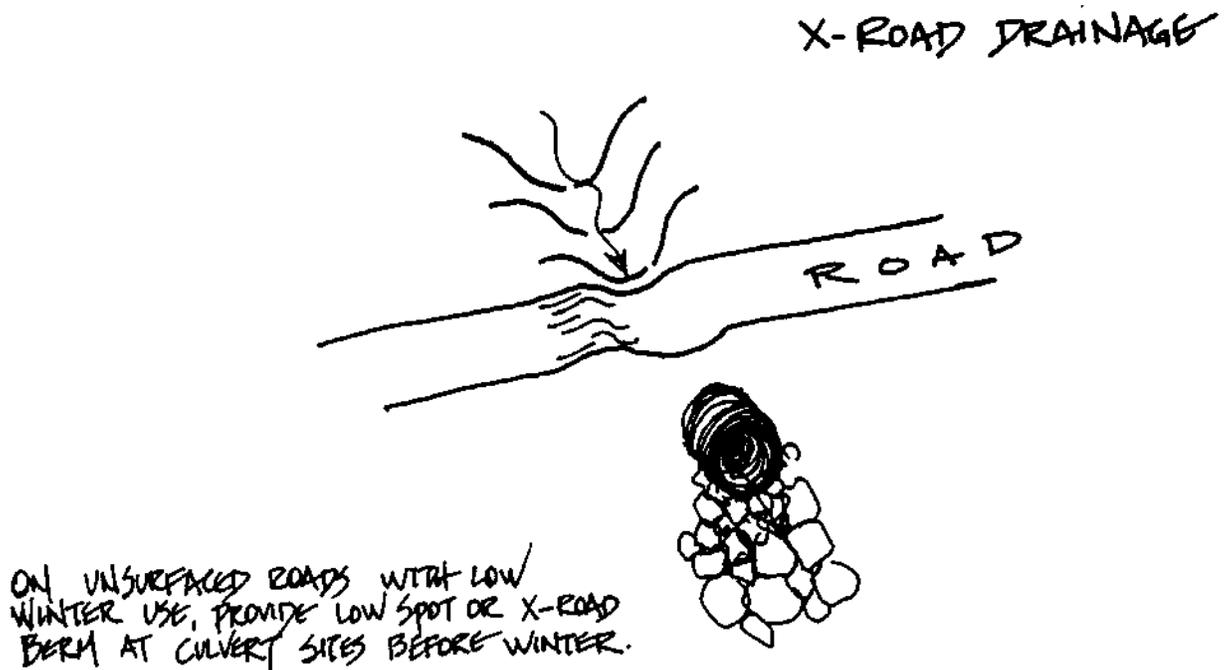
* On unsurfaced roads where winter use is low, provide low spot or cross-road berm at every culvert before the onset of winter. (See diagram.)
