# Gualala Watershed Synthesis Report

This report constitutes a first public review draft of the North Coast Watershed Assessment Program's (NCWAP) watershed assessment work on the Gualala River basin. The North Coast Watershed Assessment Program (NCWAP) was established in 2000 to provide a consistent scientific foundation for collaborative watershed restoration efforts and to better meet the State needs for protecting and restoring salmon. The program was developed as an interagency effort by the California Resources Agency and CalEPA, and includes the Departments of Fish and Game (DFG), Forestry and Fire Protection (CDF), Conservation's Division of Mines and Geology (DMG), and Water Resources (DWR), and the State Water Resources Control Board's North Coast Region (NCRWQCB). The Institute for Fisheries Resources is a contractor to CDF assisting in the development of a computerized database adapted from the Klamath Resource Information System (KRIS). The process also involved scoping and interaction with the Gualala River Watershed Council (GRWC), Gualala Redwoods, Inc. (GRI), and landowners in the watershed. This report is designed to begin to assess watershed conditions as they r

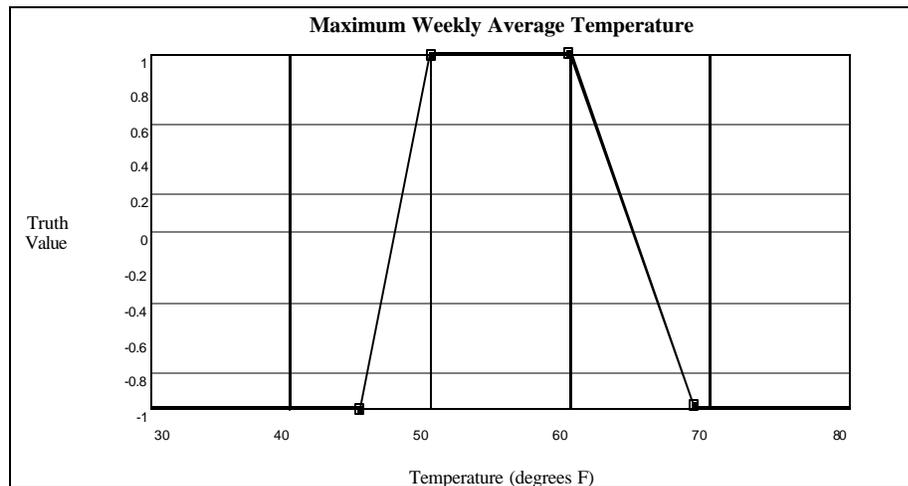
**FIGURE 6: Relationship between Water Temperature and Suitability for Salmon**

In a similar manner, each of the four main environmental factor is actually made up of smaller constituent components. For example, in the NCWAP Watershed Condition model the 'upland condition' factor consists of a sub-network of more detailed data on land use, land cover (vegetation) and slope stability that determine it (not shown in the above figure). Information in the sub-network that determines land use includes data on developed area, cultivated area, grazed area and area of timber harvests. In knowledge bases, this pattern of logic networks can be expanded up or down as much as desired, until there is a full picture of all factors affecting salmonid conditions in the watershed. The beginning boxes (end branches) in a knowledge base network are where the data is entered.

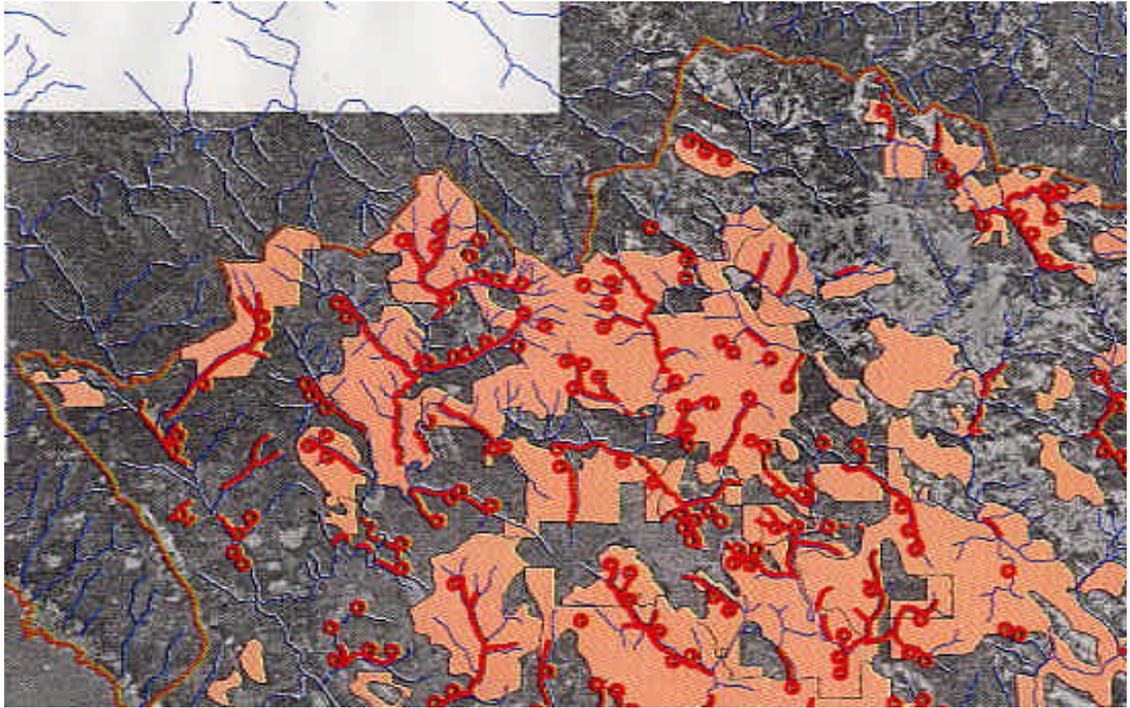
**FIGURE 9: Harvest operations 1952-1964 & streamside roads/landings 1952-1968**

All red lines show where road fill has been pushed into the creek burying the streambank..

Roadfill sidecast to the stream channel was undermined during peak flows creating numerous debris slides and road fill failures discharging into watercourses. This upper area of the basin was affected by the 1964 flood although actual impacts that can be attributed directly to the flood were not documented with this assessment due to lack of 1965 air photo coverage in Mendocino Co. Most of the lower areas of the basin, including the Little North Fork, were logged between 1965 and 1968. Lateral road construction continued to follow the streambank channel to one side, removing riparian canopy.

Logging operations accelerated during the mid-1950s in inland Douglas fir dominated areas in the middle to upper reaches of the basin. Road construction was built running adjacent to the main stream channel of all primary tributary watercourses (See Figure 9).

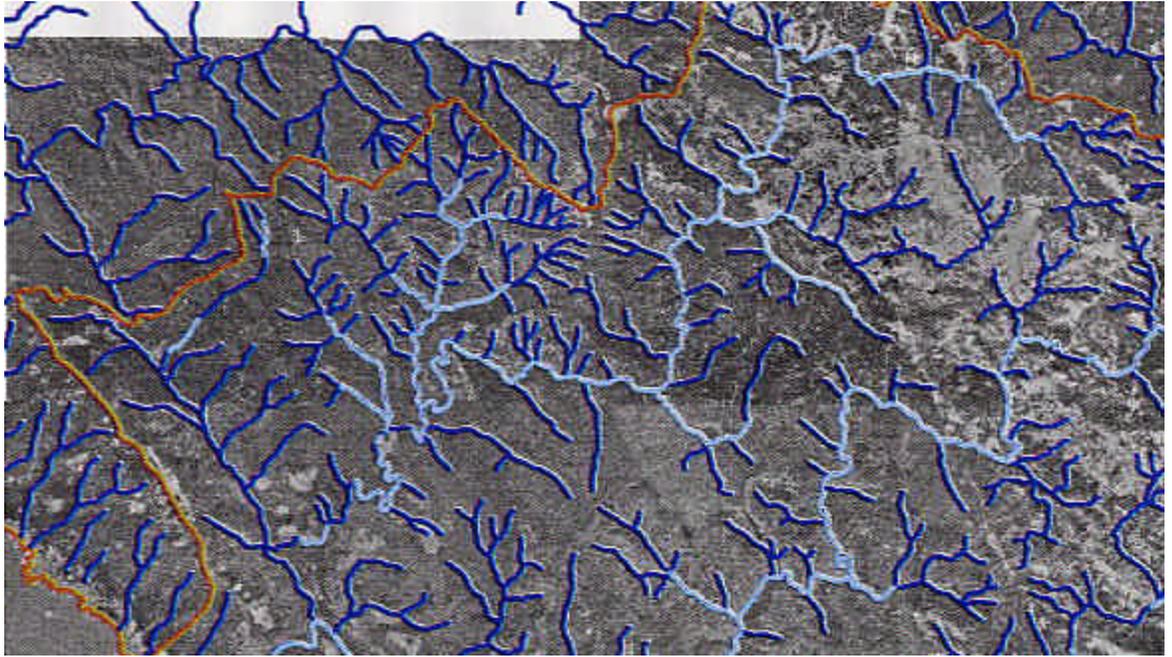
**FIGURE 10: Bank to bank shade canopy exposure (white).**

*Blue shows partial to entire shade canopy cover.*

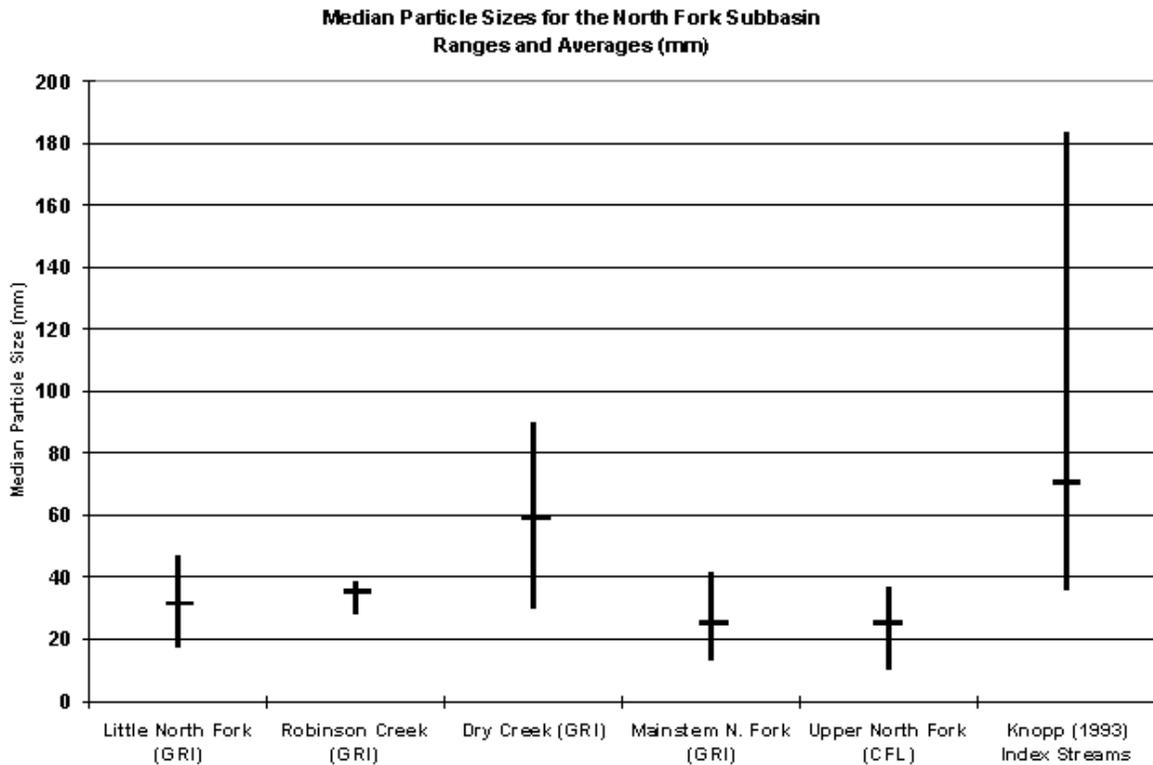
**FIGURE 13: Median Particle Sizes for North Fork Subbasin**

The significance of these data lie in the mobility of the sediments and the resultant impacts to salmonid embryo survival. Small particles are mobilized by smaller and more frequent flow events. Increased bedload mobility can directly impact salmonid spawning success due to redd destruction and capping (Nawa et al., 1990). Destruction of redds during incubation affects survival of the embryos from that spawning event, potentially affecting the timing of runs. Cedarholm (1983) found that a decrease in particle size distribution on the Clearwater River in Washington favored a later run timing in adult steelhead from January to March in response to bedload movement. Shifting bedload in northern California could have a greater impact on coho salmon, because they have not been documented spawning later than February in California coastal streams (Allen and Hassler, 1986).

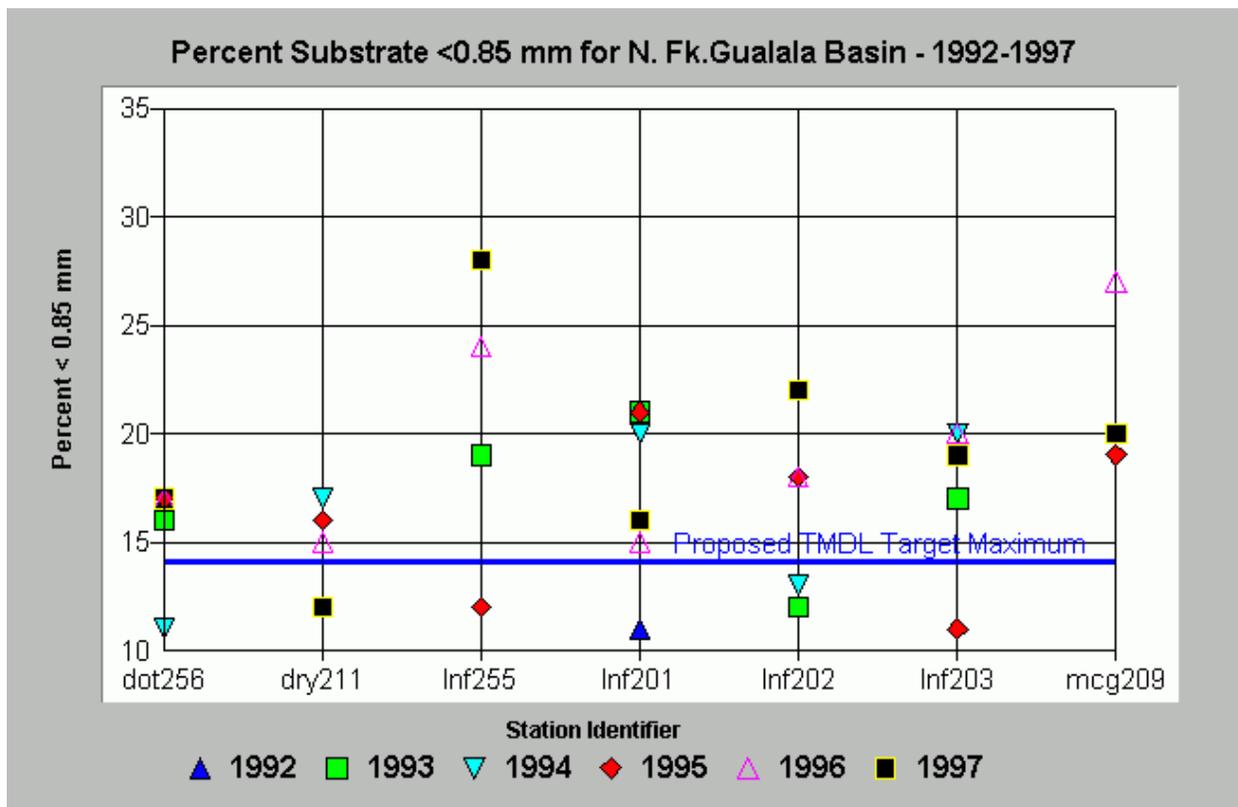
**FIGURE 14: Percent substrate for North Fork Gualala Basin 1992-1997**

Although McNeil data can be quite variable across a riffle area, percent fines <0.85 mm from McNeil cores of riffles at four sites in the mainstem Little North Fork, one site in Doty Creek, and one site in McGann Gulch (sites dot 256, mcg 209, lnf 255, lnf 201, lnf 202, lnf 203), often exceeded the Gualala proposed TMDL target of 14% (Figure 12). Dry Creek site 211 was closer to the target, but exceeding in three of four years.

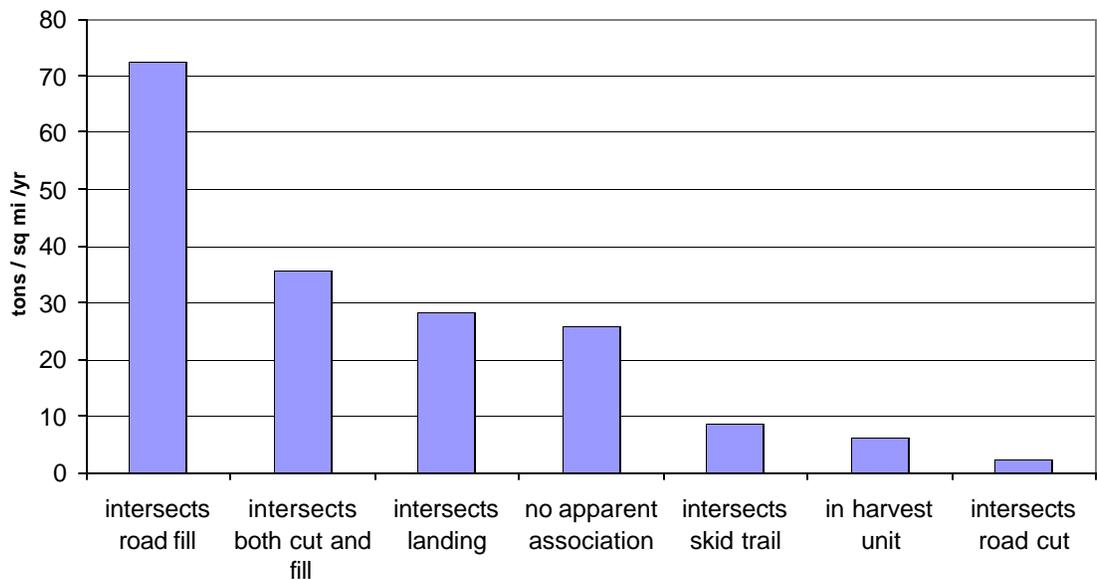
**FIGURE 15: Results of Gualala TMDL Aerial Photo Inventory**

The Gualala Technical Support Document for the TMDL (CWQCB 2001) (Gualala TSD) lists the current top eight sediment sources as: road mass wasting, bank erosion, natural sources, surficial road erosion, timber harvest, road gullies, road crossing failures, and skid trails. Figure presents data used by Regional Board staff to prepare the Gualala TSD for the Total Maximum Daily Load for Sediment (CRWQCB, 2001). Figure 13 presents estimates of sediment delivery from mass wasting features greater than 10,000 ft<sup>2</sup> in plan area observed in the 1999/2000 photos, but not observed in the 1988 photos. The estimate also includes enlargement of previously existing features. Only features greater than 10,000 ft<sup>2</sup> in plan area were estimated. Estimates of sediment delivery are presented by geographic association with management activity, regardless of cause. Rates of sediment delivery were estimated based on feature area, average depth of failure of 56 measured features, proximity to watercourses, and a conversion factor of 1.48 tons/yd<sup>3</sup>.

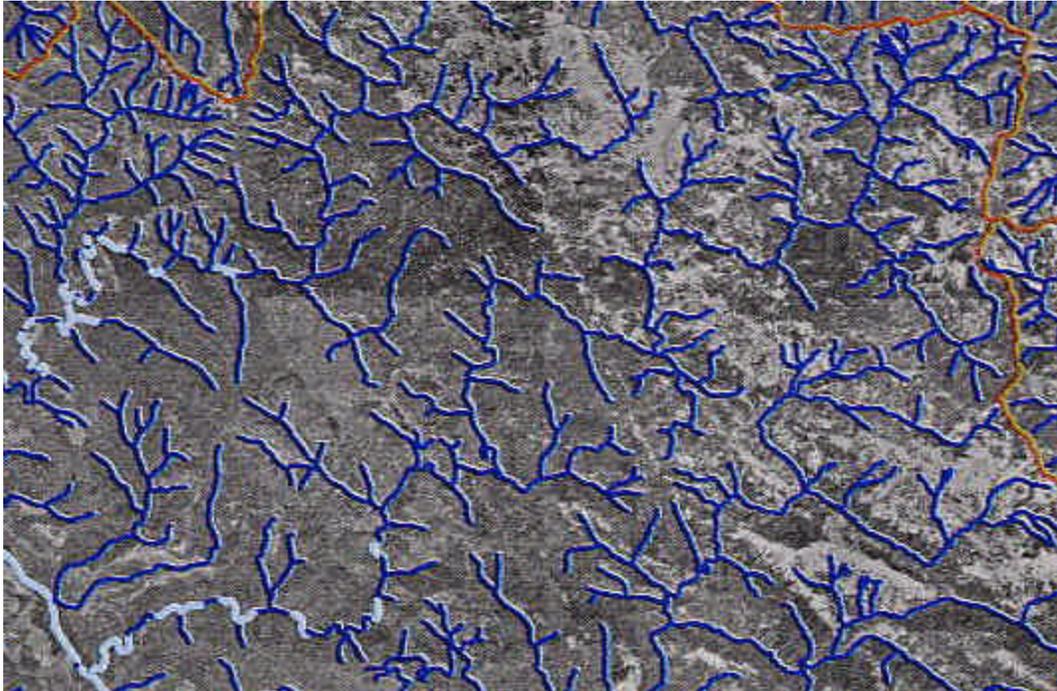
**FIGURE 19: 1941 Rockpile Creek overstory canopy exposure**

*1942 Bank to bank overstory shade canopy expose (white), lower left, on Rockpile Ck.  
Blue lines show partial to entire canopy cover.*

The narrow Rockpile basin contains high site timber ground downstream from Rockpile Peak. Upstream areas contain mixed conifer hardwood forests with grassland on ridgelines and south facing slopes. In the lower and middle reaches, the 1942 photos show dense mature coniferous shade canopy cover over all primary streams. Only the lowest reaches near the confluence point with the South Fork is Rockpile Creek wide enough to create bank to bank exposure in an alluvial flood basin (See Figure 19, below).

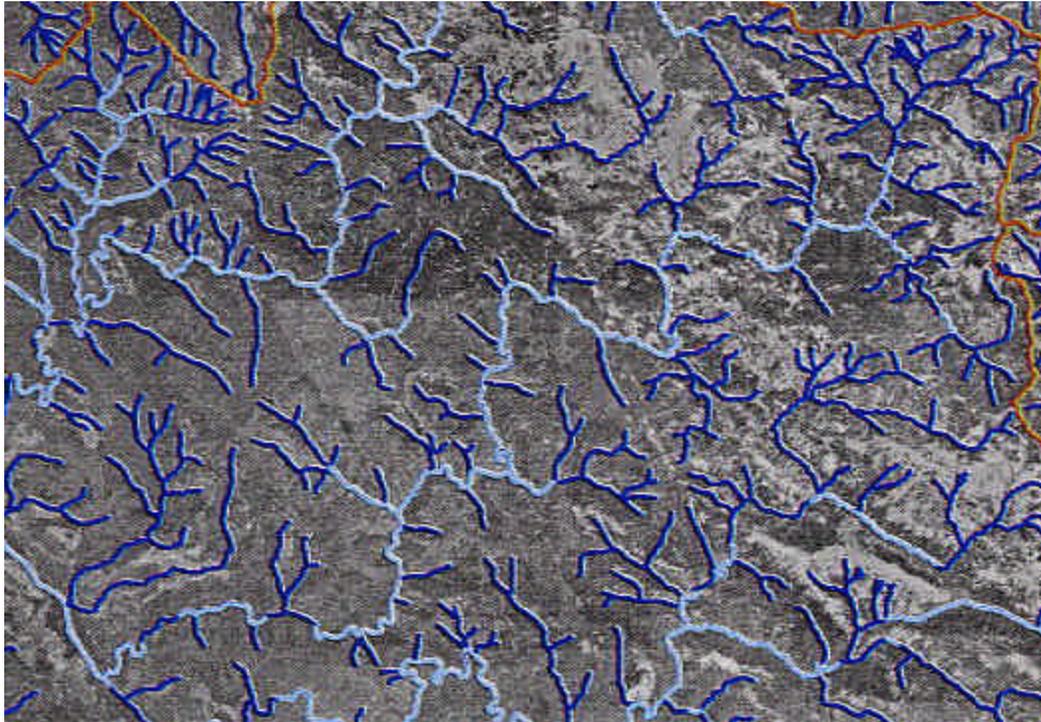
**FIGURE 21: 1981 Bank to Bank shade canopy exposure**

*1981 Bank to Bank shade canopy exposure (white), Rockpile Ck.  
Dark blue lines show partial to entrie canopy cover.*

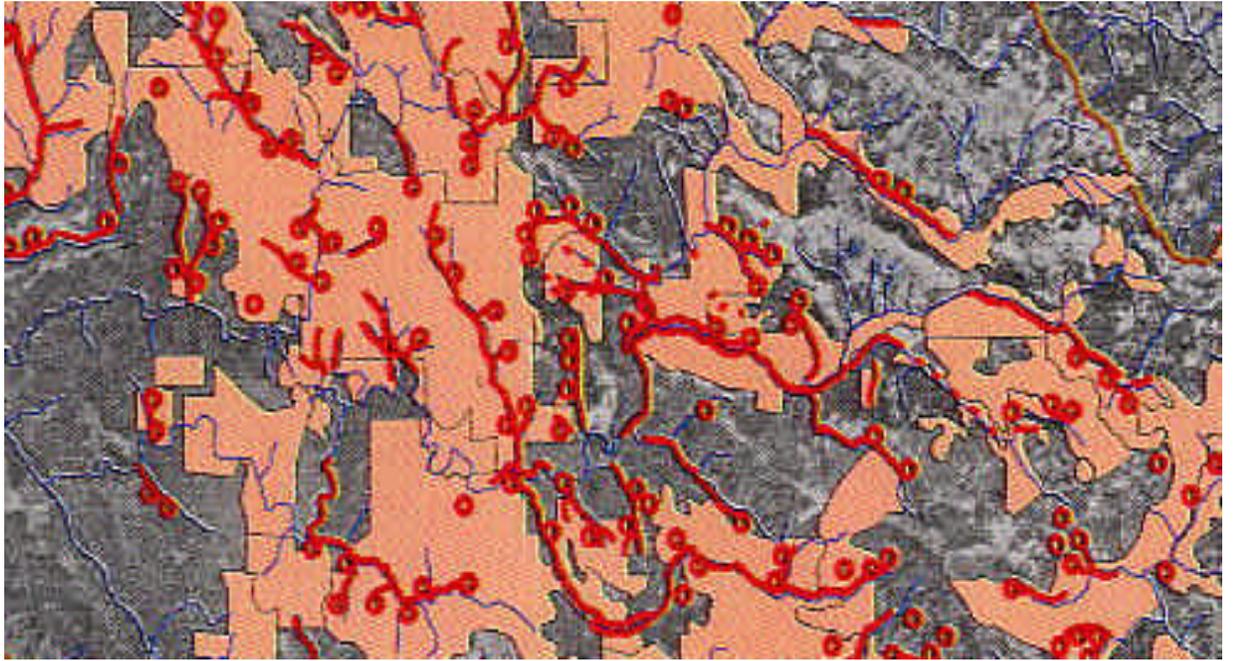
**FIGURE 27: Buckeye Basin - Harvest Operations 1952-1964**

*Also shown above streamside roads and landings 1952 to 1968. Red lines show where road fill has been pushed into the creek*

In the late 1950s, the Franchini Creek basin and surrounding area formed the south portion of the large multi basin harvest complex area bounded by the upper North Fork and the main stem Buckeye Creek. This unit followed a large mid 50s operation that extended south from the main stem Buckeye through the lower Wheatfield basin to lower Fuller Creek. In the middle 1950s, downslope Douglas fir trees lining a narrow riparian corridor were removed from both Roy and Osser Creeks. The Grasshopper Creek sub-basin was logged by 1964. Downslope areas of Douglas fir were logged throughout Soda Springs and Flatridge Creeks by 1964. Streamside roads and landings are particularly concentrated throughout (1) Francini Creek, (2) Grasshopper Creek, and (3) the North Fork Buckeye including Osser Creek. (See Figure 27 below).

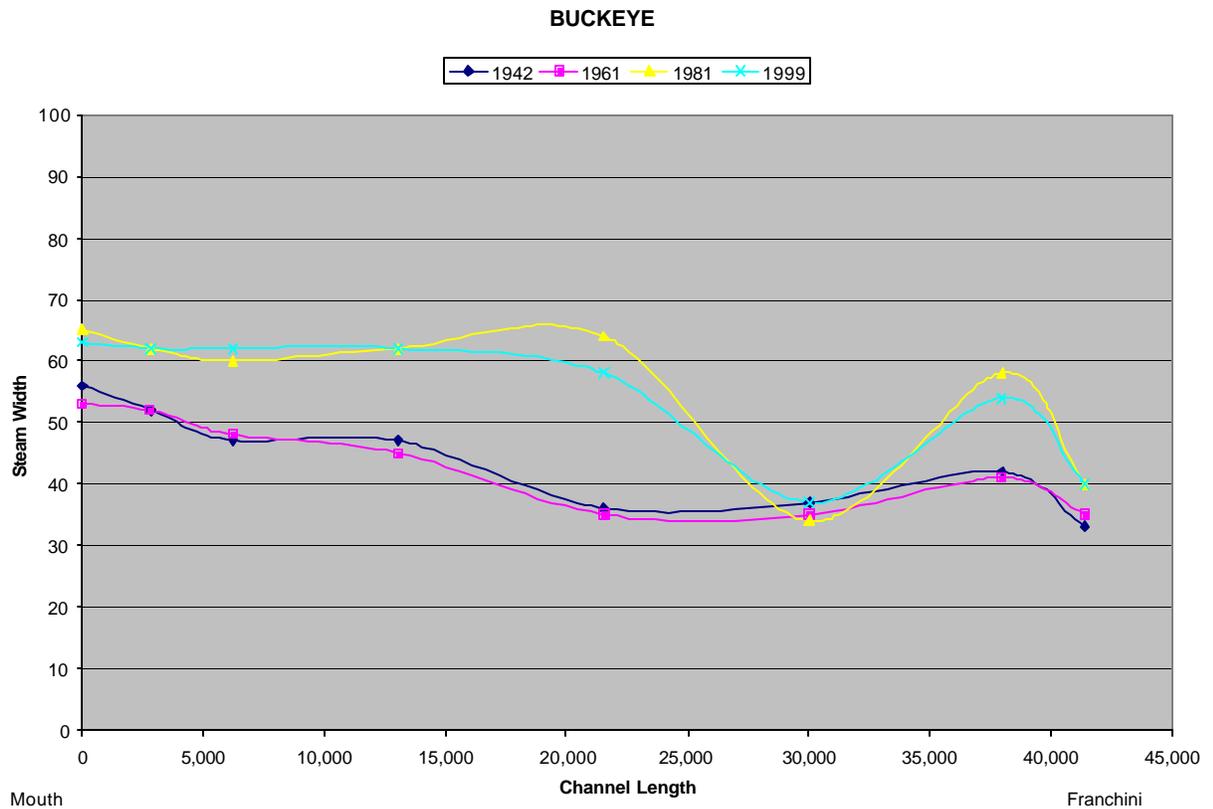
**FIGURE 29: 20 yr. interval stream channel**  
*1942 to 1999, lower Buckeye reach.*

Twenty year interval stream channel width measurements from 1942 to 1999 show a response widening of the lower Buckeye storage reach between 1961 and 1981 from the mouth to Franchini Ck. This coincides with concentrated harvest activities between the late 1950s to 1968 when most of the timbered areas in the basin had been liquidated by tractors over a narrower time frame compared to the North Fork at this time, which did not show a response. 1942 channel widths can be considered baseline as most of the basin at this time consisted of undisturbed Douglas-fir timberlands.

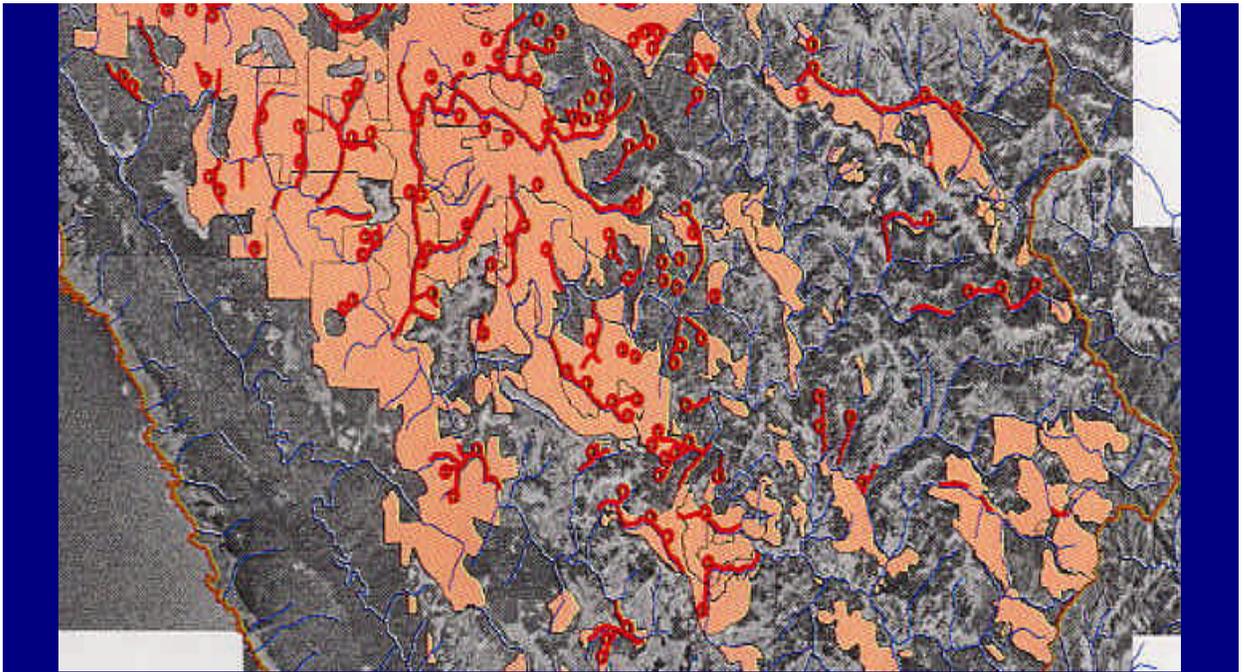
**Figure 36: TIMBER HARVEST OPERATIONS 1952-1964**

*Streamside roads and landings (red). As a result, the 1964 flood event incised the in-stream landings and undercut streamside roads collapsing sections into the creek. The non-existent road drainage concentrated runoff triggering debris slides accessing watercourses.*

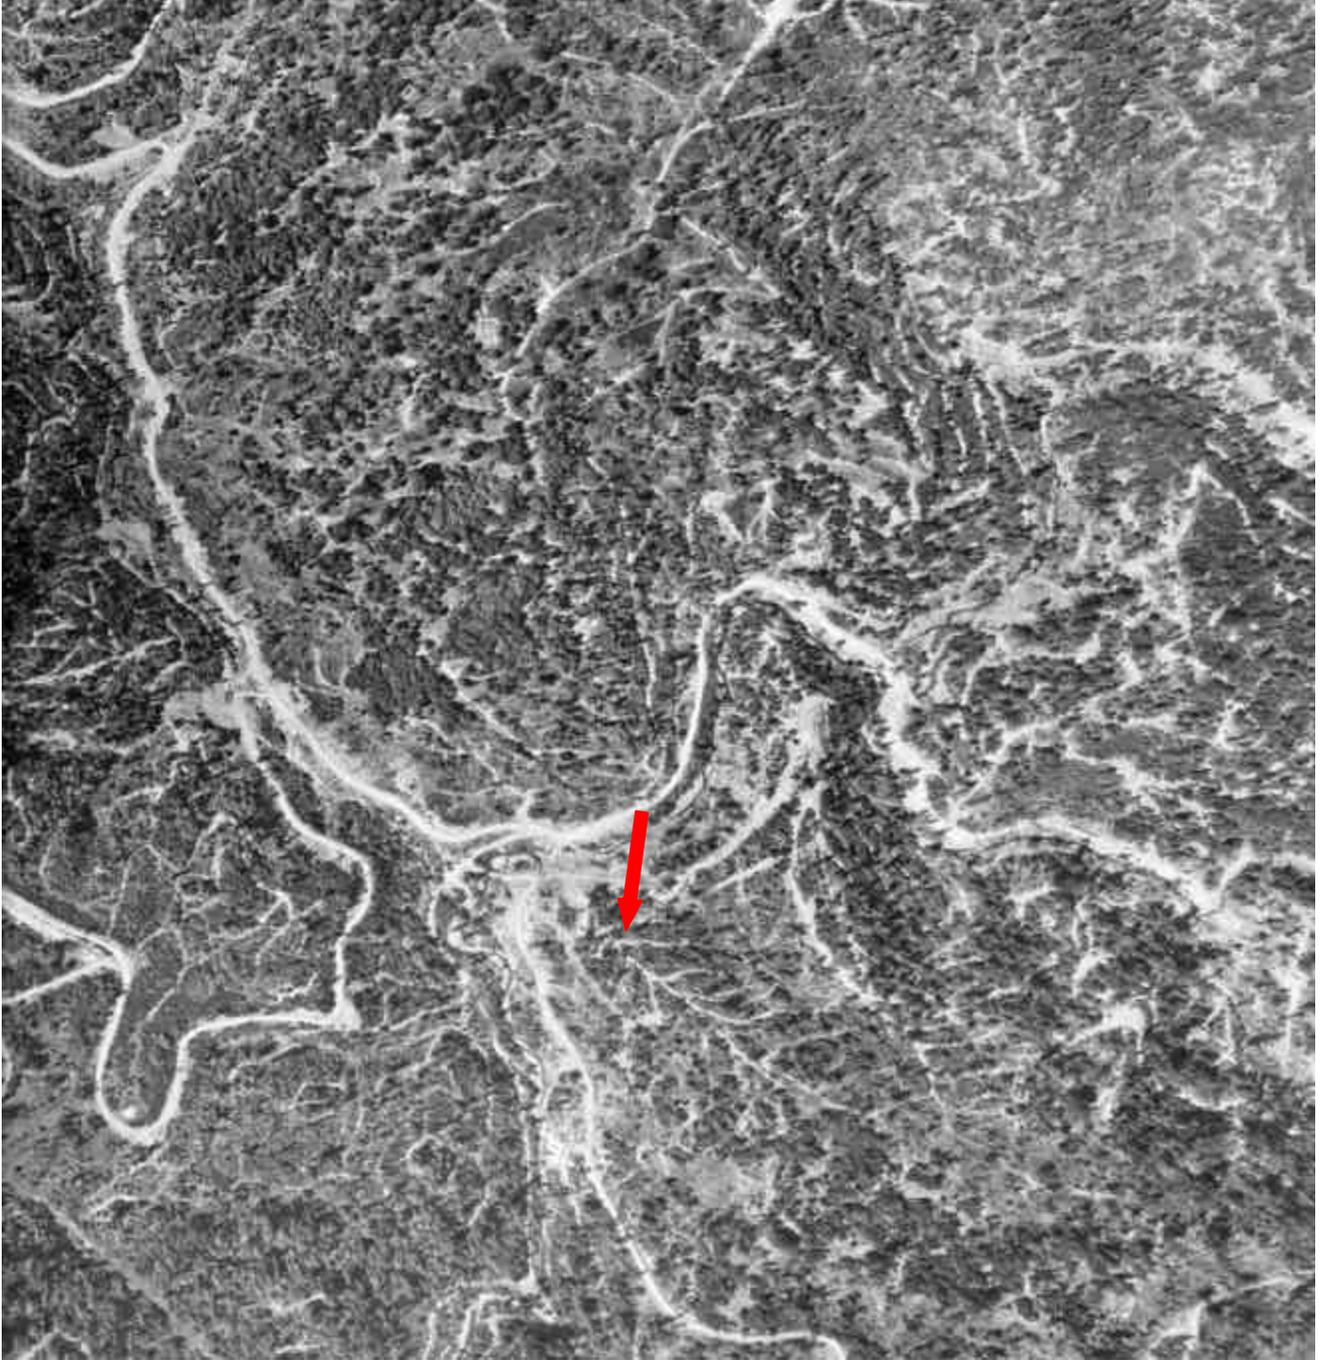
**FIGURE 38: Central Landing Complex - Main Stem Fuller Ck.**

The 1964 winter storm surge incised the landing complex (lower left) and destroyed the lower NF Fork Road (upper right). Note meandering stream flow patterns over filled substrate (red arrow). By 1984, most of this debris had washed downstream, and Fuller Creek, flowed straight through the original V-shaped stream channel bordering the landing. The 1996 storms washed remaining debris out to expose the graveled substrate seen today.

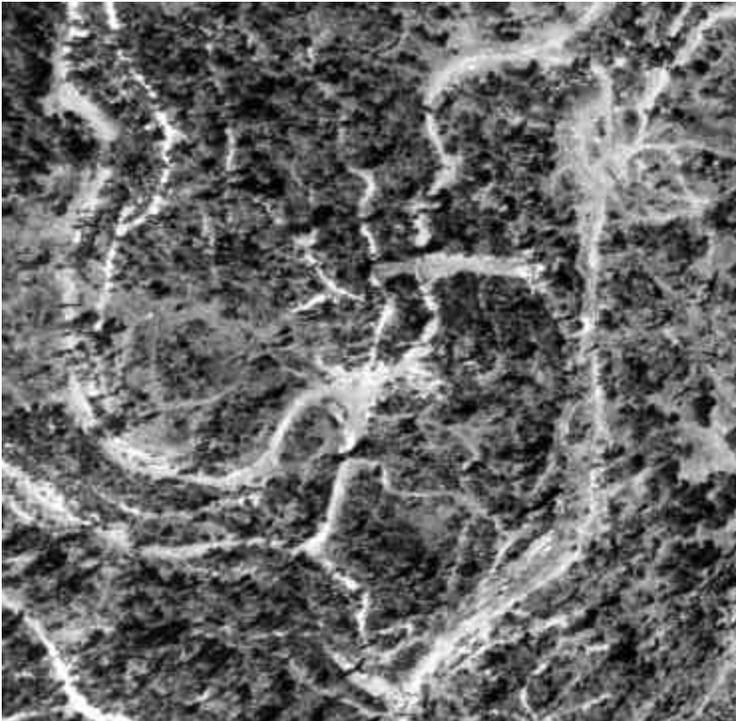
**FIGURE 39: Tobacco Ck. 1964**

Tobacco Ck. incised the in-stream landing (upper left) during the 1964 winter storm surge, creating a canyon on the discharge side (red arrow).

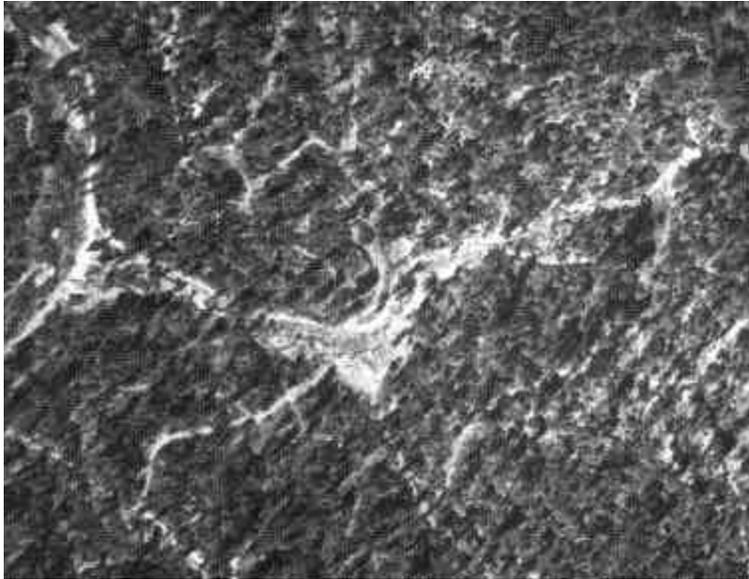
**FIGURE 41: Sullivan Creek, 1965**

Sullivan Creek meanders over buried stream pools, June 1965. Sullivan Creek follows a fault that separates the Coastal and highly erodible Central Belts of the Franciscan Formation and crosses the poorly consolidated Ohlson Ranch Formation. As a deeply incised canyon, the haul road was built along the creek. By 1984, this debris had washed downstream. Sullivan Ck returned to a linear drainage. Much of this debris is probably still deposited on the aggregated substrate of Wheatfield Fork, one quarter mile downstream.

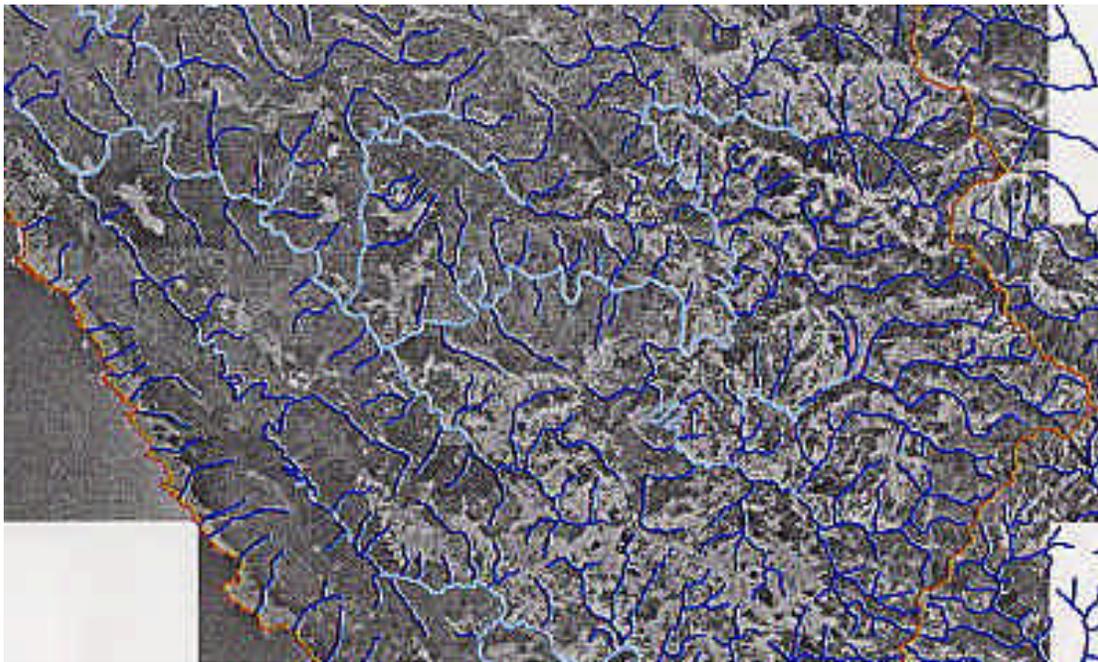
**FIGURE 42: Bank to bank shade canopy exposure 1981**

*1981 Bank to bank shade canopy exposure (white) and partial to entire shade canopy cover (blue).*

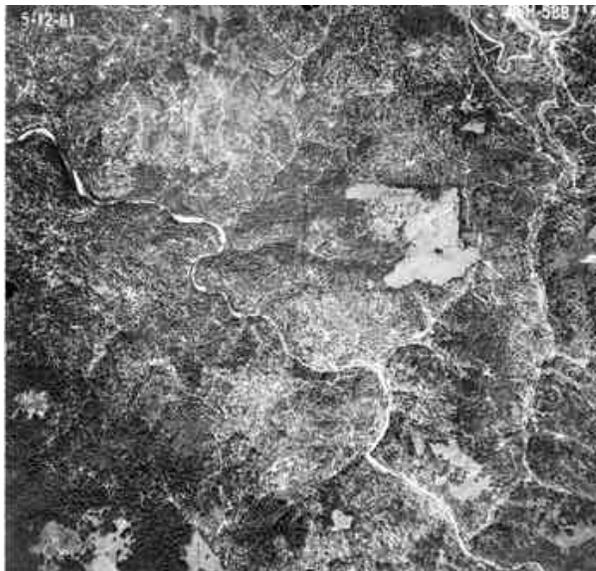
**FIGURE 44: Wheatfield Basin 1961**

1961. Starting during the mid 1950s, early versions of the D-8 and D-10 tractors block cleared the entire lower Wheatfield basin. Tractors roamed up and down smaller creeks, and built roads and landings in or along larger streams. The lack of any erosion control measures in these areas made large parts of watershed vulnerable to large storm events. Stream channel widths did show a widening response, see Figure below. Tractors eliminated riparian canopy cover and in stream Large Woody Debris.

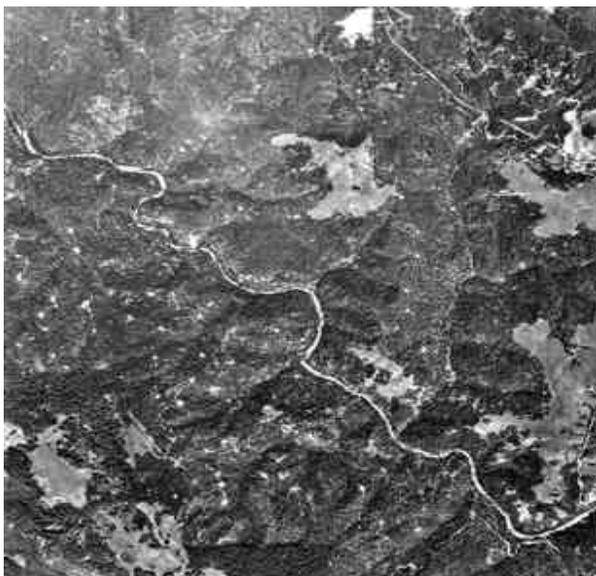
**FIGURE 45: 1984 photo**

1984. Young conifer in-growth reestablished vegetative cover, although storm run-off continues to concentrate along streamside legacy roads and skid trails. Pool infill, shallow pool structure, stream simplification, and increasing embeddedness, impair anadromous fisheries viability. DMG mapped stream channel disturbances in addition to landslide densities using the 1984 aerial photos. Stream surveys show declines of anadromous fisheries.

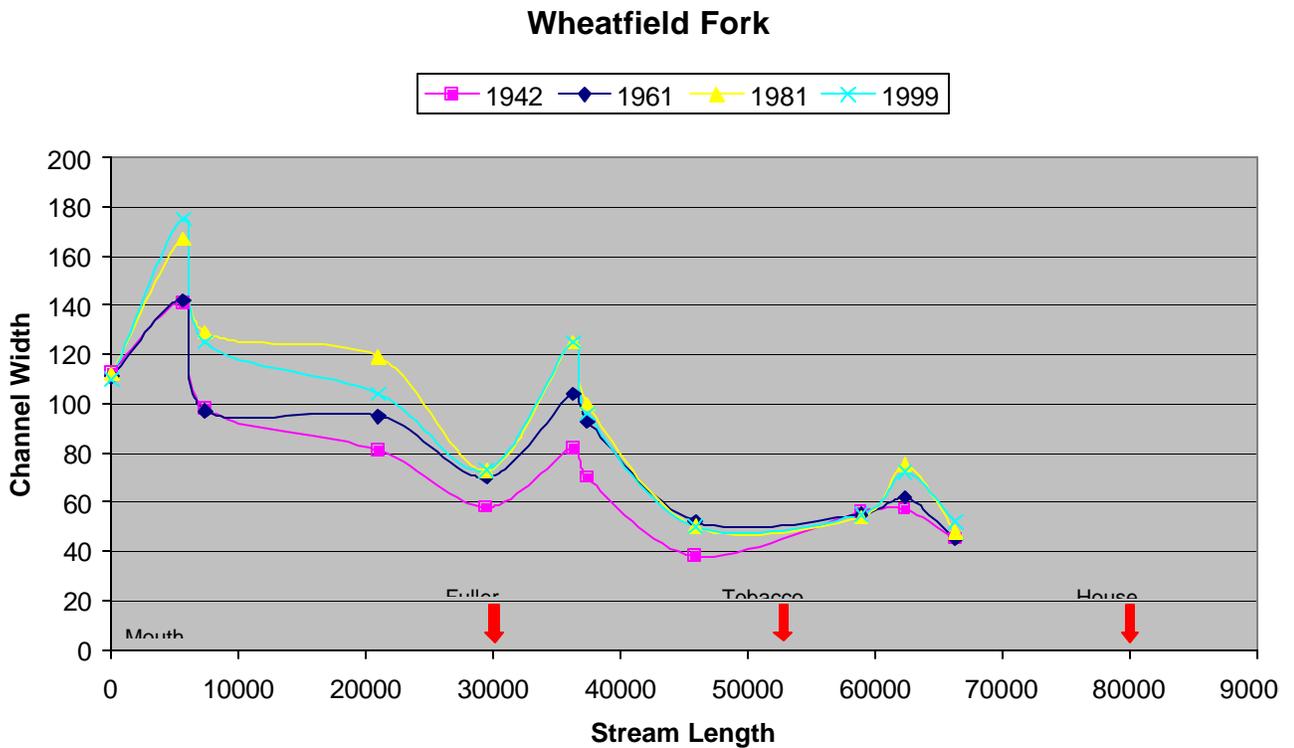
**FIGURE 47: Stream channel measurements-Wheatfield Fork**

Twenty year interval stream channel width measurements from 1942 to 1999 show a response widening of the lower Wheatfield Fork between 1942 and 1961 from the mouth to Haupt Ck, but possibly narrowing back down to 1942 widths at House Ck. This coincides with concentrated harvest activities between 1952s and 1960 when most of the timbered areas in this part of the basin had been operated by tractors over a narrow time frame. 1961 to 1981 continues to show a response widening compared to 1942. 1942 channel widths can be considered baseline as most of the basin at this time consisted of undisturbed Douglas-fir timberlands (see 1942 photo above)

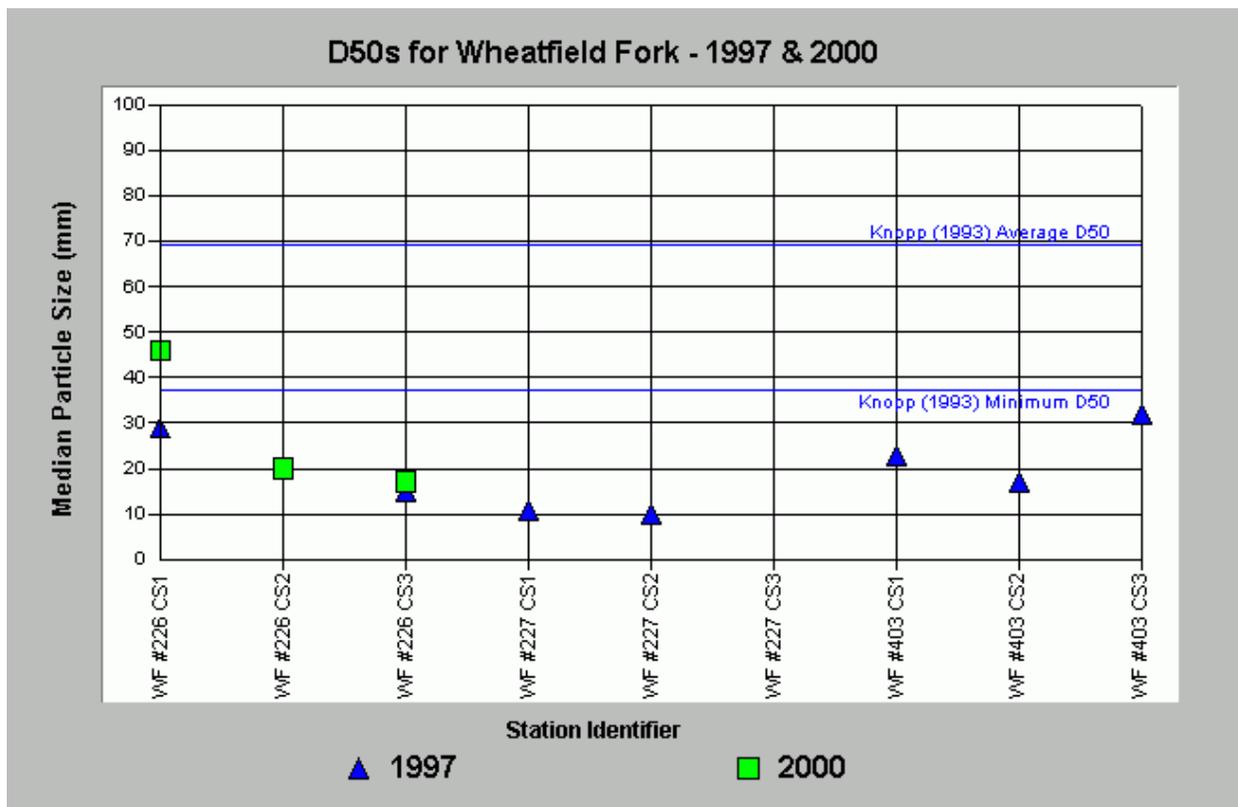
**FIGURE 48: Median particle sizes - Wheatfield Fork 1997/2000**

The NCRWQCB evaluated median particle size ( $D_{50}$ ) measurements provided by GRI for two sites in 1997 WF#227 and WF#403) and one site (WF#226) in 1997 and 2000 from the lower three miles of the Wheatfield Fork mainstem (Annapolis Planning Watershed) (Figure 40). To compare the data to Knopp (1993), the individual  $D_{50}$  values for the sites (3 transects per site) were averaged. Then the minimum, maximum, and average for those averages were compared to the same statistic from Knopp (1993) in the following table.

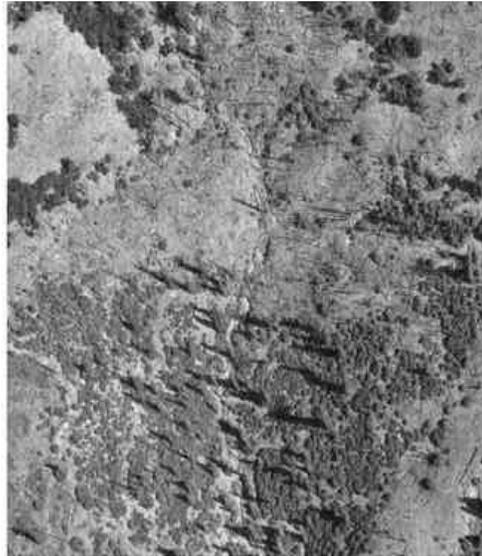
Conversion project removing conifers over the creek, leaving hardwoods upslope.
