KARUK ECOSYSTEM RESTORATION PROGRAM
FINAL REPORT
FY 2002

KARUK ECOSYSTEM RESTORATION PROGRAM

Karuk Ancestral Territory
Mid-Klamath/Salmon River Sub-basin
Humboldt and Siskiyou Counties, California

PROGRESS REPORT
31 March 2003

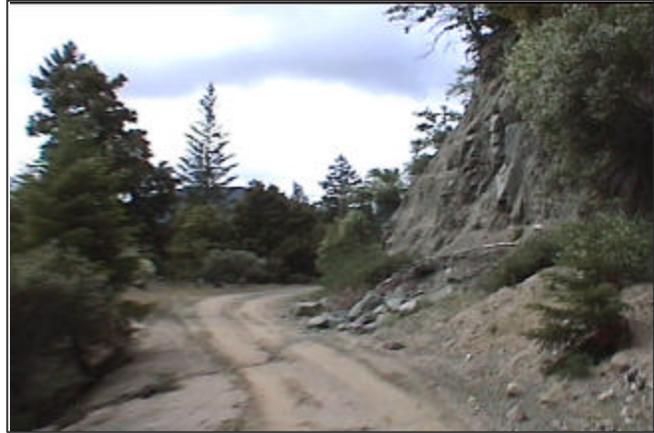
Steinacher Road was the only road within the Steinacher Creek watershed. Planned to be the primary transportation route to cut timber and haul logs from the Salmon River basin to mills in Happy Camp, road construction began in 1968. However, only 7.2 miles of it was completed due to the creation of Marble Mountain Wilderness. Construction of the road was complex: topography, incompetent soils, and bedrock presented engineering difficulties in maintaining a 26-foot roadbed with a uniform grade. In 1997, the Klamath National Forest decommissioned the upper 2 miles of the 7.2-mile road.

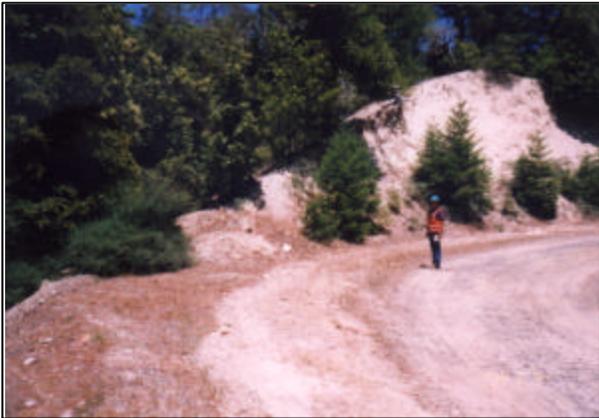
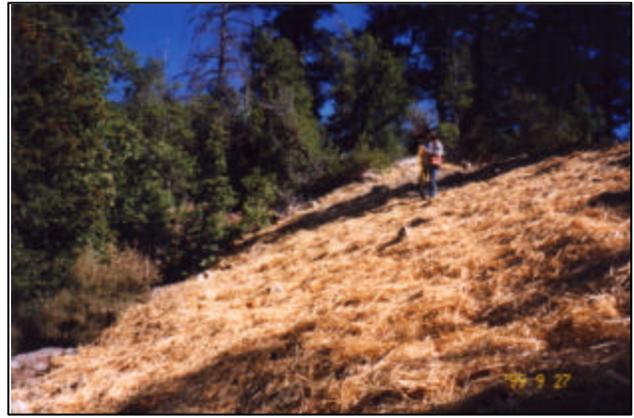
RR1 stored approximately 13,766 yd³ of fill: 600 yd³ was end-hauled from RX10; 11,164 yd³ was pushed by bulldozers from RX1; and 411 yd³ came from internal excavation sites. Before starting to excavate RX1, end-hauling to RR1 had to be completed. As well, before RX1 could be completed, all disposal outsloping within RR1 had to be finished.

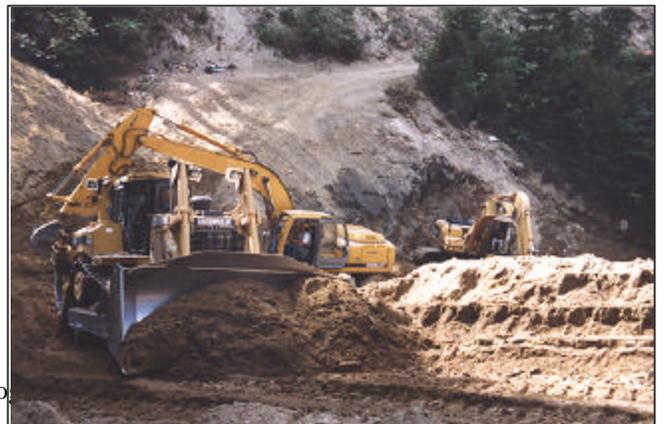
RX1 was a complicated double-crossing excavation with 12,151 yd³ of fill: channel A had a 48-inch culvert on grade with the natural bed; channel B had a 24-inch culvert that was not on grade. Both pipes contained flowing water at the time of excavation. Water quality measures were taken to safeguard off-site effects, which consisted of diverting flow away from the excavation and installing in-channel straw bale catchments. Approximately 92 percent of the fill material is disposed in RR1. The remaining 987 yd³ is disposed in RR2.

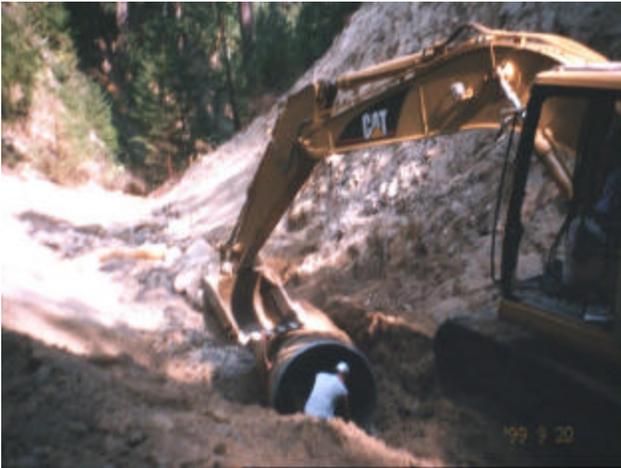
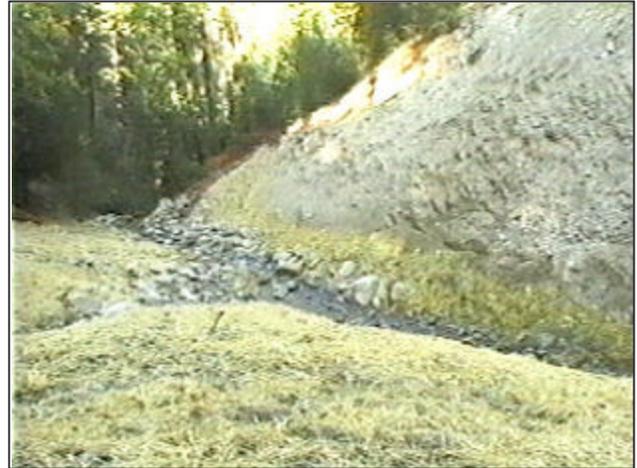
RR2 has the second largest storage capacity on the road at 23,010 yd³. Spoils imported into RR2 came from RX1, internal excavation treatments, and end-hauled material from RX10—approximately 987 yd³, 561 yd³ and 21,462 yd³, respectively. While disposal operations were occurring on RR2, a pioneer road had to remain open to access RX1. Once RX1 was finished, outsloping of fill disposed in RR2 could then proceed.

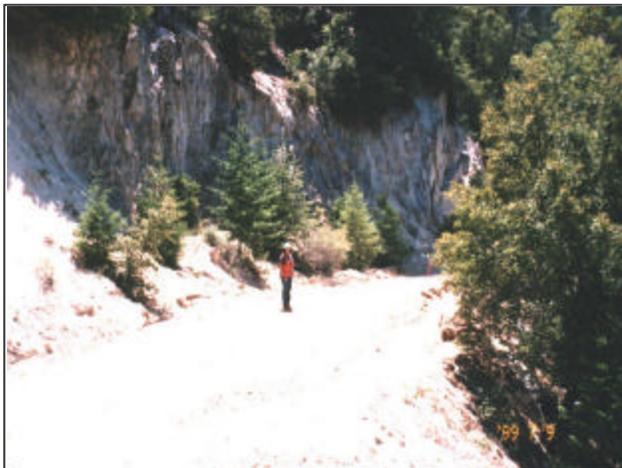
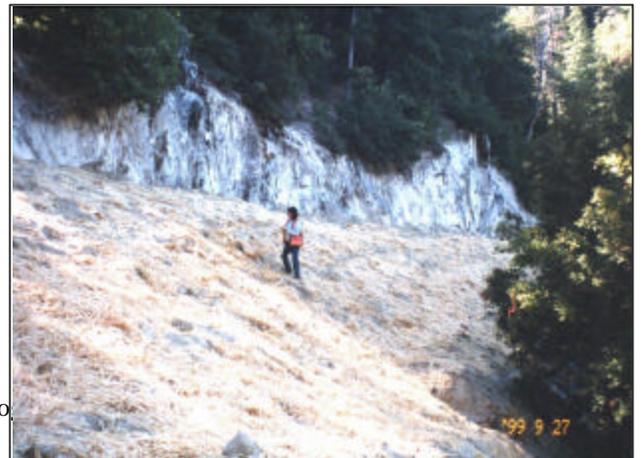
RX2 was an average size stream crossing with a massive rock outcrop on the left bank. A 42-inch engineered oval culvert was set above natural channel grade with an elbow and 70 feet of down spout. Although the crossing had a volume estimate of 2,771 yd³, only about 1,800 yd³ was necessary to excavate due to the rocky composition of the fill and high percentage of large boulders encountered during excavation. We suspect the boulders came from the massive rocky outcrop during road construction. Because the culvert was oblique to the channel grade, minimum water quality measures were necessary so that stream flow could remain in the pipe during the excavation process. Boulders extracted from the fill were stockpiled for later transport to RX8, a crossing that will require channel armoring. Fill from RX2 was disposed in RR3 and RR4—approximately 750 yd³ and 1,050 yd³, respectively.

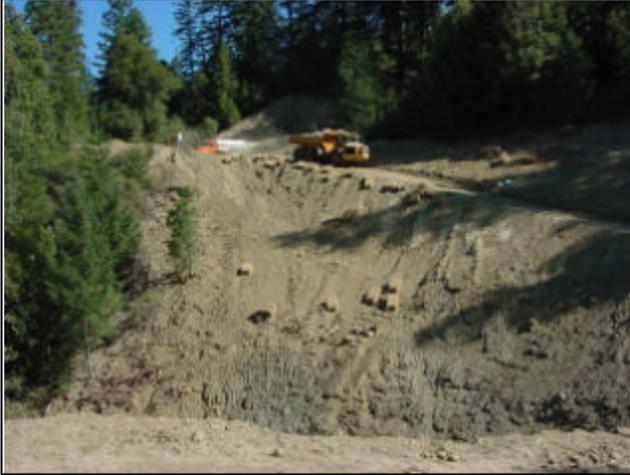
RX3 was the first stream crossing to be completed in FY01; over 11,917 yd³ of material was excavated. A D8R began by excavating the stream crossing. The material was pushed into disposal areas in RR4 and RR5. The original crossing fillslopes were veneered with rock slope protection (RSP), large boulders that act to reduce surface erosion and stabilize the fill prism. This RSP was salvaged and reused to armor the new channel bottom. More RSP was recovered than needed locally so the

excess was hauled down to RX10; over 200 yd³ was loaded into an A30 and hauled out. Although RX3 was a very large crossing, working conditions soon were cramped due to staging of the rock and as the excavation got deeper. Heavy equipment worked for 26 days to reach and remove the 60 inch diameter culvert.

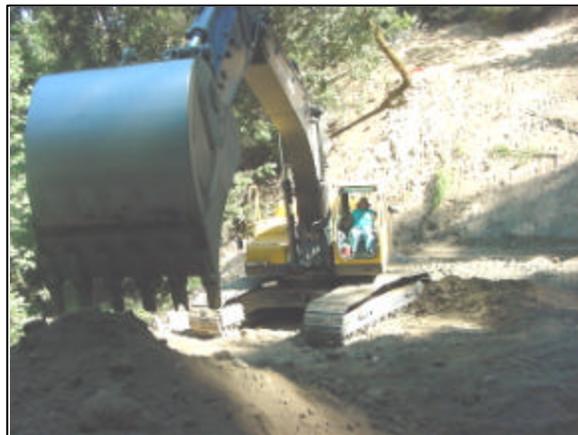
RX4 was a normal, average size stream crossing with a volume of 1,362 yd³. A D8R was used to excavate the top portion of the crossing; then a CAT 325L and D6R finished the job. A 36-inch diameter culvert (not to grade) was removed. No channel armoring was prescribed. Rock salvaged during excavation was installed as channel armor conjunct with native rock outcropping in the bed and on the right bank. Fill removed from RX4 was disposed in RR5 and RR6.

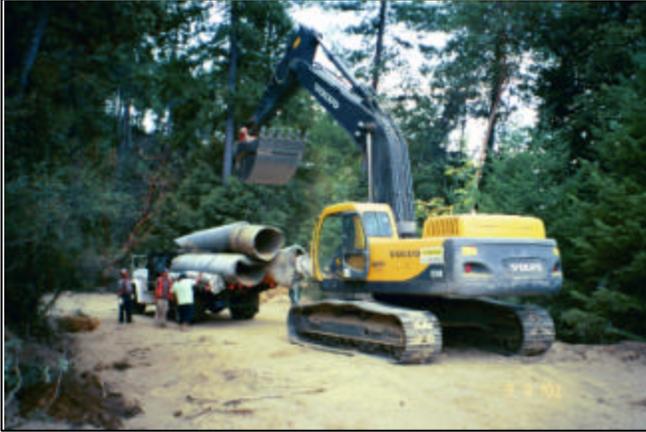
RX5 is a large stream crossing excavation between segments A and B of RR6, approximately 5,981 yd³ in volume. A 36 – inch diameter, 145 –foot long culvert was removed and hauled away for disposal. The natural crossing banks are steep, the left bank averages 150% slope, the right bank averages 81% slope. The channel is 31% grade. Water quality was maintained through out the excavation by pumping stream flow around the job.

The initial crossing volume was excavated using a Volvo 360 excavator and end-hauling by an A30 off-road dump truck to the farthest disposal site in RR6. Rock RSP was encountered during the excavation and salvaged for reuse in armoring the finished channel. No rock channel armor was originally prescribed. The crossing was left unfinished to allow access to the above work then completed between September 7th and 11th using the CAT 325L, D8R and D6R. The total excavation took approximately 9 days to complete (about 2.5 days were spent moving rocks during excavation and armoring the finished channel).

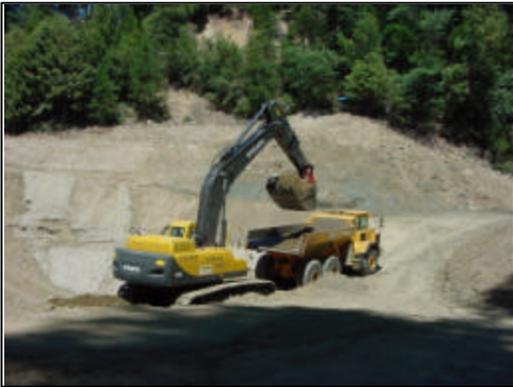
Estimating the volume of fill to excavate at a double crossing, where two or more streams join at the road crossing, is difficult to calculate. Complex buried landscape and natural channel geometry adds uncertainty to the volume estimate. To date, approximately 56,203 yd³ (83%) of

fill has been removed from the original estimate of 67,828 yd³ in RX10: approximately 32,000 yd³ in FY99 and an additional 24,403 yd³ during a 25-day period beginning on 26 June 2001.

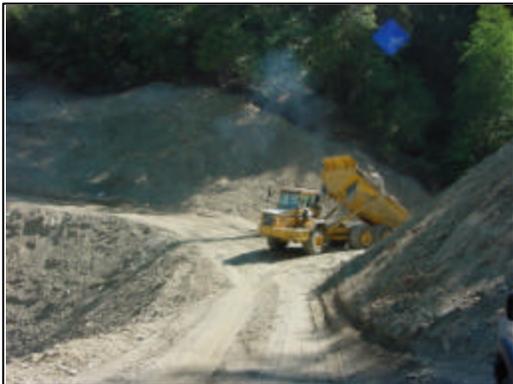
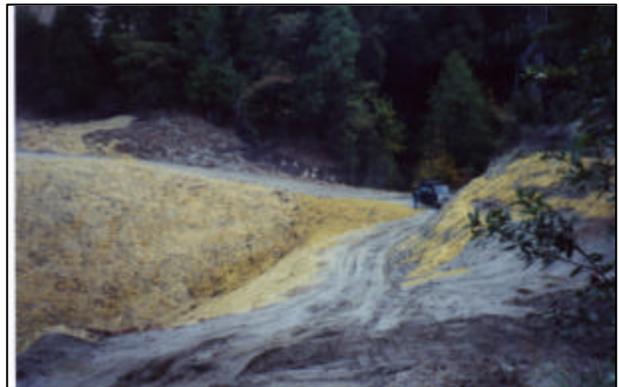
Excavation of **RX10** commenced on July 19. The trucking operation ran from July 20 to September 16. A Hitachi 330 excavator with a 2.5-yd³ bucket capacity was used to load dump trucks that hauled the fill to disposal sites mentioned above. Up to nine trucks were used per day, making a total of 3,673 loads, hauling approximately 31,800 yd³ of fill. A truck was loaded or dumped every four to seven minutes for 39 days. Daily haul production rate fluctuated, depending on disposal site conditions, such as: frequency of turn around locations; length of back up in the disposal reach; road width, and steepness of disposal ramps. Approximately 45 percent of RX10's volume had been extracted at the end of Phase II. Size can be deceptive in photographs. RX10 is less than half excavated, and about 36,028 yd³ remained.

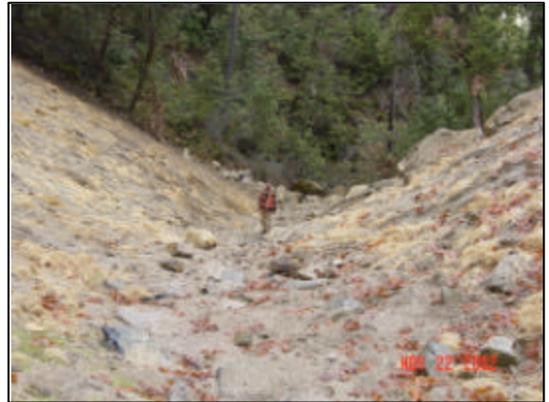
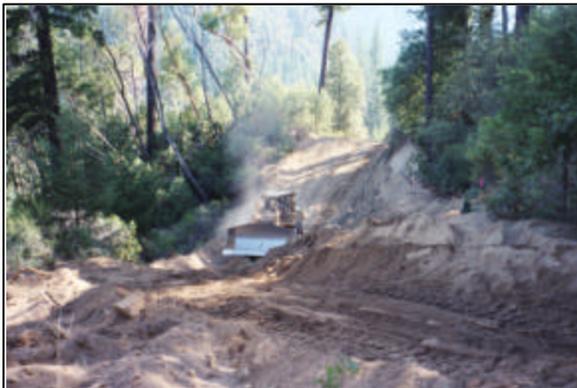
RX6 was a relatively large stream crossing excavation located between RR8A and RR8B. The total amount of fill within this crossing was approximately 5,487 yd³. A 36" diameter, 155' culvert was excavated and transported to a temporary storage area onsite. The natural bank steepness within this crossing varies between 38%-156% depending upon location. The channel length, measured in slope distance (SD) is 172' with a 10' channel bottom. The channel gradient is approximately 32%, with a slight curvature (meander) to approximate natural conditions. At the time of excavation no water quality control measures were necessary due to dry conditions. Rock (RSP) encountered during excavation was utilized to armor the head of the channel. The head of the channel on the left bank was widened to incorporate a spring into the finished crossing. The total post-excitation disturbed area of 21,672ft² was mulched with certified weed-free rice straw, and seeded with a native grass seed mix to the extent possible due to slope steepness.

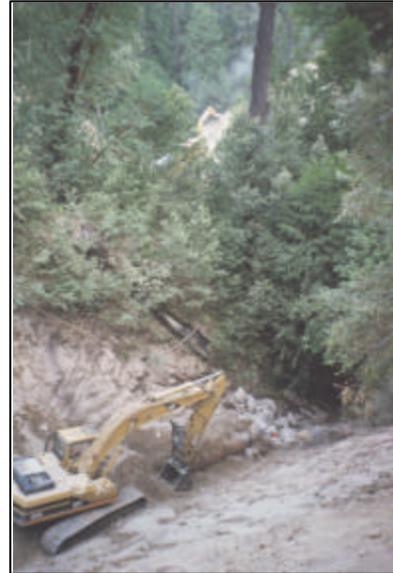
RX9 was the second largest crossing excavation on the Steinacher Project. The total volume of material excavated exceeded 19,597 yd³. The depth of excavation at the outboard edge of road (OBR) to the top of the culvert was approximately 62.2' as compared to RX6 with a depth of excavation at the OBR of only 33.5'. The bank steepness through this excavation varies between 65%-104%. The channel excavation length was 254' (SD), with a gradient of 18%-19%. As with RX6, a meander was re-established to approximate natural conditions prior to road building activities. Rock encountered during excavation was used as channel armoring. In addition a series a rock check dams were placed in the channel. The culvert used to convey flow through this crossing was a 60"-multi-plate, with a total length of 235' and a cement headwall. A multi-plate culvert is assembled on-site utilizing sections that are bolted together resulting in one continuous length of culvert. The cement headwall had to be broken apart with a hydraulic hammer attachment in lieu of a bucket on the CAT 330 excavator. The amount of stream flow encountered during excavation required dewatering the site to protect water quality.

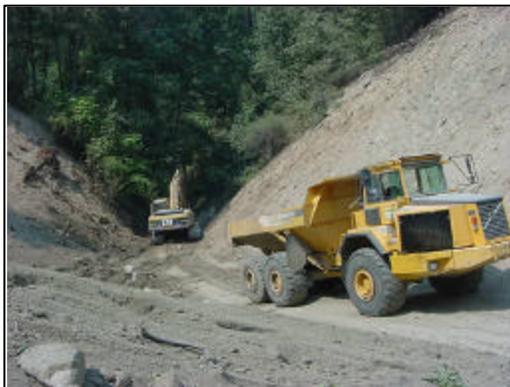
RX10 with an initial 67,828 yd³ of fill material required three seasons to completely excavate and reshape. In FY99 32,000 yd³ was excavated, while in FY01 resulted in the removal of

24,403 yd³. During the Final Phase excavation of FY02, 36,267 yd³ had been excavated along with the dismantling and disposal of 325 linear feet of 60" MULTI-PLATE culvert. Two channels merging in the excavation, forming a double stream crossing exacerbated the complexity of this excavation. The sheer amount of RSP encountered during excavation required it to be handled numerous times before final placement. The RSP salvaged from the excavation was utilized for channel armoring along the entire channel length. As with previous

crossings a meander was re-established to emulate the original valley contour. This excavation included RX10B, which created a double crossing. Without the dedication of our team coupled with the expertise provided by our contractor, this crossing would still have the potential to deliver over 67,000 yd³ of material downstream.

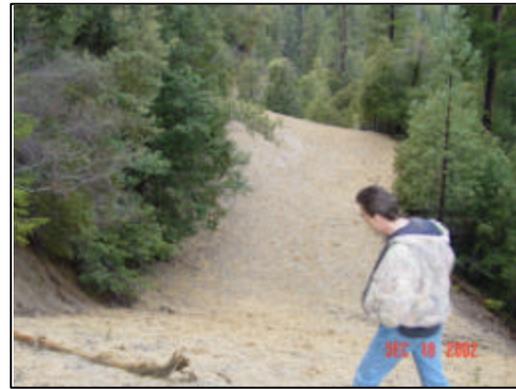
RX13 was one of the smallest crossings excavated with 922 yd³ of fill material. The final channel length is 115 ft., with a gradient of 41%. The channel width is 8 ft. with a average left bank slope of 54% and on average a right bank slope of 54%. Removal of a 24-inch culvert was also accomplished. The culvert inlet was buried for an undetermined amount of time, which is the major contributor to road crossing failures.

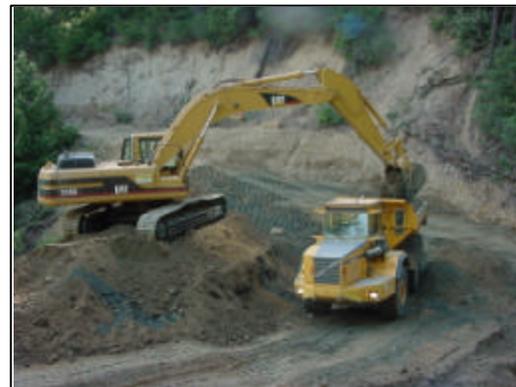
RX14 had 5,705 yd³ of material, which was evenly distributed between RR13 and RR14. The channel length is 242 ft., with a channel gradient of 51%, which is the steepest, yet encountered during the Final Phase. The channel width of 8 ft. was achieved, while the left and right bank slope averaged 69% and 75% respectively. We also removed a 24inch culvert with about 60 ft. of downspout. In addition we removed a 12" culvert on the right-side outboard edge of road (OBR) with an 80 ft. downspout.

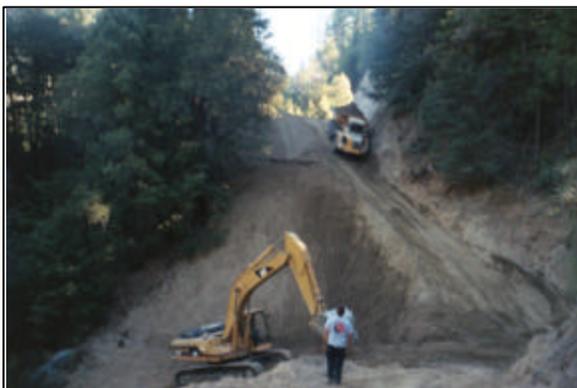
RX15 had approximately 9,904 yd³ of fill material. This crossing had a curved channel alignment adding to the complexity of excavation. The channel length was 283 ft., and an average 10ft. width with a channel grade approaching 44%. The average left bank slope is 89%, while the average right slope of 84% is representative of the natural slopes both upstream and downstream of the site. A 36" CMP with accompanying perforated pipe was removed. This channel has also been armored with RSP.

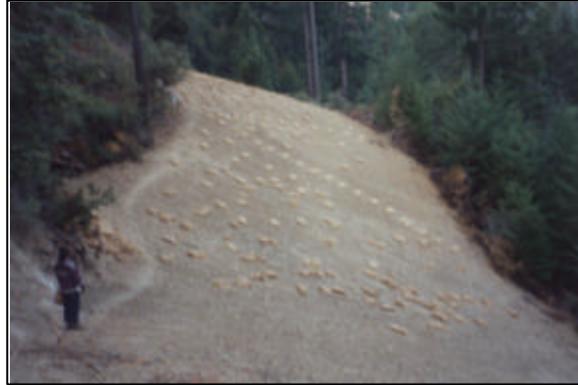
RX16 was another large stream crossing excavation containing approximately 7,654 yd³ of material. The 24" CMP angled 45 degrees to the right edge of cut, at this point an elbow reduced the pipe to 12" CMP down the fillslope had to be excavated and removed. The channel length is 221 ft. in length with a 42% gradient. The channel width at the top of the crossings is 8 ft., while the bottom portion approaches 15 ft. The finished left and right bank slope average is 58% and 77%. Extensive gully erosion on the bottom half of the fill added a complexity that had yet been encountered so far in the project.

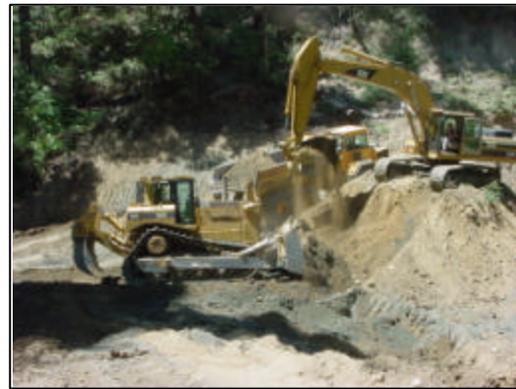
RR16 had a design capacity of 5,138 yd³ and is 320 ft. in length. A 12" CMP drop outlet and hardware was removed from this road reach. The fill material used in this reach was acquired from the excavation of RX15-17. RX15 contributed approximately 3,059 yd³, while RX16 and RX17 contributed 1,979 yd³ and 100 yd³ respectively.

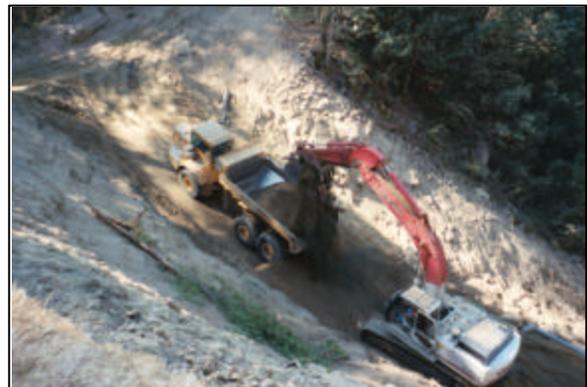
RR17 is 287 feet in length with a design capacity of 4,088 yd³ of material. Another through-cut was filled and outsloped in this road reach. The majority of fill used to outslope this reach came from RX17, totaling approximately 3,988 yd³. A 12" CMP drop outlet and downspout was also removed
