Erosion and Sediment Delivery Following Removal of Forest Roads

Mary Ann Madej

U.S. Geological Survey Western Ecological Research Center
1655 Heindon Road
Arcata, CA 95521
USA

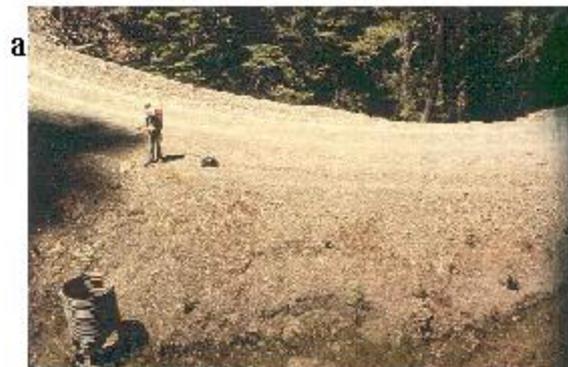
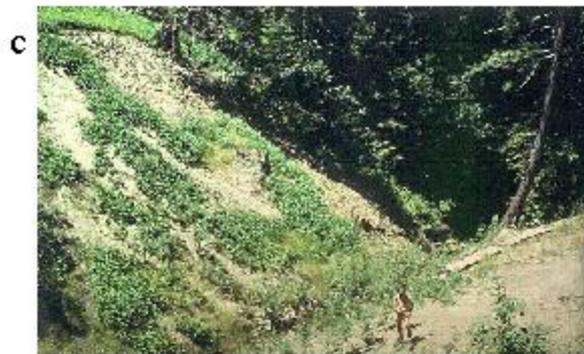
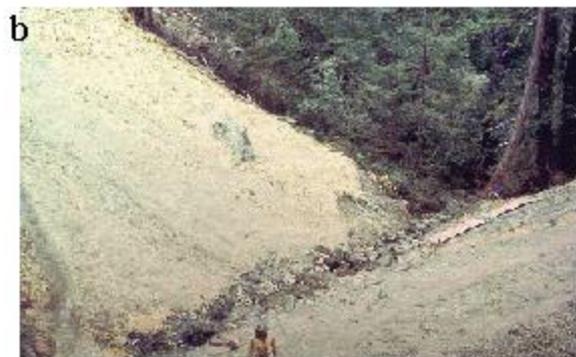
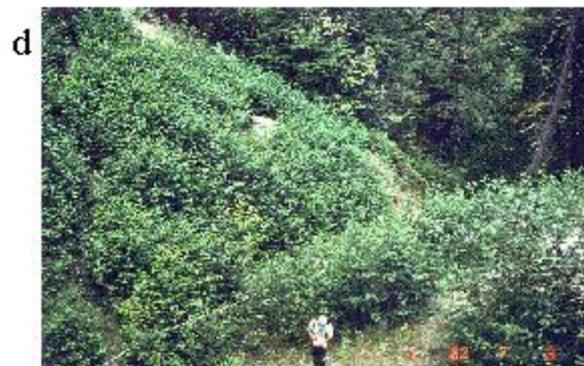
Figure 2. Typical stream channel excavation. a) Abandoned logging road with intact culvert before treatment. b) Immediately following stream crossing excavation. In this case, rock armor and check dams were installed on the channel bed to prevent downcutting. c) Less than one year later, revegetation of the streambanks is well underway. d) Three years after treatment, alders have revegetated most of the ground disturbed during treatment.

The first step in treating forest roads was to map the geomorphic and hydrologic features of the road and adjacent hillslopes. Erosion features, drainage structures, the stream network, and the location of all roads, skid trails, seeps, and springs were identified on enlarged aerial photographs at a scale of 1:1200. Following the mapping phase, road removal treatments were designed and implemented. In the early 1980's, road treatment work focused on removing culverts and pulling back road fill from streambanks (Figure 2a-d). In some cases, newly excavated stream channels were protected with check dams or large rocks (Figure 2b). The crossing excavations surveyed in this study varied from 100 to 7500 m³ in volume, and averaged about 1000 m³. Stream gradients of excavated stream crossings ranged from 1 to 50 percent.

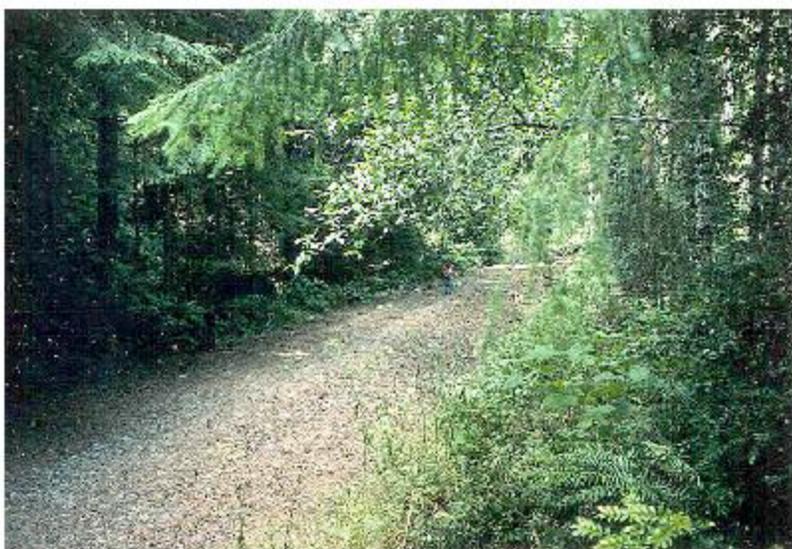
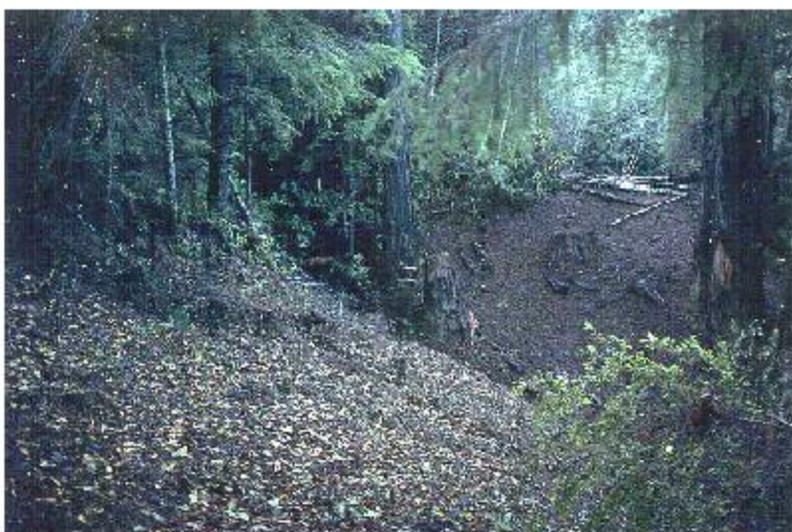
Figure 5. An example of the most intensive road rehabilitation technique. a) Abandoned logging road before treatment. b) The road bench is obliterated and the hillslope is recontoured (total outsloping of the road bench, and total excavation of the stream channel). Stumps uncovered during excavation indicate the location and elevation of the original hillslopes.

As the program progressed, park geologists began to use more intensive treatment methods, which included partially outsloping the road surface by excavating fill from the outboard edge of the road and placing the material in the inboard ditch at the base of the cutbank (Figure 3c). This technique required more earth moving (1000 to 2000 m³/km of treated road). By the 1990's, geologists commonly prescribed complete recontouring of the road bench (total outslope), in which the cutbank was covered by excavated fill, original topsoil from the outboard edge of the road was replaced on the road bench where possible, stream channels were excavated to the original channel bed elevation, streambanks were extensively reshaped and the road bench was fully recontoured (Figures 3d, 5a and b). Total outsloping involved moving an average of 6000 m³/km of treated road. Channel armoring was seldom used in this phase, but trees felled during road treatment were later placed in the stream channels and on the treated road surface. On some road segments, excavated road fill was removed from the road bench and transported to a more stable location, and this technique is termed export outslope (Figure 3e). The locations where the road spoils were placed are called fill sites. Export outsloping involved the greatest amount of earth moving (15,000 to 20,000 m³/km of treated road). Because surface erosion is not considered to be a major sediment source (Kveton *et al.*, 1983), and natural revegetation is
