THE RESOURCES AGENCY OF CALIFORNIA
DEPARTMENT OF FISH AND GAME

STREAM SURVEY

Date: August 19, 1977

NAME: Canshea Creek **COUNTY:** Sonoma

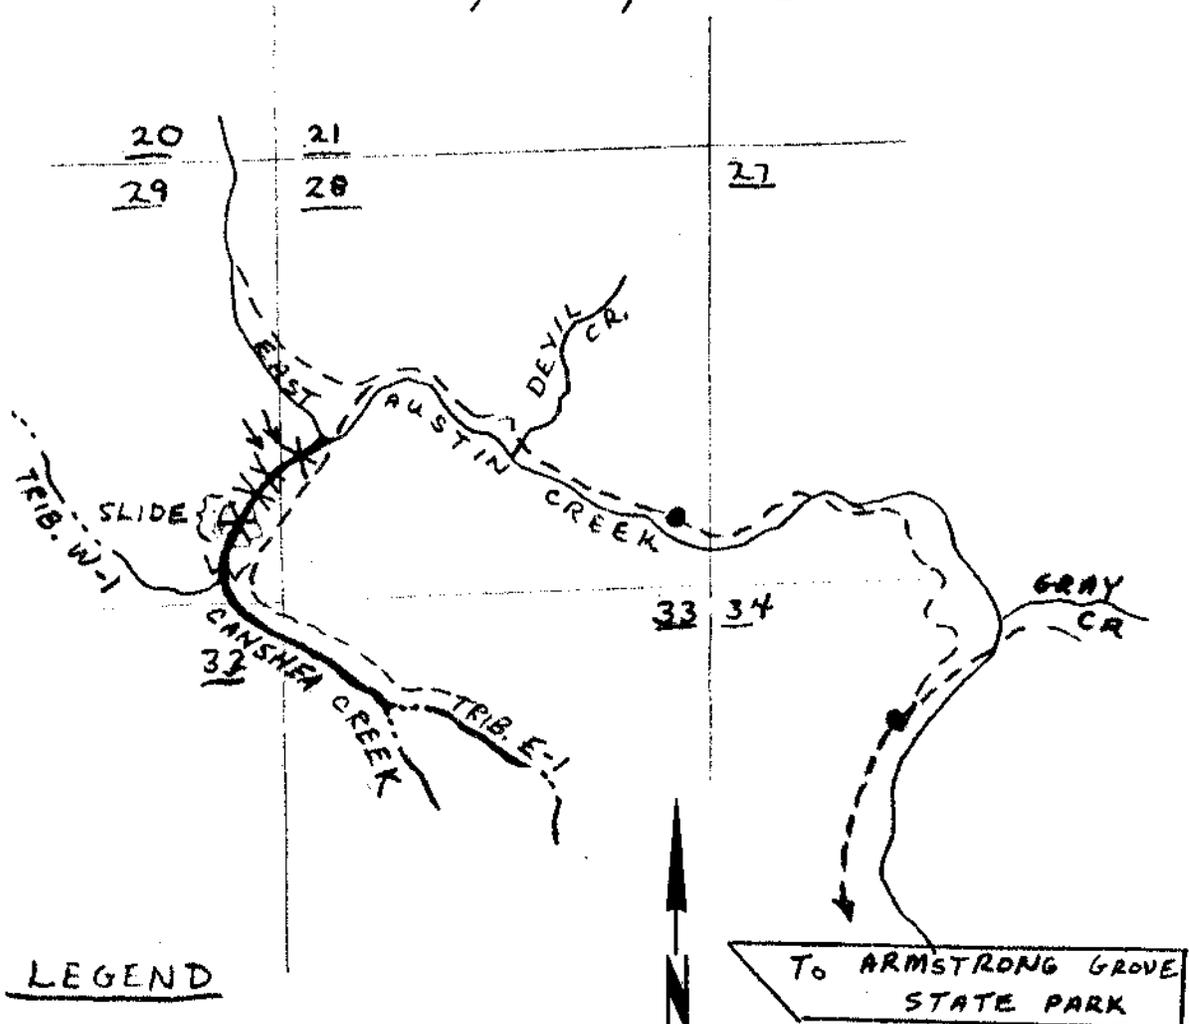
CANSHEA CREEK

Barriers - Four log jams were observed from the mouth to 0.4 miles upstream from the mouth (see sketch map). The upper 3 log jams are causing a build-up of silt and soil raising the streambed upstream from the log Jam. The severe siltation and lack of cover in the remaining 0.9 miles makes the area uninhabitable to fish.

ACCESSIBILITY - Canshea Creek is accessible near the mouth by a private dirt road which may be reached by taking the Armstrong Grove Park dirt road. (see sketch map) The keys for the first 2 locked gates may be obtained from the Park headquarters. A third gate is privately owned, the keys may be obtained from the local Game Warden. The creek is also accessible at any point from a dirt road paralleling its entire length.

IMPROVEMENTS - Removal of the 4 log jams would be beneficial, as well as stabilization of erosion prone areas within the watershed.
