THE RESOURCES AGENCY OF CALIFORNIA
DEPARTMENT OF FISH AND GAME

STREAM SURVEY

Date: September 1 and 6, 1977

CROCKER CREEK

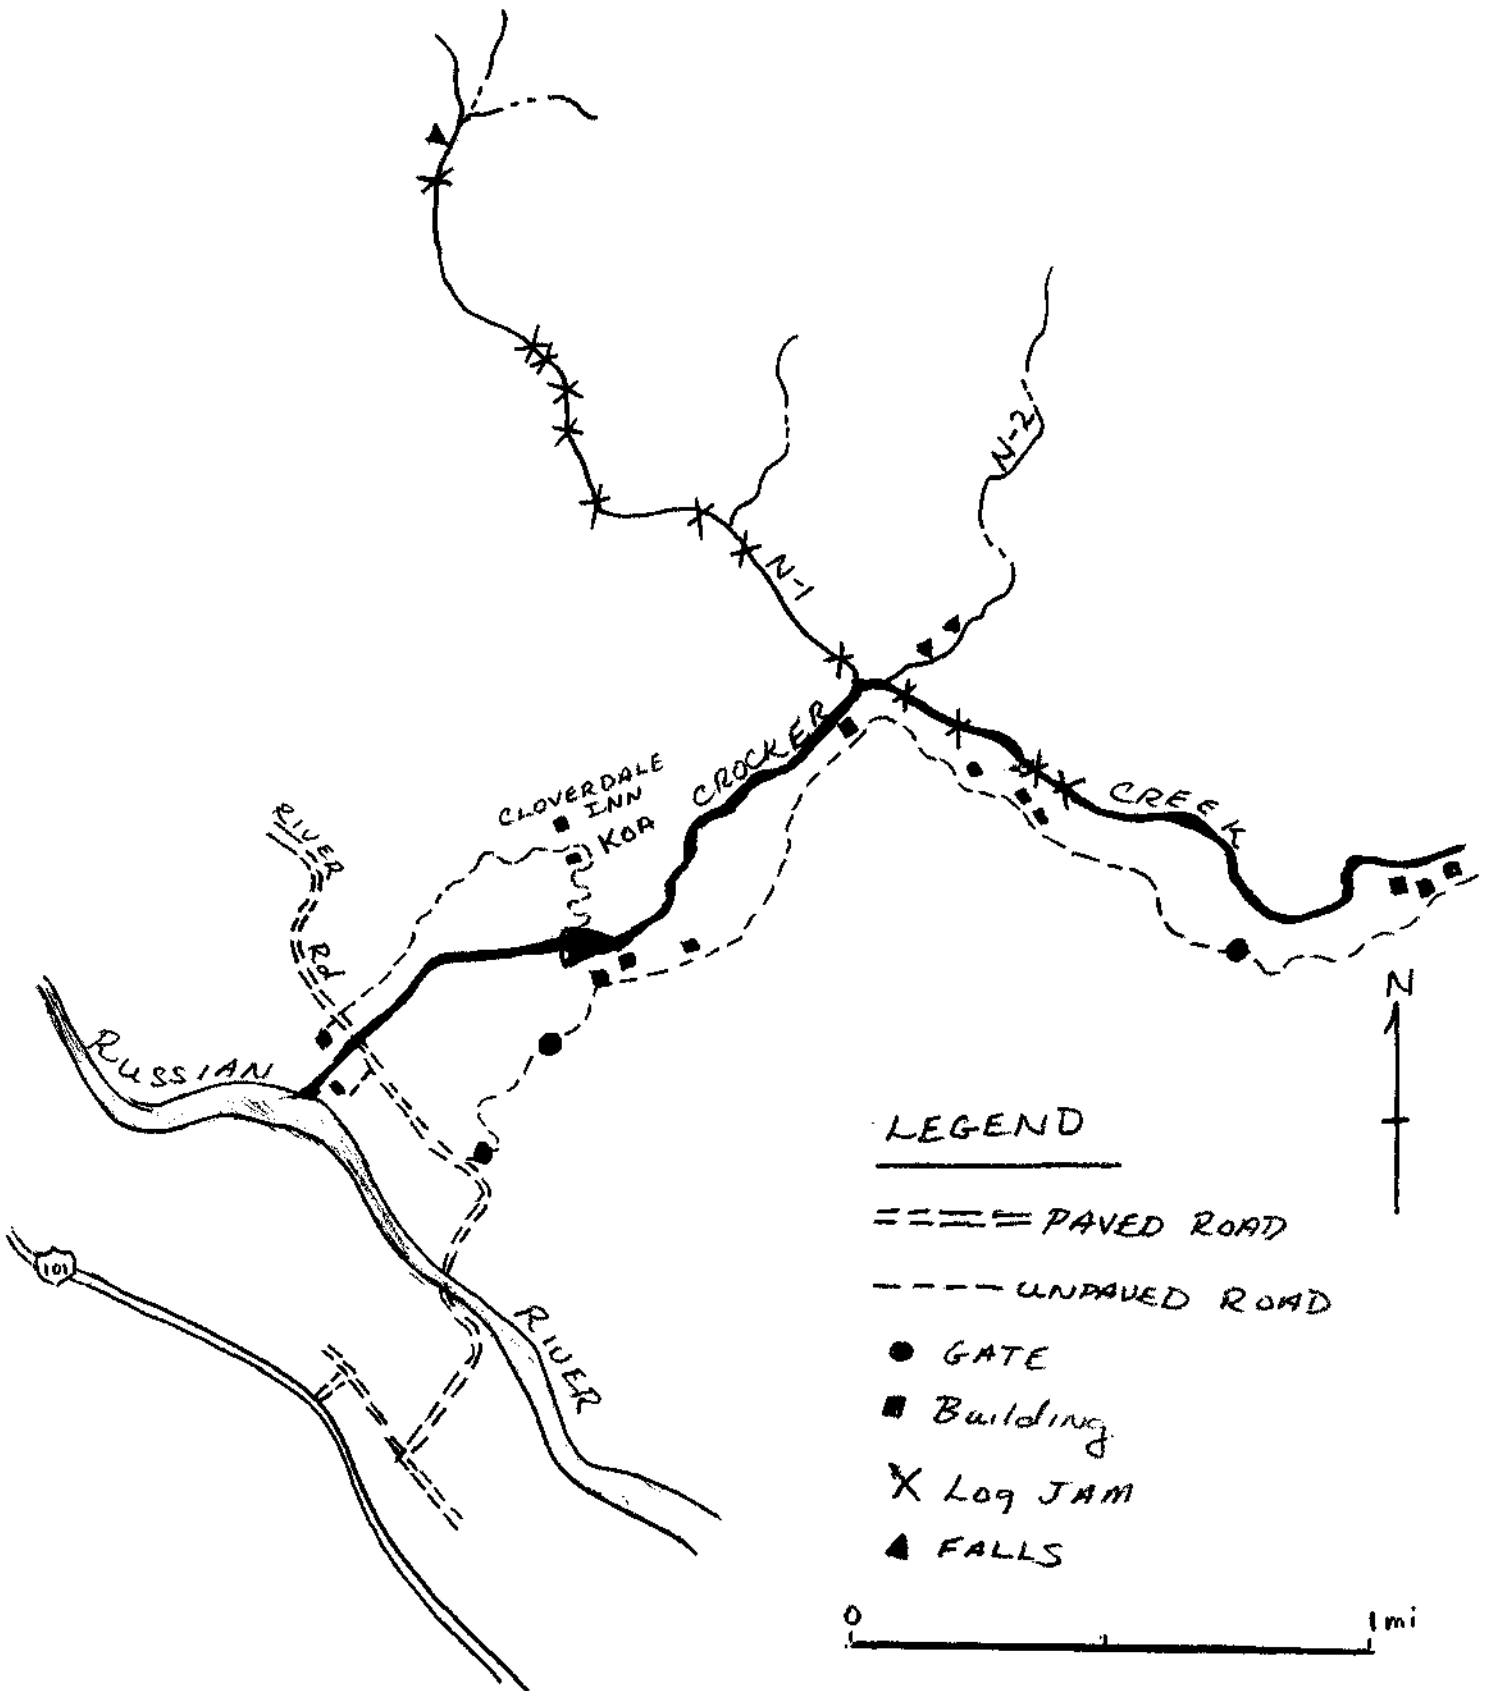
mile upstream, and at a boulder roughs area 0.8 mile upstream. Both of these created barriers to fish movement. Gradient of tributary N-1 (see attached sketch map) and that of the southeastward section of Crocker Creek were slight. The gradient of tributary N-2 was steep averaging 20'/100'.

Barriers—Barriers to fish movement included a 50' high dam 0.6 mile upstream and a boulder roughs area 0.8 mile upstream. Numerous small log jams (listed on the sketch map) were observed on tributary N-1 and Crocker Creek upstream from N-1. None created falls greater than 6'. Tributary N-2 had 2 boulder falls within 0.1 mile of its mouth.
