**Analysis of the
1997 Garcia River Cross Sections**
by
Dennis Jackson

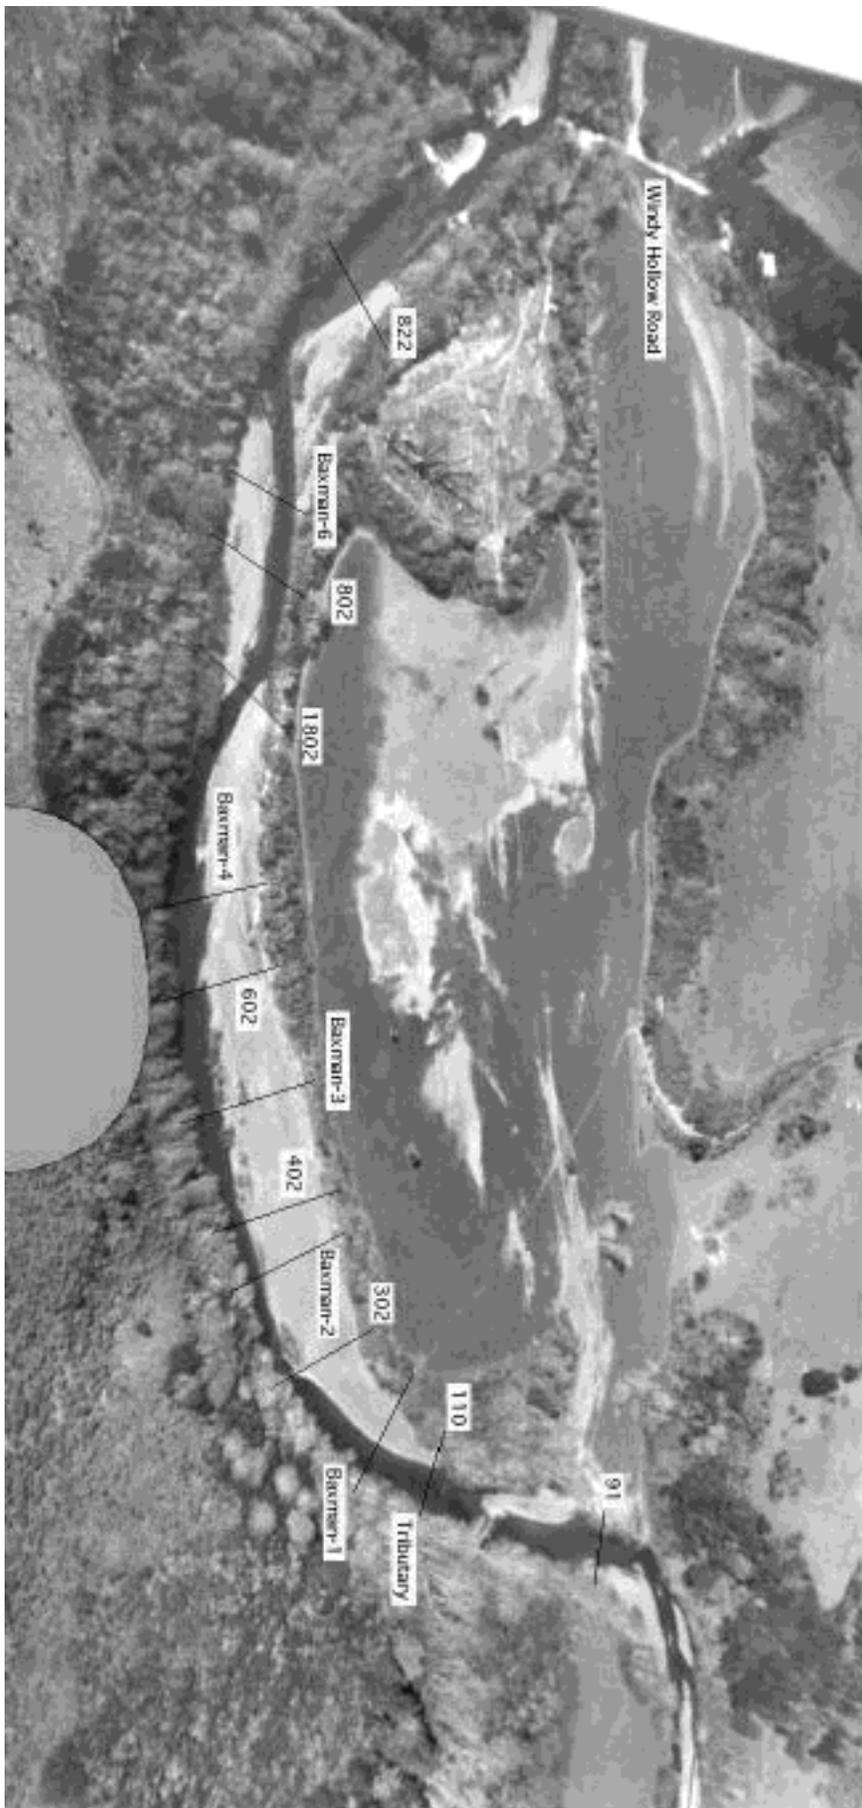
In 1996 there was a 6 foot deep pool between Baxman-4 and cross section 1802. A diving platform was constructed next to this pool. This pool was between the downstream end of Bar 30 and the upstream end of Bar 31. In 1997 the river eroded the head of Bar 31 and deposited material extending Bar 30 downstream past cross section 1802. The low flow channel now crosses the head of Bar 31 and the location of the pool has shifted approximately 100 feet to the west-southwest. The pool is now about 4 feet deep.

In 1992, the river began to erode the access road in the channel connecting the processing plant to Bar 30. The road was a bench cut along the bottom of the right bank. This section of river lies between cross section 802 and Baxman-4. The 1993 event completely removed the road and eroded the right bank just downstream of Bar 30, causing a few trees to fall into the river. The 1995 flood eroded the right bank a little more.

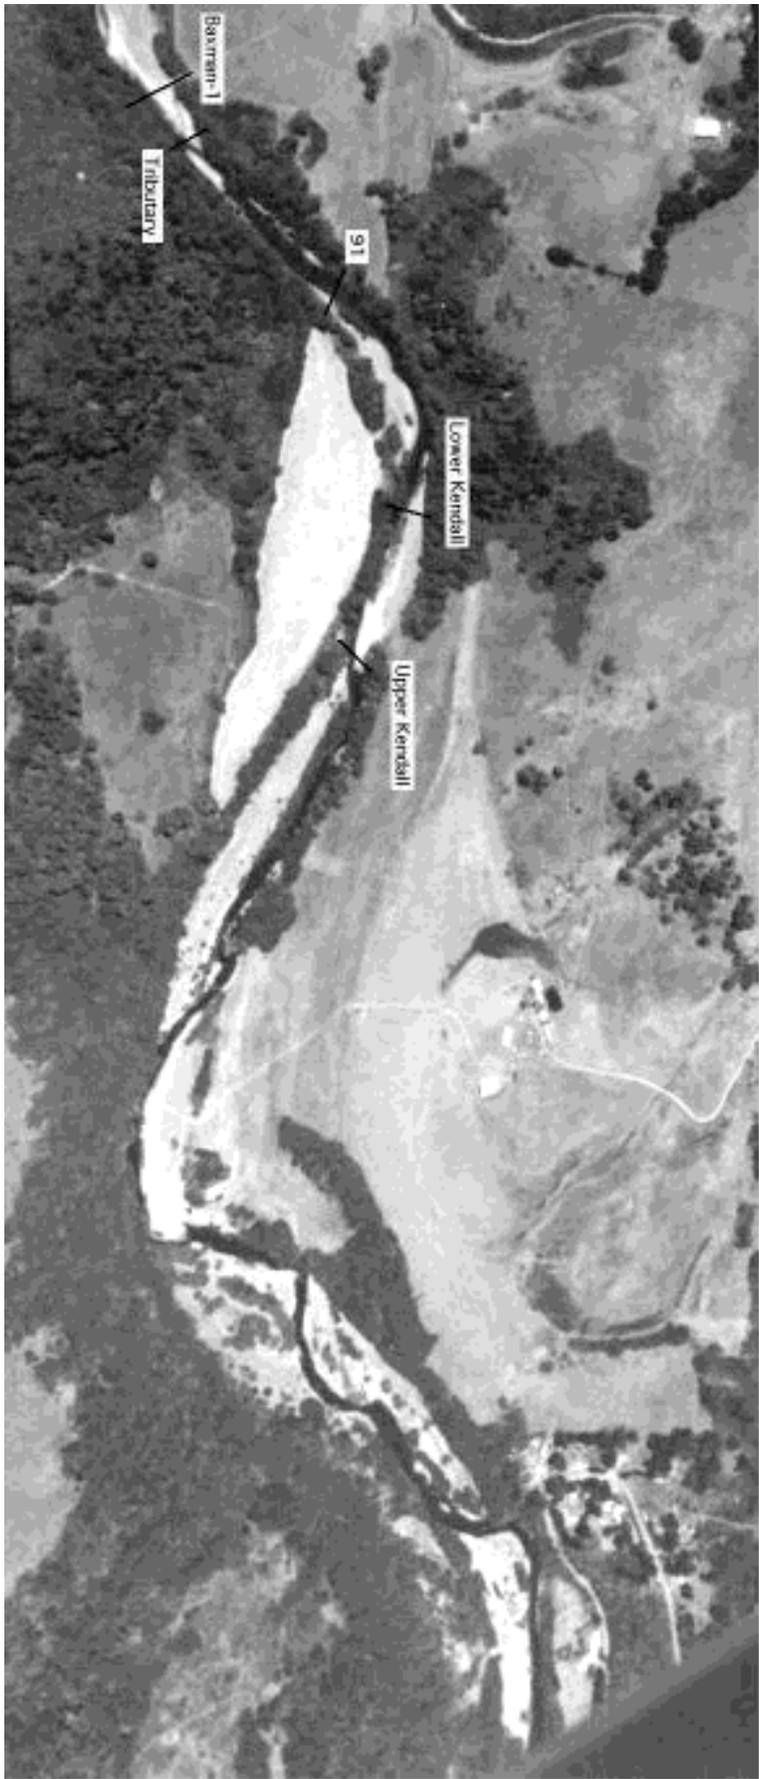
In early 1995 the Garcia River experienced a flood with a peak flow estimated at 32,500 cfs with a stage of 17.9 feet. The 1995 event was the largest event ever recorded at the Conner Hole gaging station. The event resulted in approximately 400 hundred feet of bank erosion just below the downstream end of Bar 26. The erosion ended approximately ± 600 feet upstream of the MCWA cross section near the powerline crossing. In January 1997 the third largest flood recorded on the Garcia River occurred, it had a stage of 17.4 feet and the peak flow is estimated to be 30,200 cfs. The 1997 event extended the erosion an additional ± 600 feet downstream of the 1995 damage. As a result a significant source of bedload was made available for transport downstream past the Kendall cross sections.

Bar 26 is a point bar on the right (north) bank of the river. Directly across from Bar 26 a steep hill rises up from the river. The hill forces the river to turn towards the west. A review of a sequence of aerial photographs reveals that the point where the river first contacts the hill has shifted downstream with time. Consequently, the river now “bounces” off the hillside instead of “glancing” off as it did in 1972. The change in exit angle has resulted in the main force of the river being directed at the right bank just below Bar 26. The damage has increased each year since 1992 in proportion to the size of the storms.

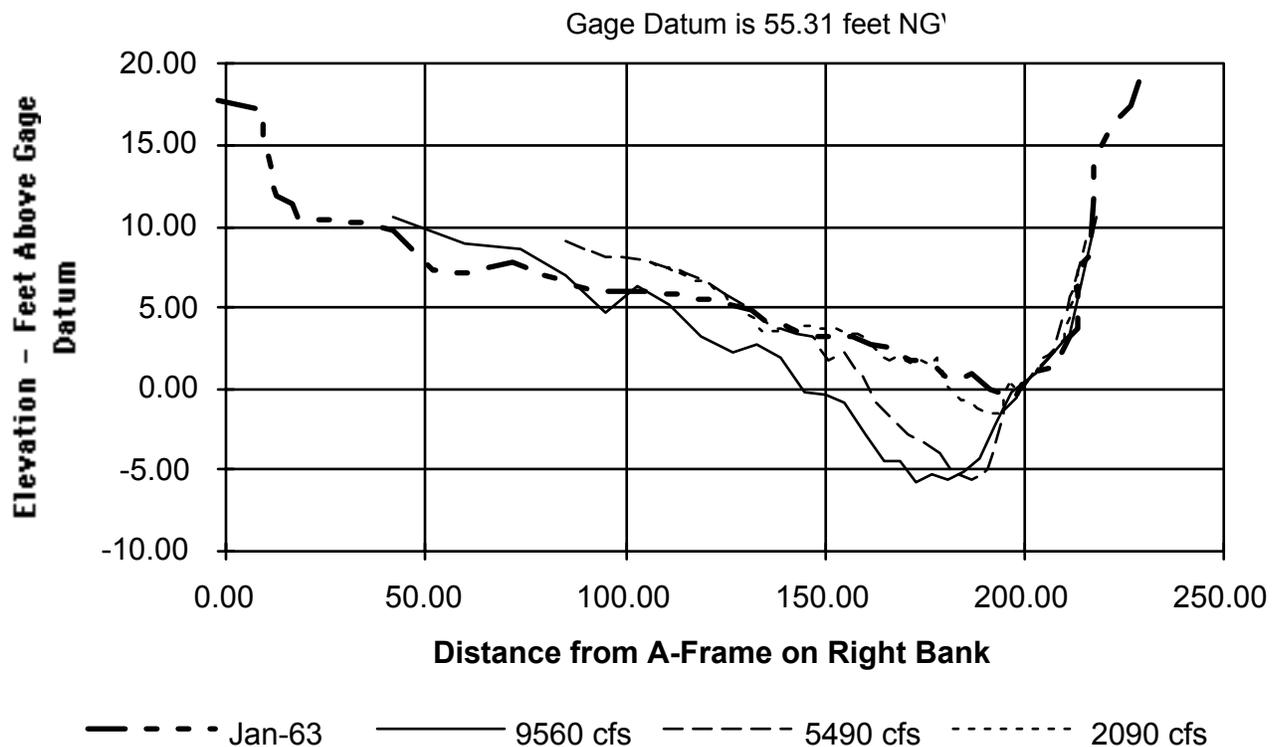
Figure 11. Garcia River at Conner Hole Channel Bed Mobilization

Table 8 shows the water surface and thalweg elevations. Table 9 gives the cross sectional area data for the surveys since 1991. The graph, in the appendix, labeled *Cross Section at Cableway* shows the cableway surveys from 1991, 1993, 1995-1997. The floods of 1993 eroded the right bank gravel bar, relative to 1991. The 1993 floods also appear to have built up the downstream riffle that controls flow out of the pool because the October 1993 water surface is 1.3 feet higher than the July 1991 water

surface (Table 8). The higher 1993 water surface prevented the rod man from crossing the river on the cross section, as indicated by the missing 1993 data. The 1995 flood, the largest recorded at this location, deposited material on the right bank gravel bar. However, most of the material deposited by the 1995 flood was concentrated in the delta that formed at the mouth of Olsen Creek, the small tributary on the right bank just upstream of the cableway. Table 9 shows that the delta deposits resulted in an 16% decrease in cross sectional area from 1991 to 1995.

The downstream control appears to have been eroded by the 1995 flood since the water surface dropped by about 0.5 feet, relative to the 1993 level. The storms of 1996 removed a portion of the material deposited in 1995 resulting in an increase in cross section area from 1995 to 1996 (Table 9). The downstream control was further eroded in 1996 since the water surface dropped 1.5 feet relative to the 1995 level (Table 8). The erosion of the downstream control has resulted in the 1996 water surface being 0.75 feet lower than the 1991 water surface. The drop in water surface required the lowering of the stage recording sensor in 1995. The 1997 water surface elevation was 0.1 feet higher than it was in 1996 indicating the downstream control was unchanged by the 1997 event.
