**MARIN COUNTY STREAM CROSSING INVENTORY AND FISH PASSAGE
EVALUATION**

FINAL REPORT

Prepared for the County of Marin – Department of Public Works

Ross Taylor and Associates

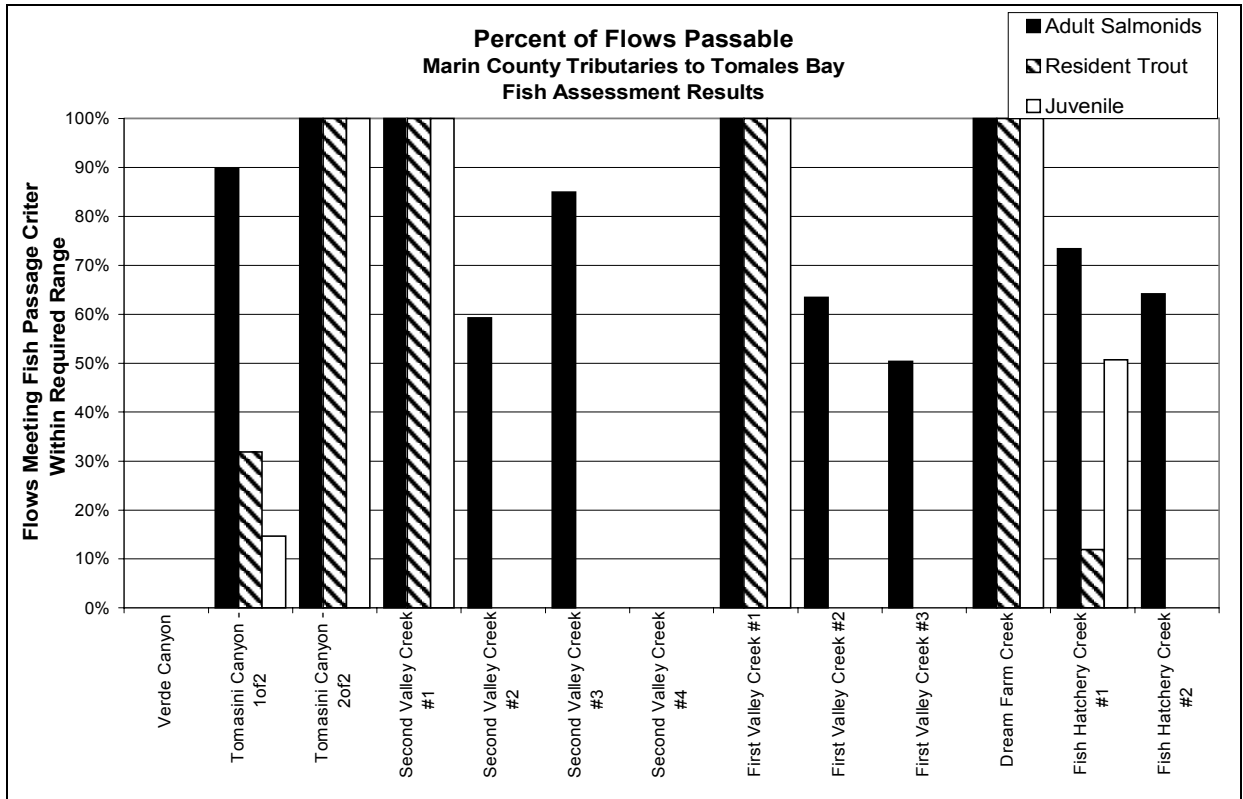
Figure 7. Percent passable as estimated by the Green-Gray-Red evaluation filter and FishXing for 12 Marin County stream crossings within tributaries of the Tomales Bay sub-watershed, by three groups of life stages.

Passage results generated by FishXing are displayed as "percent passable" for the range of migration flows calculated for each stream crossing location within the eight sub-watershed categories or areas (Figures 7-14). For each site, by species and lifestage, FishXing evaluation results are provided in Appendix B. The "Comments" column in Appendix B lists assumptions made concerning specific sites while running FishXing. Also provided in Appendix B are the hydrologic information utilized to calculate peak flows and fish passage flows.

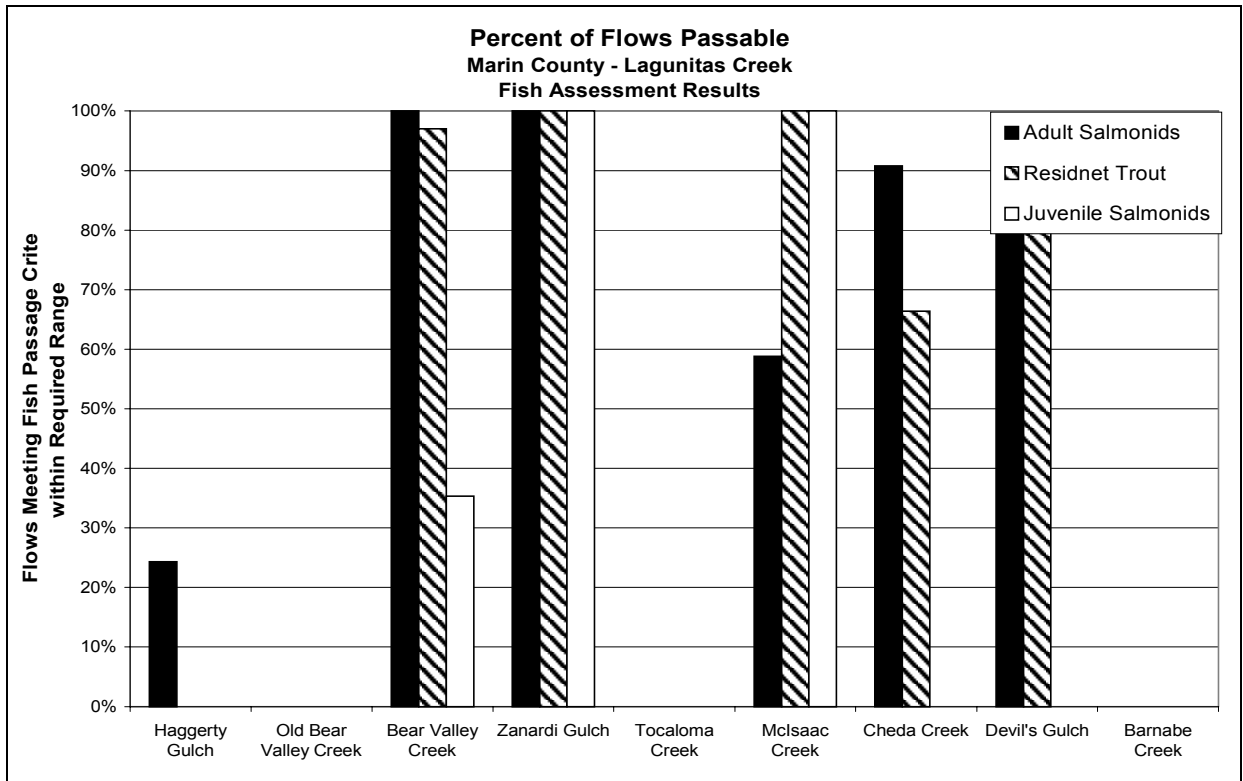
Figure 8. Percent passable as estimated by the Green-Gray-Red evaluation filter and FishXing for nine Marin County stream crossings within tributaries of Lagunitas Creek, by three groups of life stages.

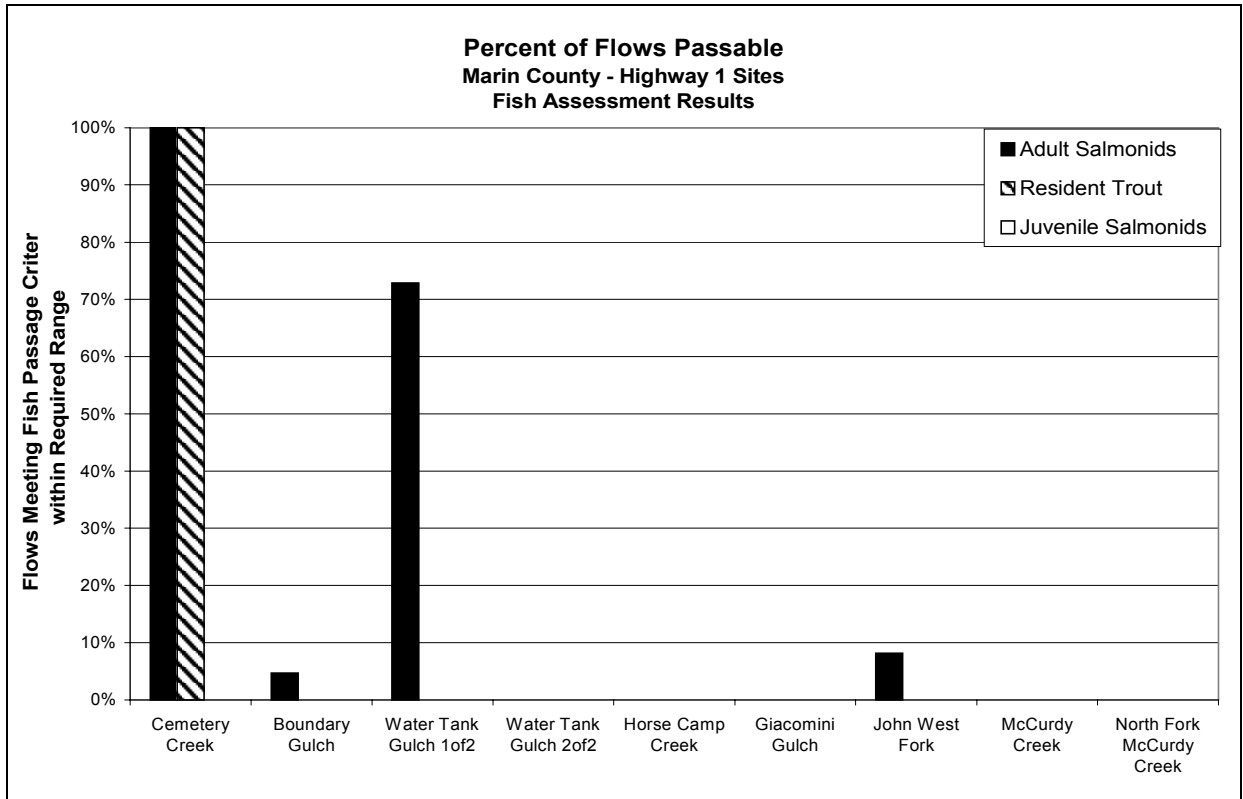
Figure 9. Percent passable as estimated by FishXing for eight Marin County stream crossings located on Highway One on tributaries to Olema Creek and Pine Creek, by three groups of life stages.

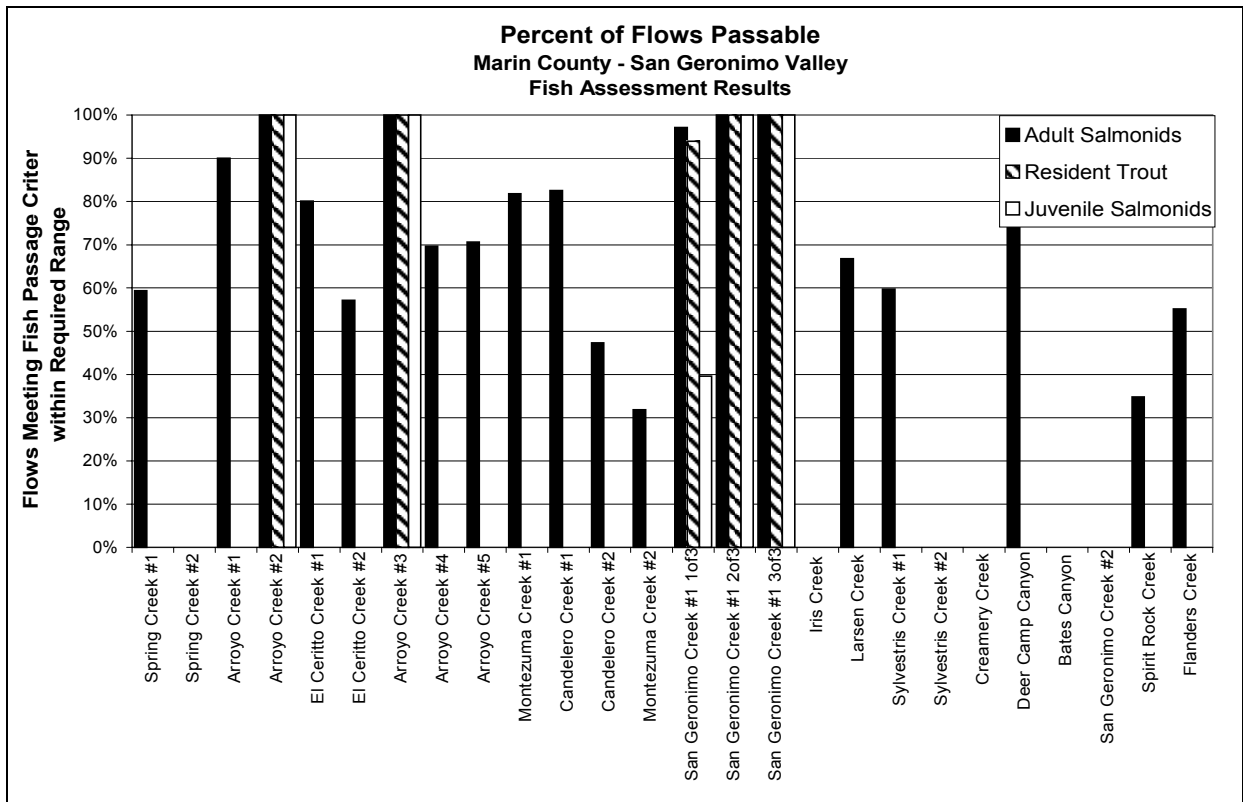
Figure 10. Percent passable as estimated by FishXing for 24 Marin County stream crossings within the San Geronimo sub-basin of the Lagunitas Creek watershed, by three groups of life stages.

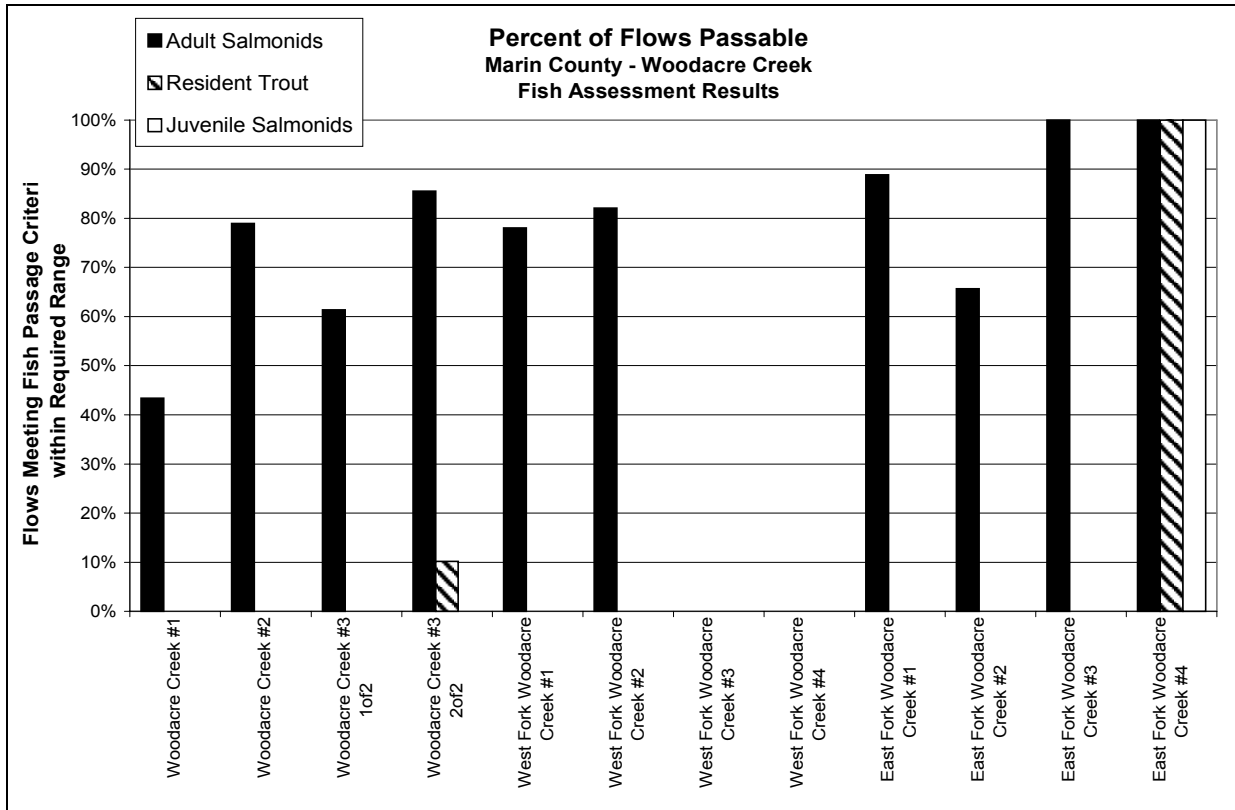
Figure 11. Percent passable as estimated by FishXing for 11 Marin County stream crossings within the Woodacre Creek sub-basin of the Lagunitas Creek watershed, by three groups of life stages.

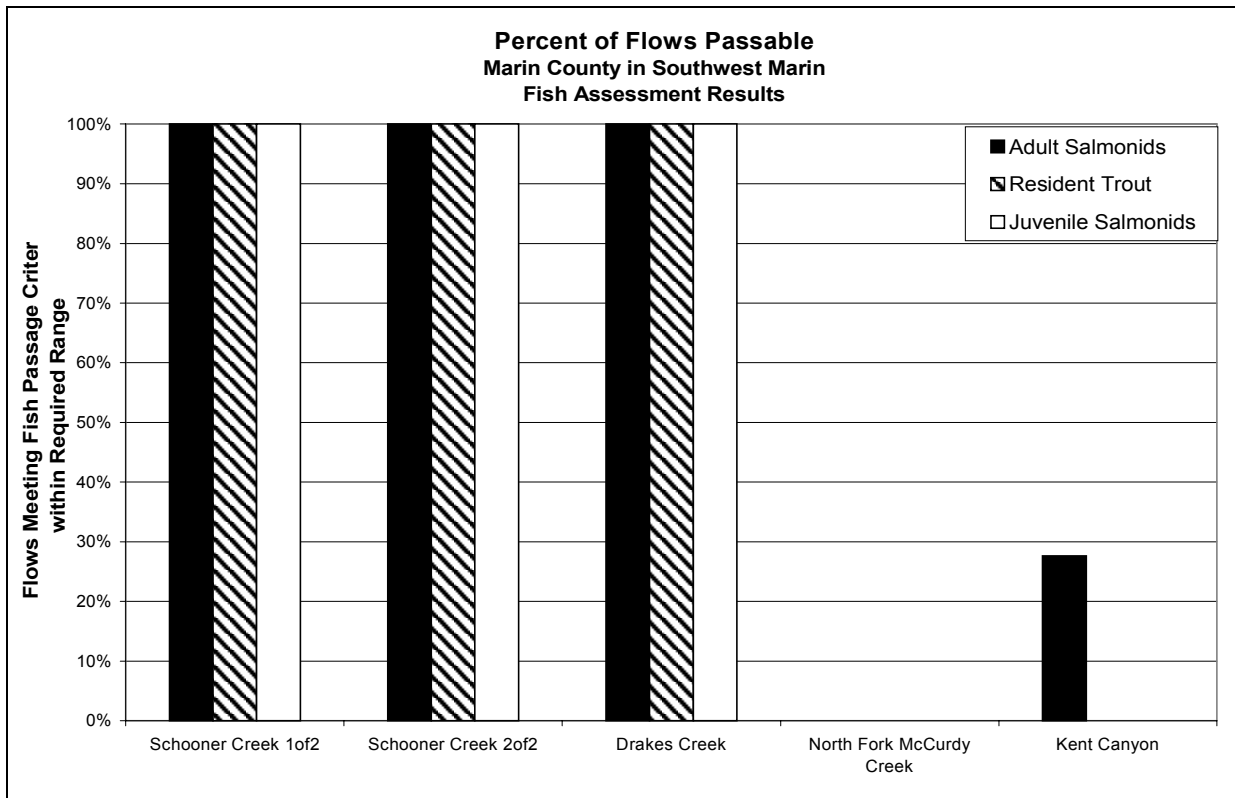
Figure 12. Percent passable as estimated by FishXing for four Marin County stream crossings on tributaries located in southwestern Marin County, by three groups of life stages.

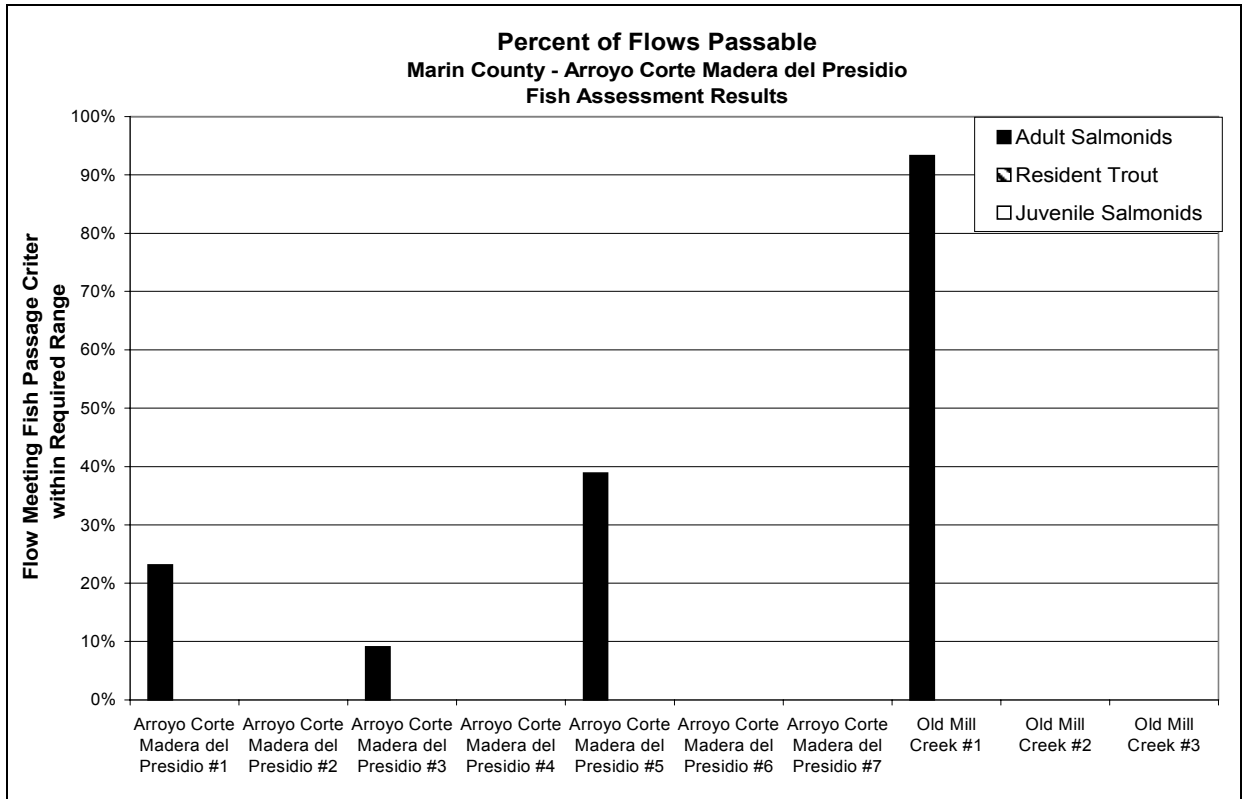
Figure 13. Percent passable as estimated by FishXing for 10 Marin County stream crossings within the Arroyo Corte Madera del Presidio watershed, by three groups of life stages.

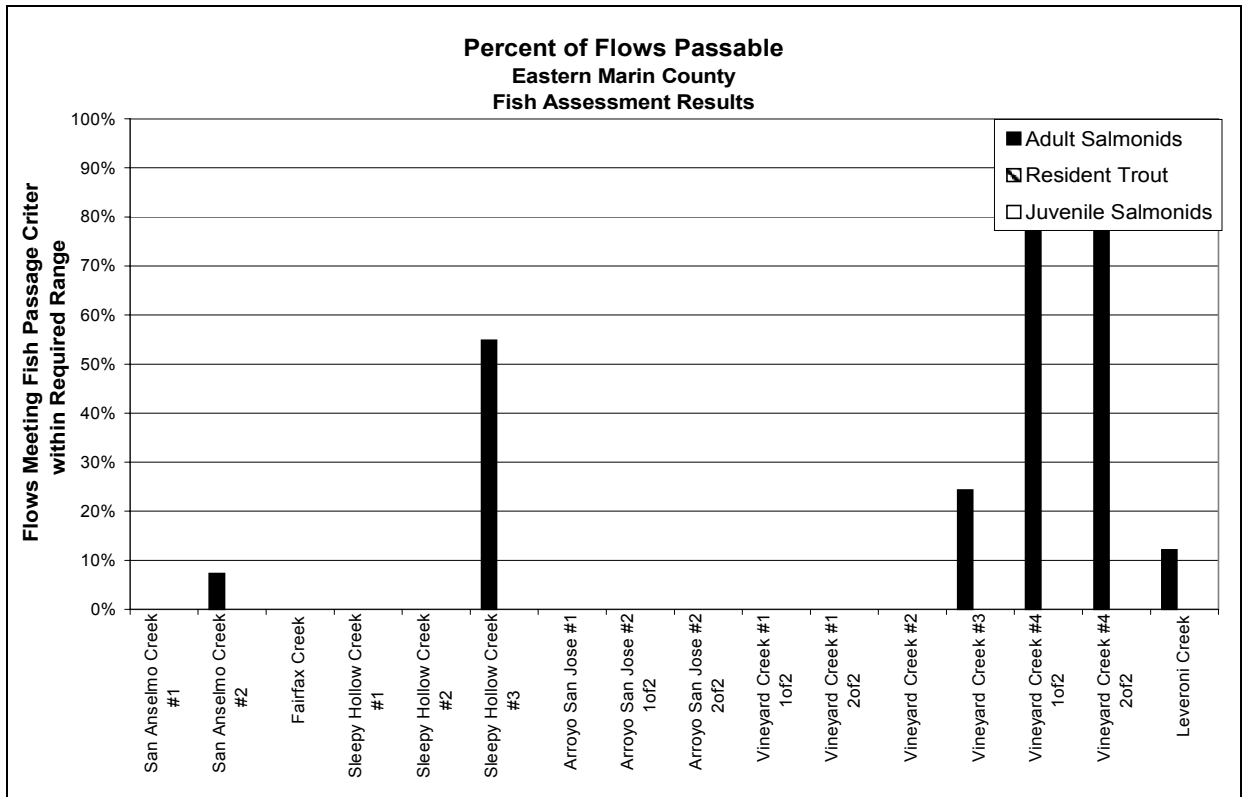
Figure 14. Percent passable as estimated by FishXing for 13 Marin County stream crossings within eastern Marin County watershed, by three groups of life stages.
