## **News Release**

U.S. Department of the Interior U.S. Geological Survey Release March 6, 2001

## **Removal of Obsolete Forest Roads Can Reduce Erosion and Sediment That Impair Salmon-bearing Streams**

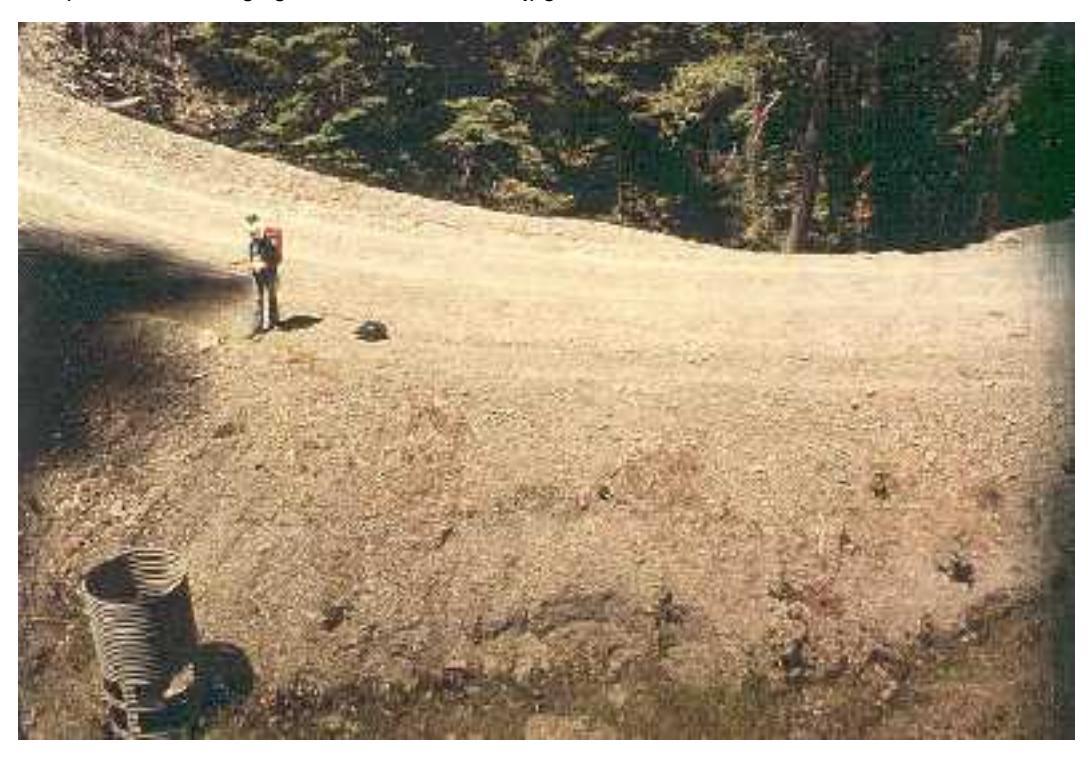
http://www.werc.usgs.gov/news/2001-03-06a.jpg

Note to News Editors: Reproducible photos for this release are available for use at: http://www.werc.usgs.gov/news/2001-03-06a.jpg(Abandoned logging road with intact culvert before treatment, Redwood National and State Parks, Calif. Photo courtesy NPS) http://www.werc.usgs.gov/news/2001-03-06b.jpg(Immediately following treatment of stream crossing, Redwood National and State Parks, Calif. Photo courtesy NPS) http://www.werc.usgs.gov/news/2001-03-06c.jpg (Less than one year after treatment, revegetation of the streambanks is well underway, Redwood National and State Parks, Calif. Photo courtesy NPS) http://www.werc.usgs.gov/news/2001-03-06d.jpg (Three years after treatment, alders have revegetated most of the ground disturbed during treatment, Redwood National and State Parks, Calif. Photo courtesy NPS)
