STREAM SURVEY

Date September 7, 1967

NAME Rolling Brook COUNTY Mendocino
 STREAM SECTION Entire FROM Air Force Pump Station To Mouth Length 3 1/2 miles
 TRIBUTARY TO Garcia River Twp. 12N R. 16W Sec. 24
 OTHER NAMES None known RIVER SYSTEM Garcia
 SOURCES OF DATA Personal observation

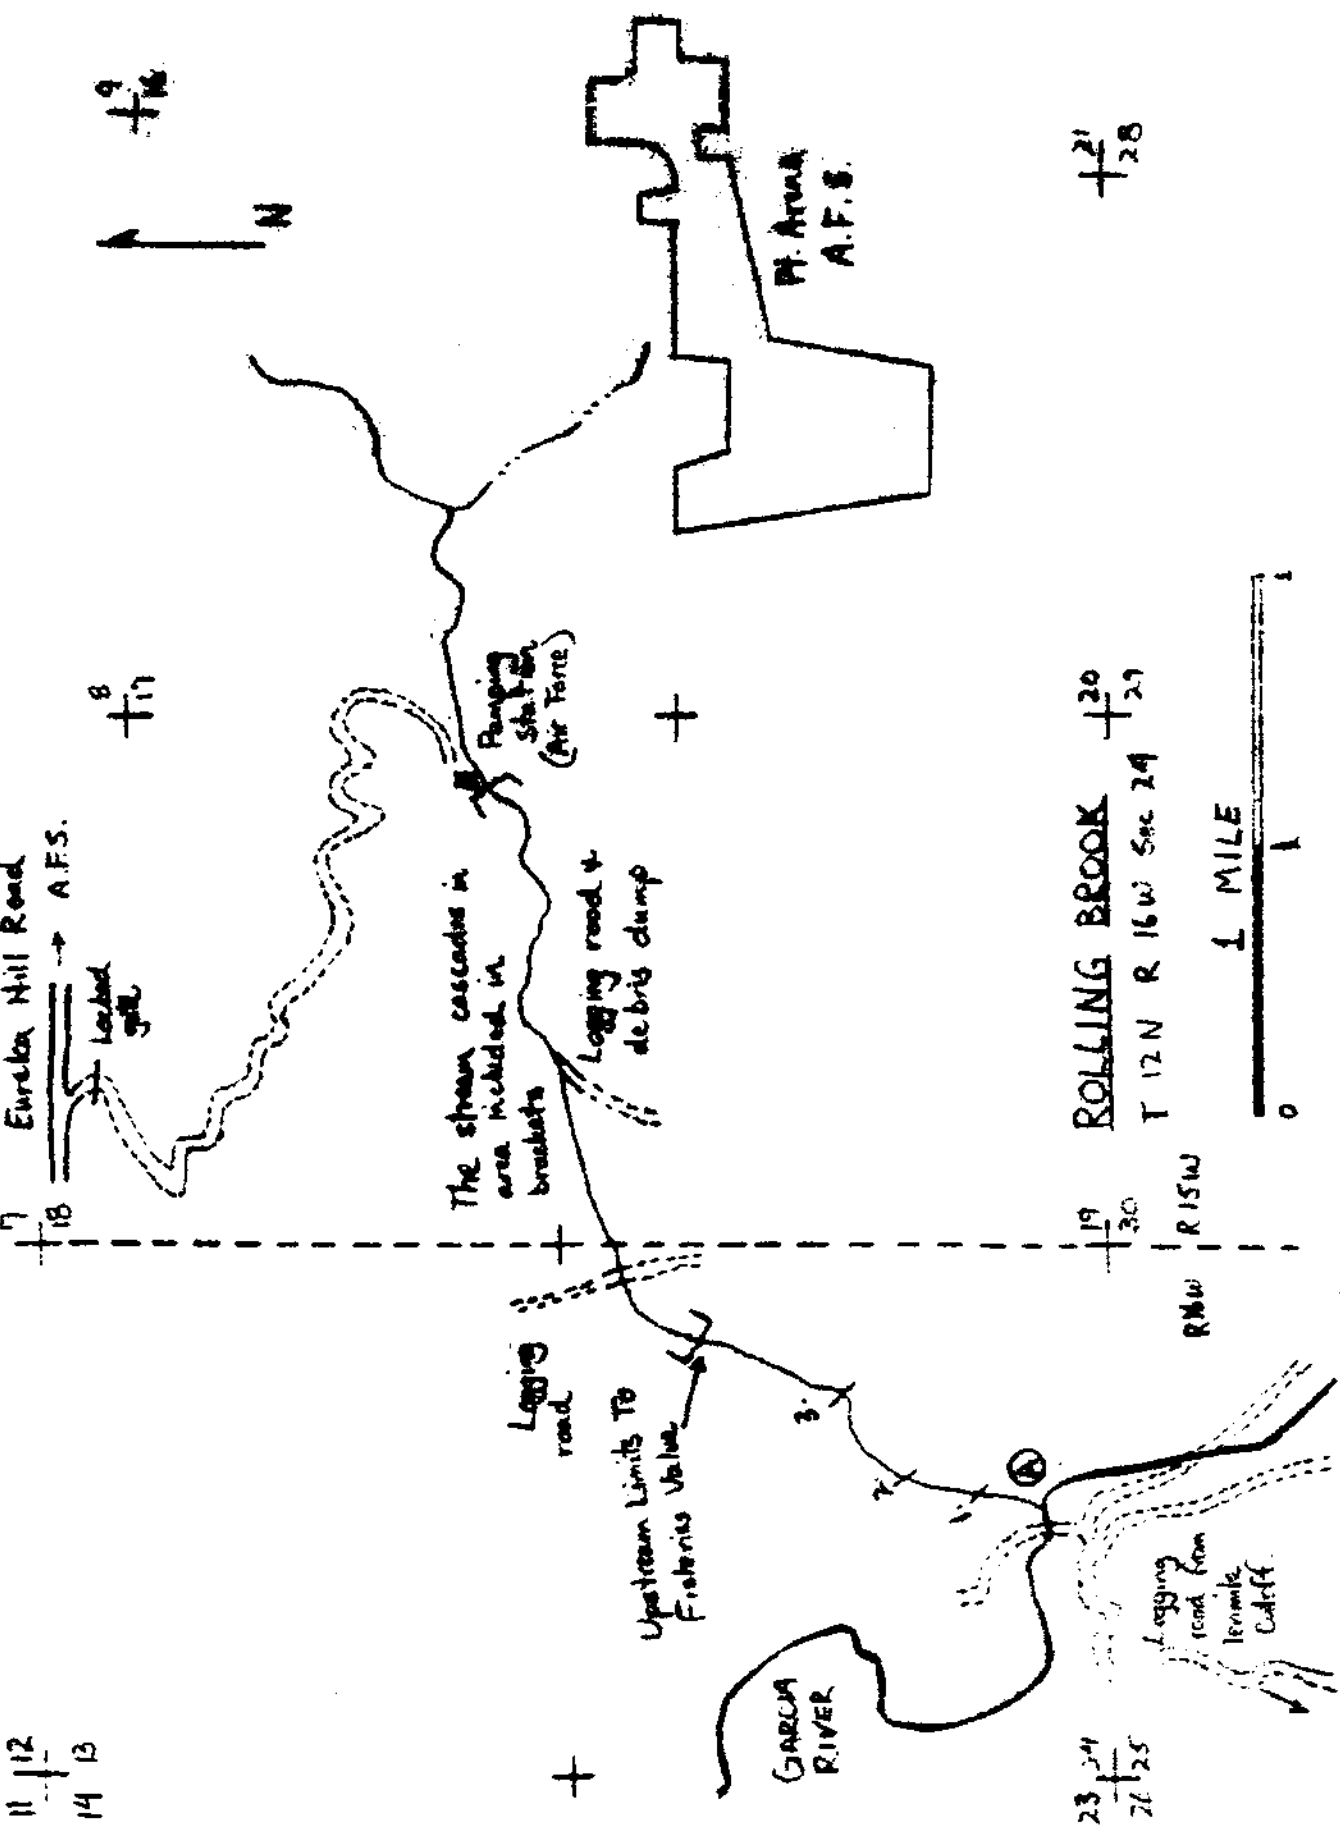
ROLLING BROOK
T 12 N R 16 W Sec 24 29

The stream cascades in
area included in
breakoffs

Logging road &
debris dump

Pumping
Station
(Air Force)

Upstream Limits To
Fisheries Value

Logging
road from
ten-mile
cut-off

RECOMMENDED MANAGEMENT - This stream should be retained as a fisheries stream for salmon and steelhead. Removal of the small log jams would facilitate passage in the lower 3/4 mile. Removal of debris above this point would insure a clear streambed for the future.
