Freshwater Creek Watershed Analysis Final Report

**Pacific Lumber Company (PALCO)
Scotia, CA**

Watershed Professionals Network

December 2003

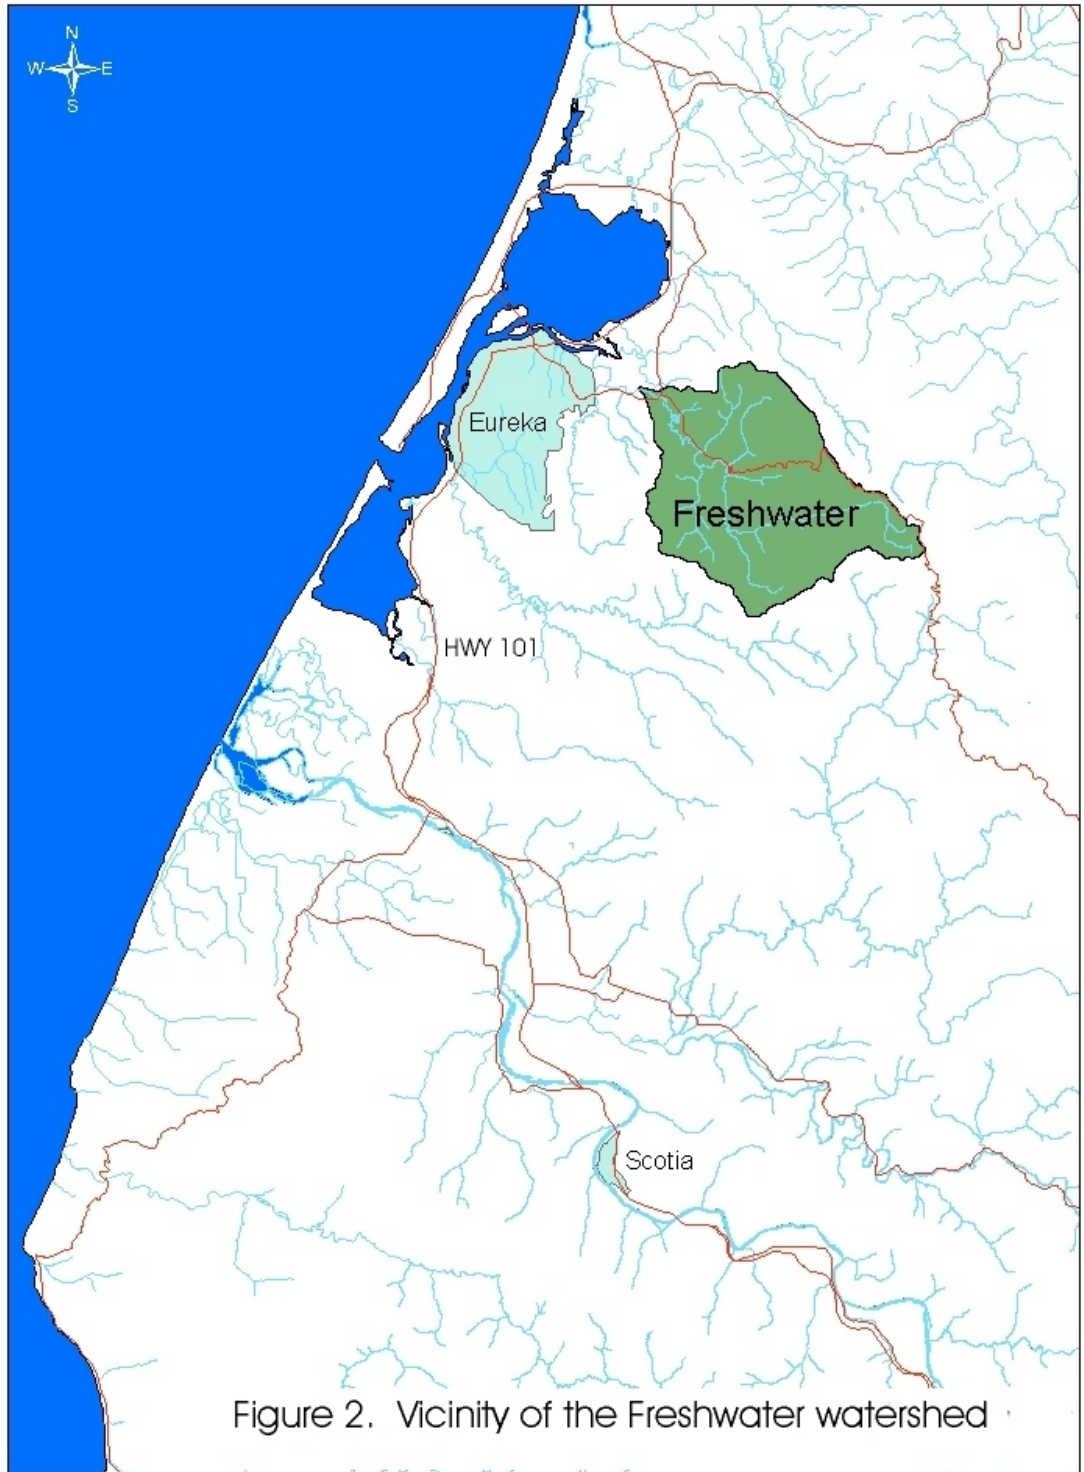
Figure 2: The vicinity of the Freshwater Watershed.

The Freshwater Creek watershed is a 31-mi² drainage basin located approximately 5 miles east of Eureka, California in Humboldt County (Figure 2). Freshwater Creek drains into Humboldt Bay through the Freshwater and Eureka Sloughs at the north end of Eureka. Freshwater Creek is the primary stream flowing through the basin. Major tributaries of Freshwater Creek include Cloney Gulch, South Fork Freshwater Creek, Little Freshwater Creek, McCready Gulch, and Graham Gulch.

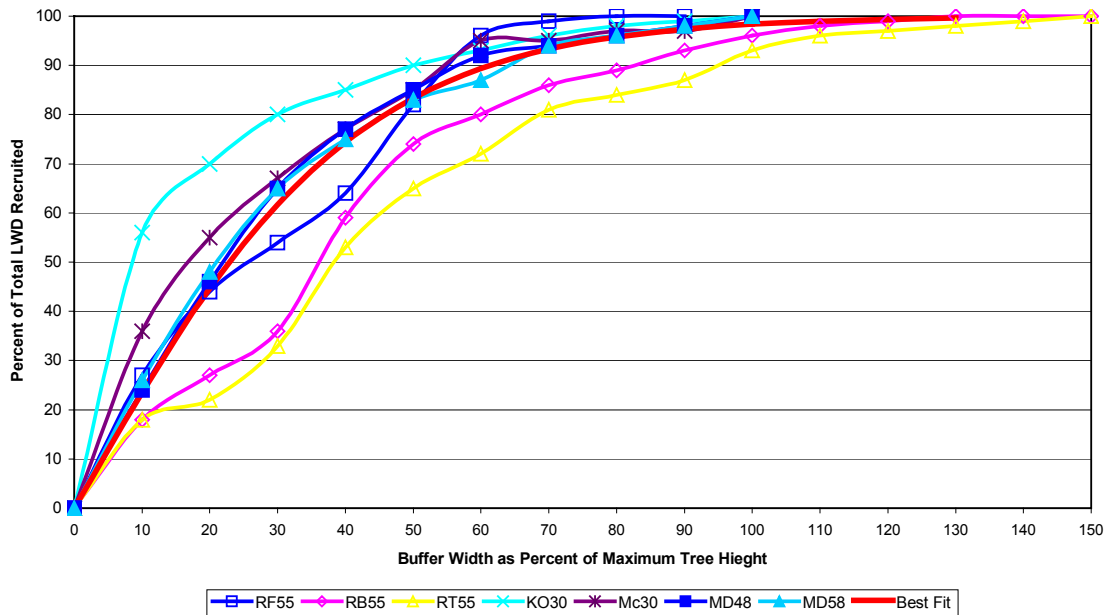
Figure 24: Source distance curves for empirical data. See the Riparian Condition Module Report for further explanation.

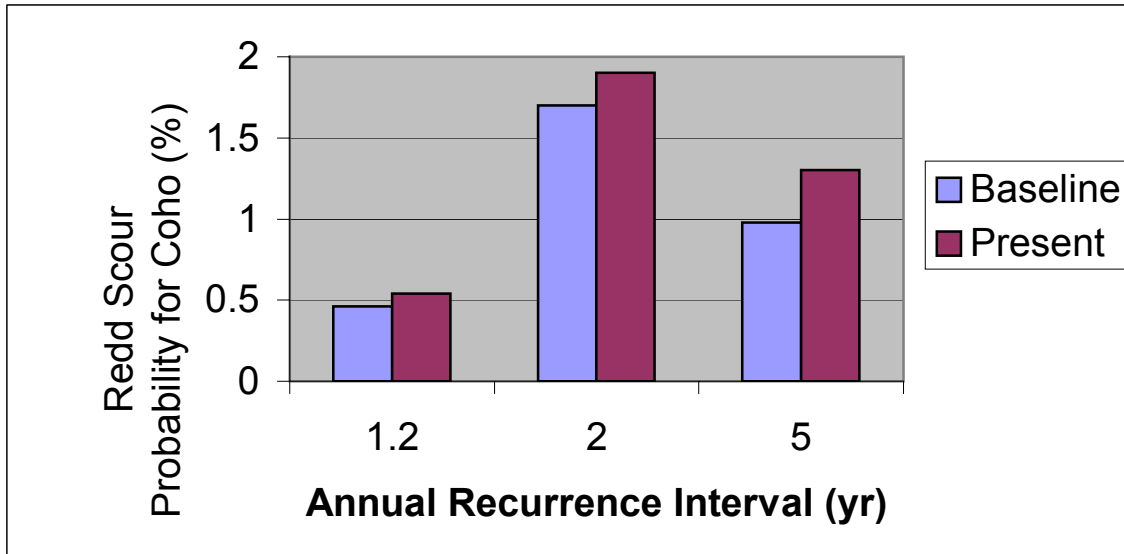
Figure 30: Comparison of the probability of critical bed scour under baseline hydrologic conditions and present managed conditions in MS1.

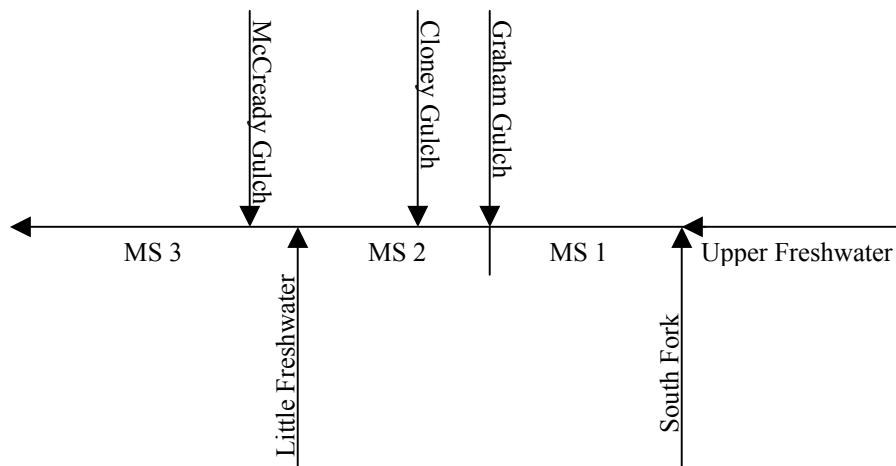
Figure 4-2: Diagram of Freshwater sediment routing model. Arrows indicate subbasin sediment inputs. Additional inputs to MS3 from smaller tributary subbasins are not shown in the diagram, but are included in the analysis.

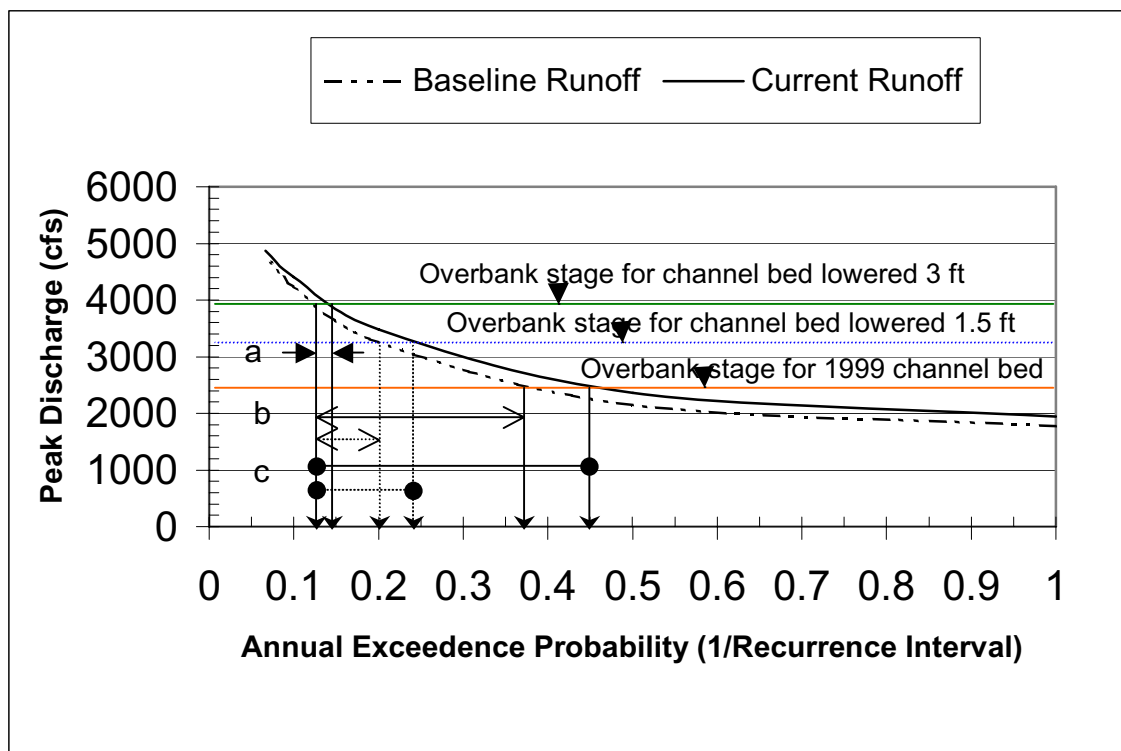
Figure 6-2: Graphical representation of the effect of peak flow increase alone (a-solid arrows), presumed aggradation alone (b-open arrows), and the combined effects of peak flow increase and presumed aggradation (c-solid circles). The dotted lines relate to a hypothetical bed elevation 1.5 ft lower than in 1999; the solid lines farthest to the right relate to the existing channel bed, while those farthest to the left relate to a hypothetical channel bed elevation 3 ft lower than in 1999.

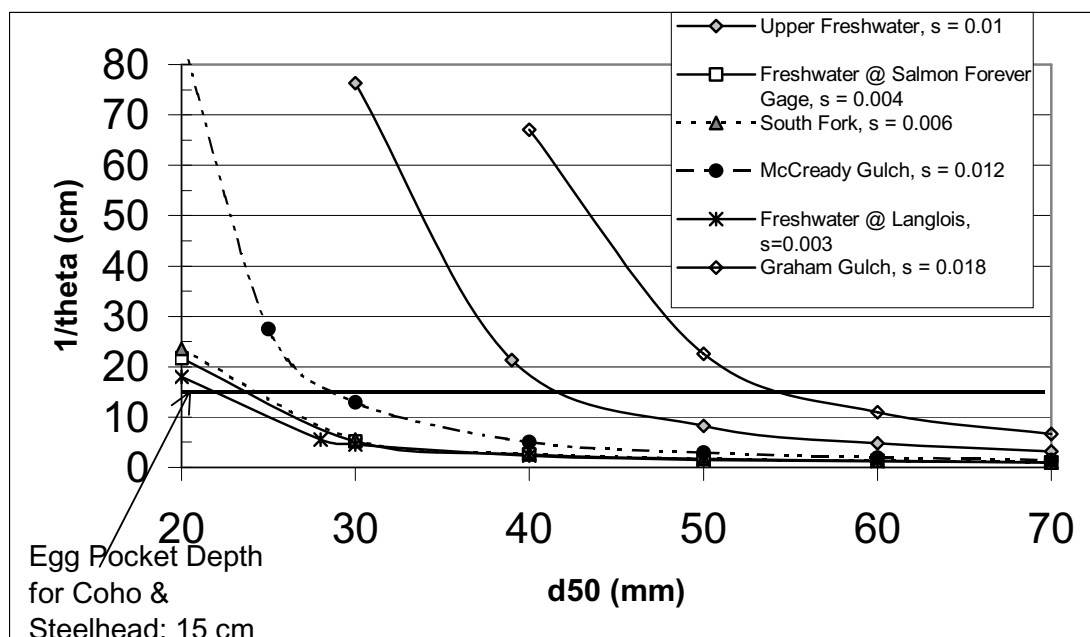
Figure 6-5: Predicted depth of scour and fill as a function of median grain diameter for hydraulic conditions during a 1.2-year recurrence interval flow.

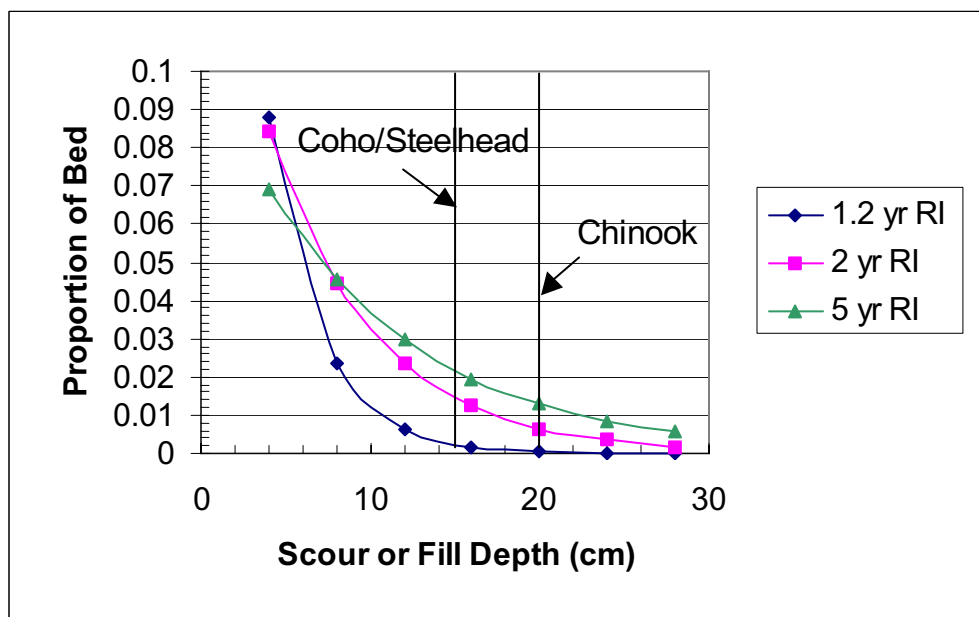
Figure 6-7: Predicted proportion of bed scour or fill in the survey reach containing the Salmon Forever gage site for specified flows under present watershed conditions. The typical depths of egg pockets for different salmonids are also shown.

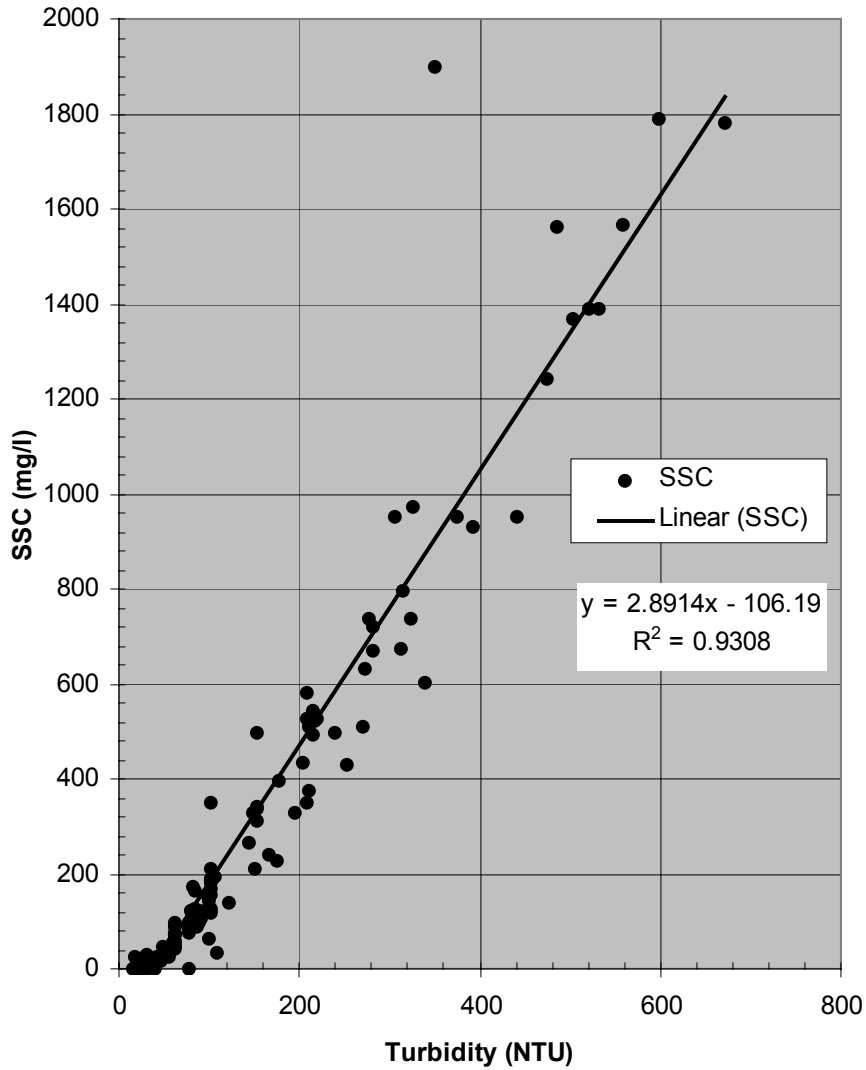
Figure 3-8: Turbidity versus suspended sediment, 1999.
