The Resources Agency of California
Department of Fish and Game

STREAM DAMAGE SURVEYS - 1966¹

Inland Fisheries Administrative Report No. 66-10.

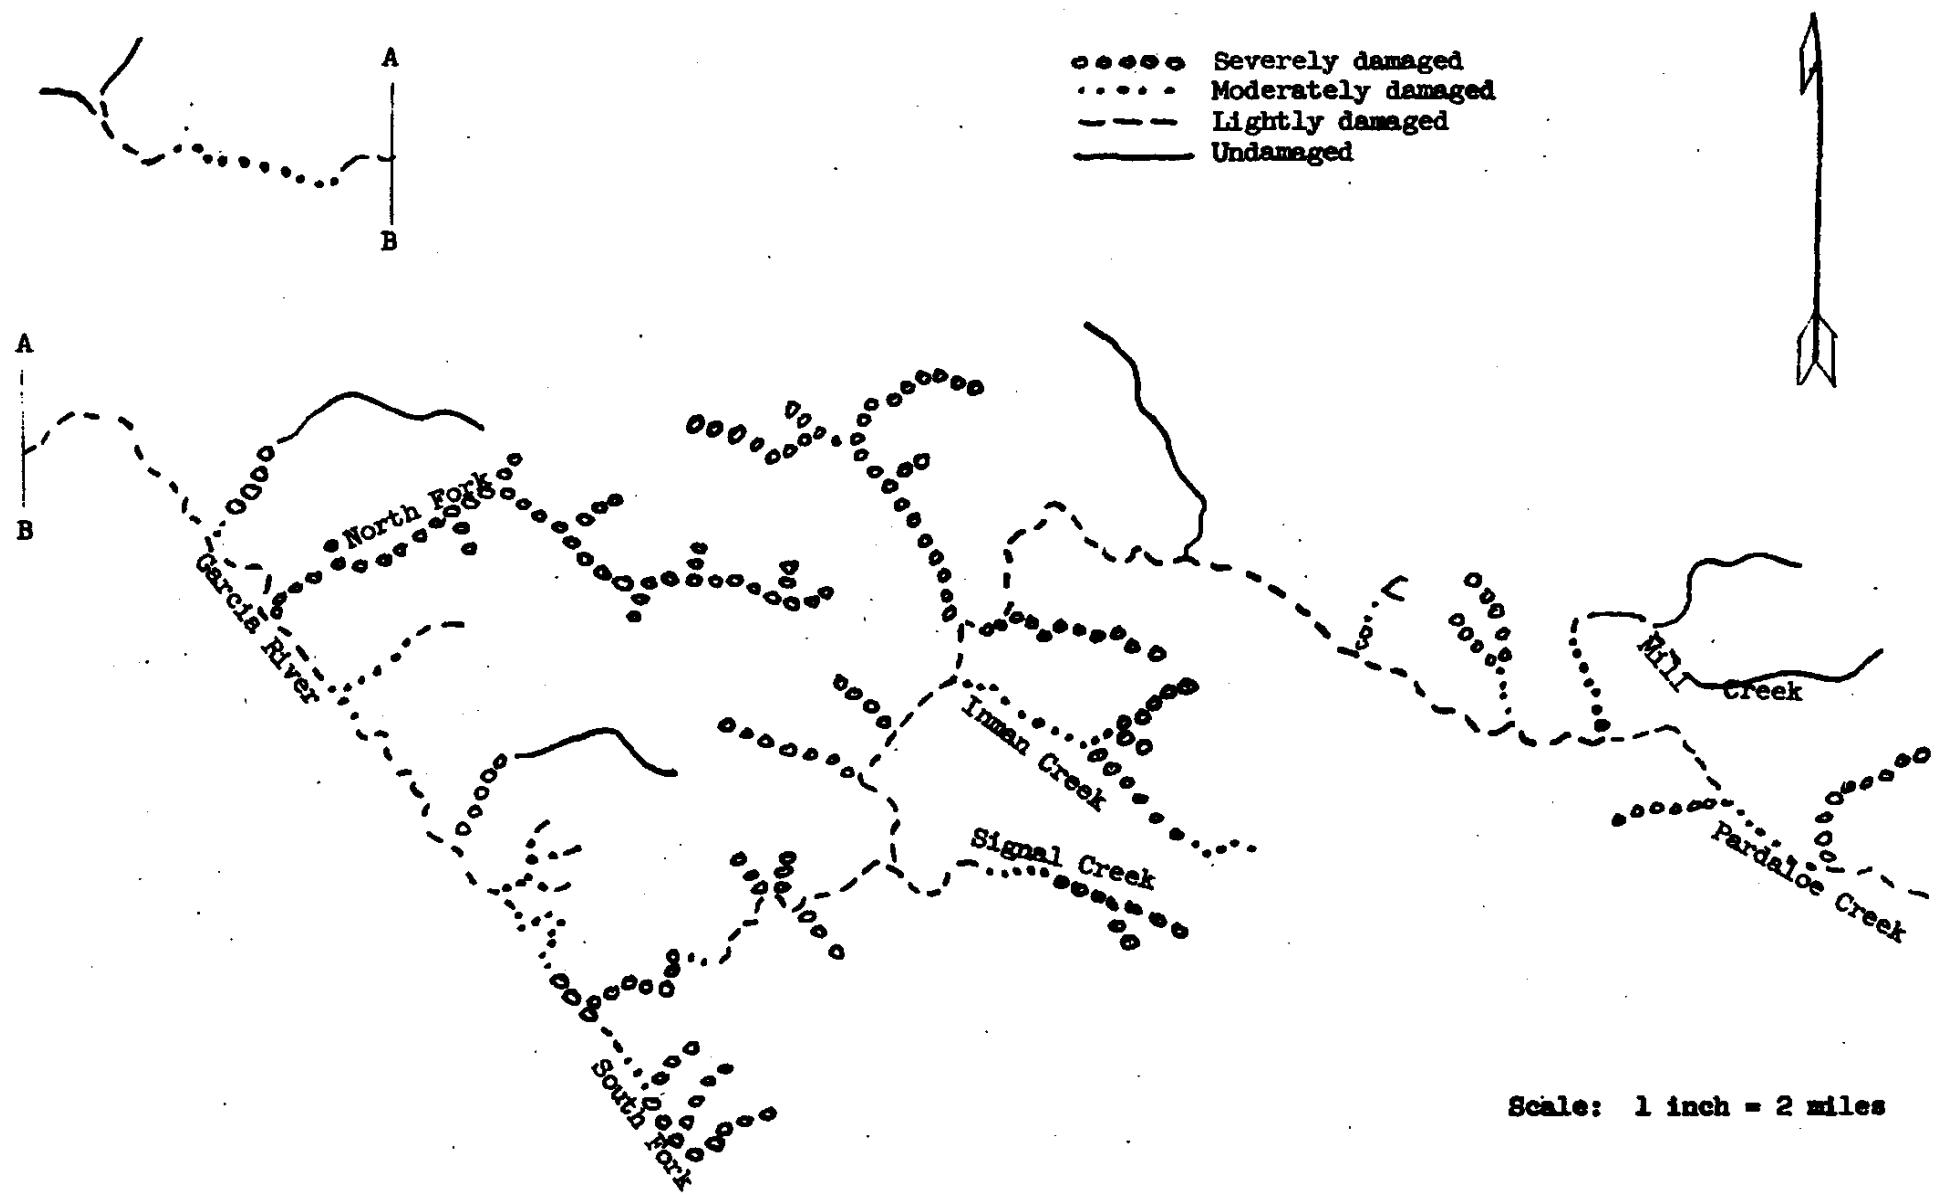
FIGURE 1. Garcia River, Mendocino County, stream damage.

Most of the severely damaged areas in the Garcia River are the result of current operations. Sidehill slopes are very steep, and many of them are laced with skid trails and logging roads. There has been little effort to keep heavy equipment out of the streambeds, and in numerous instances roads have been constructed in the stream channels, oftentimes moving the stream out of its natural channel.

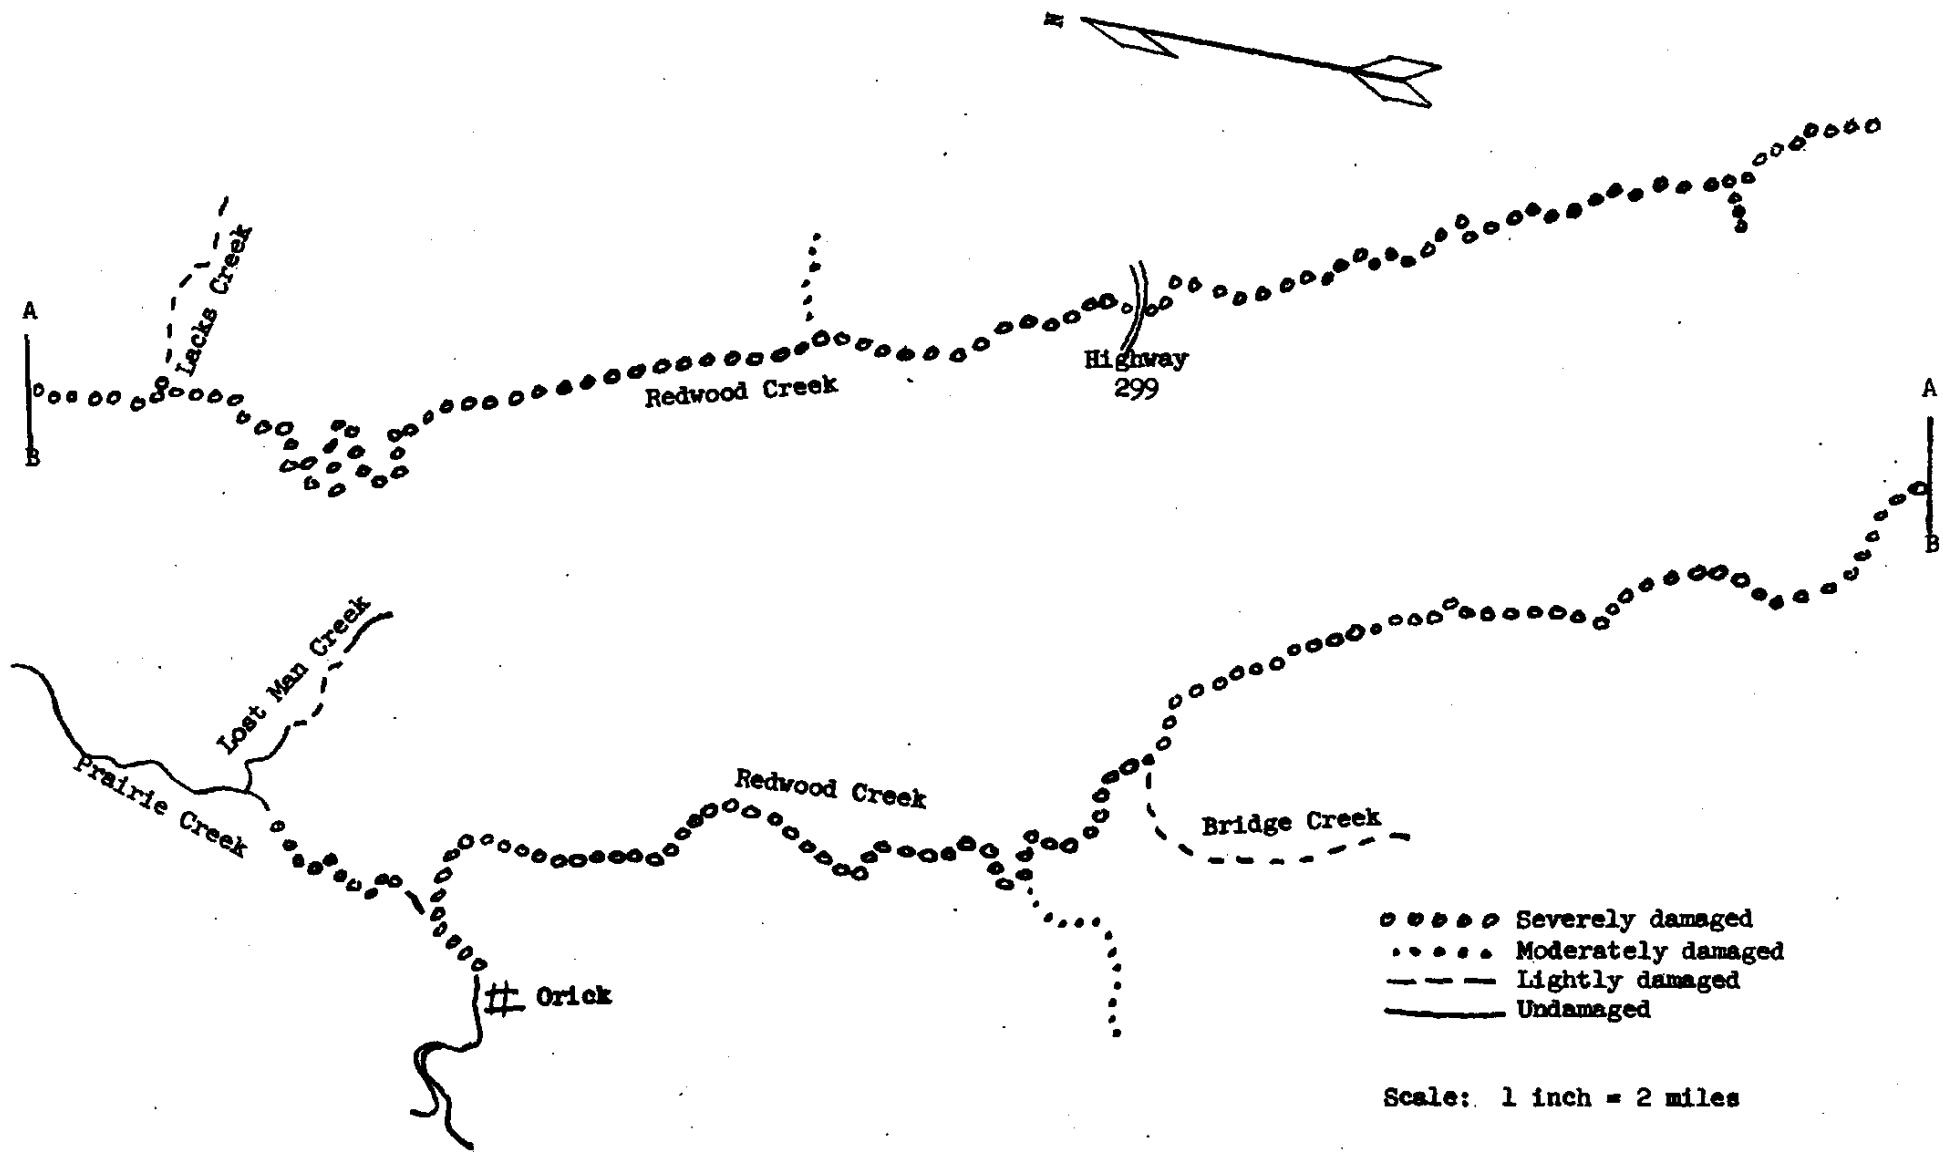
FIGURE 2. Redwood Creek, Humboldt County, stream damage.

The main stem of Redwood Creek has undergone extensive change in recent years. Large amounts of sand, silt, and gravel have been deposited in the channel, and as a consequence, the streambed has widened and raised. Pools are almost nonexistent, taring low flows, the water is exposed to direct sunlight almost throughout the entire length of stream. Streamside vegetation is presently too far from the live stream to be of much benefit. The river channel is largely unsuitable as a nursery for young salmon and steelhead in its present condition.

Both man-made and natural conditions have contributed to the deterioration of Redwood Creek. Major floods in 1955, 1964, and 1965 washed enormous amounts of material into the main stem, filling pools and widening the channel. Logging activities, particularly the construction of roads and skid trails and the removal of vegetative ground cover, have been a major factor contributing to increased erosion and land slippage.

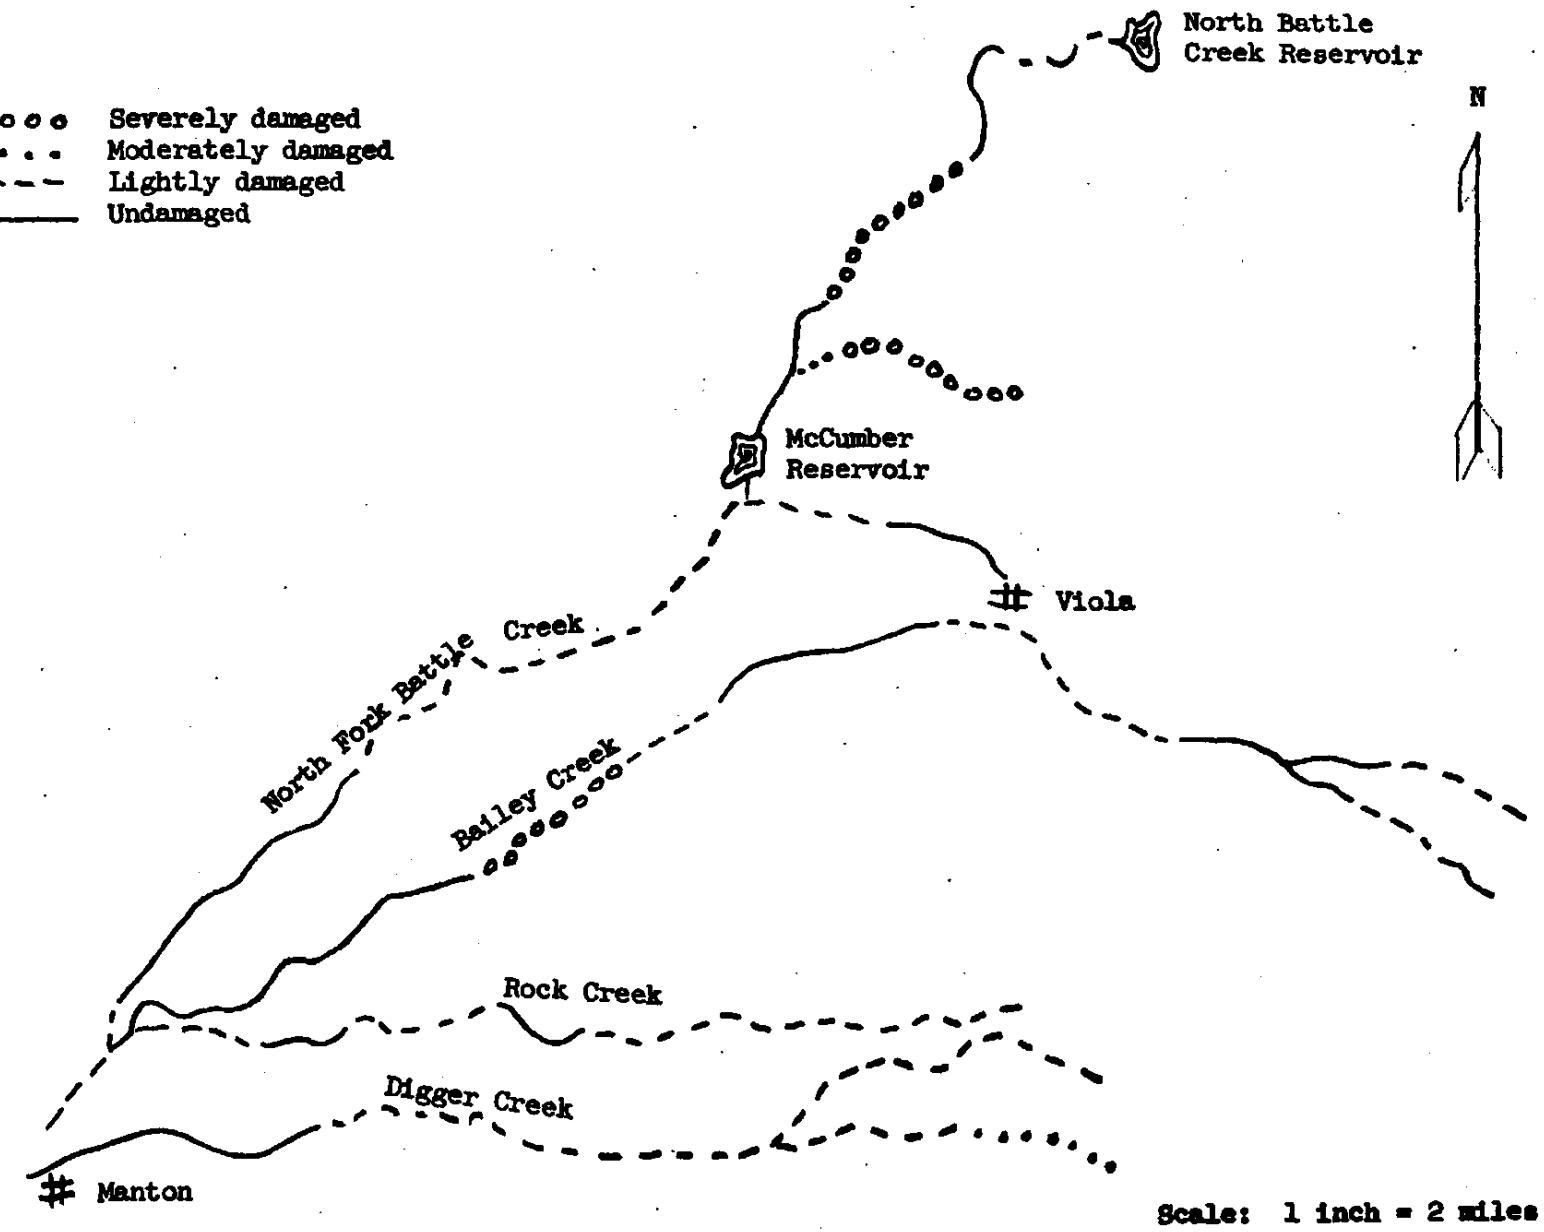
FIGURE 3. North Fork Battle Creek, Shasta County, stream damage.

Logging has been conducted since the 1800's in the Battle Creek drainage; however, because of a number of factors, erosion problems are not as great here as in many other localities. Extensive damage does not generally occur due to any particular disturbance, although there was one bad operation along the creek in 1965. Damage due to logging has been localized and relatively minor in this area as a whole.

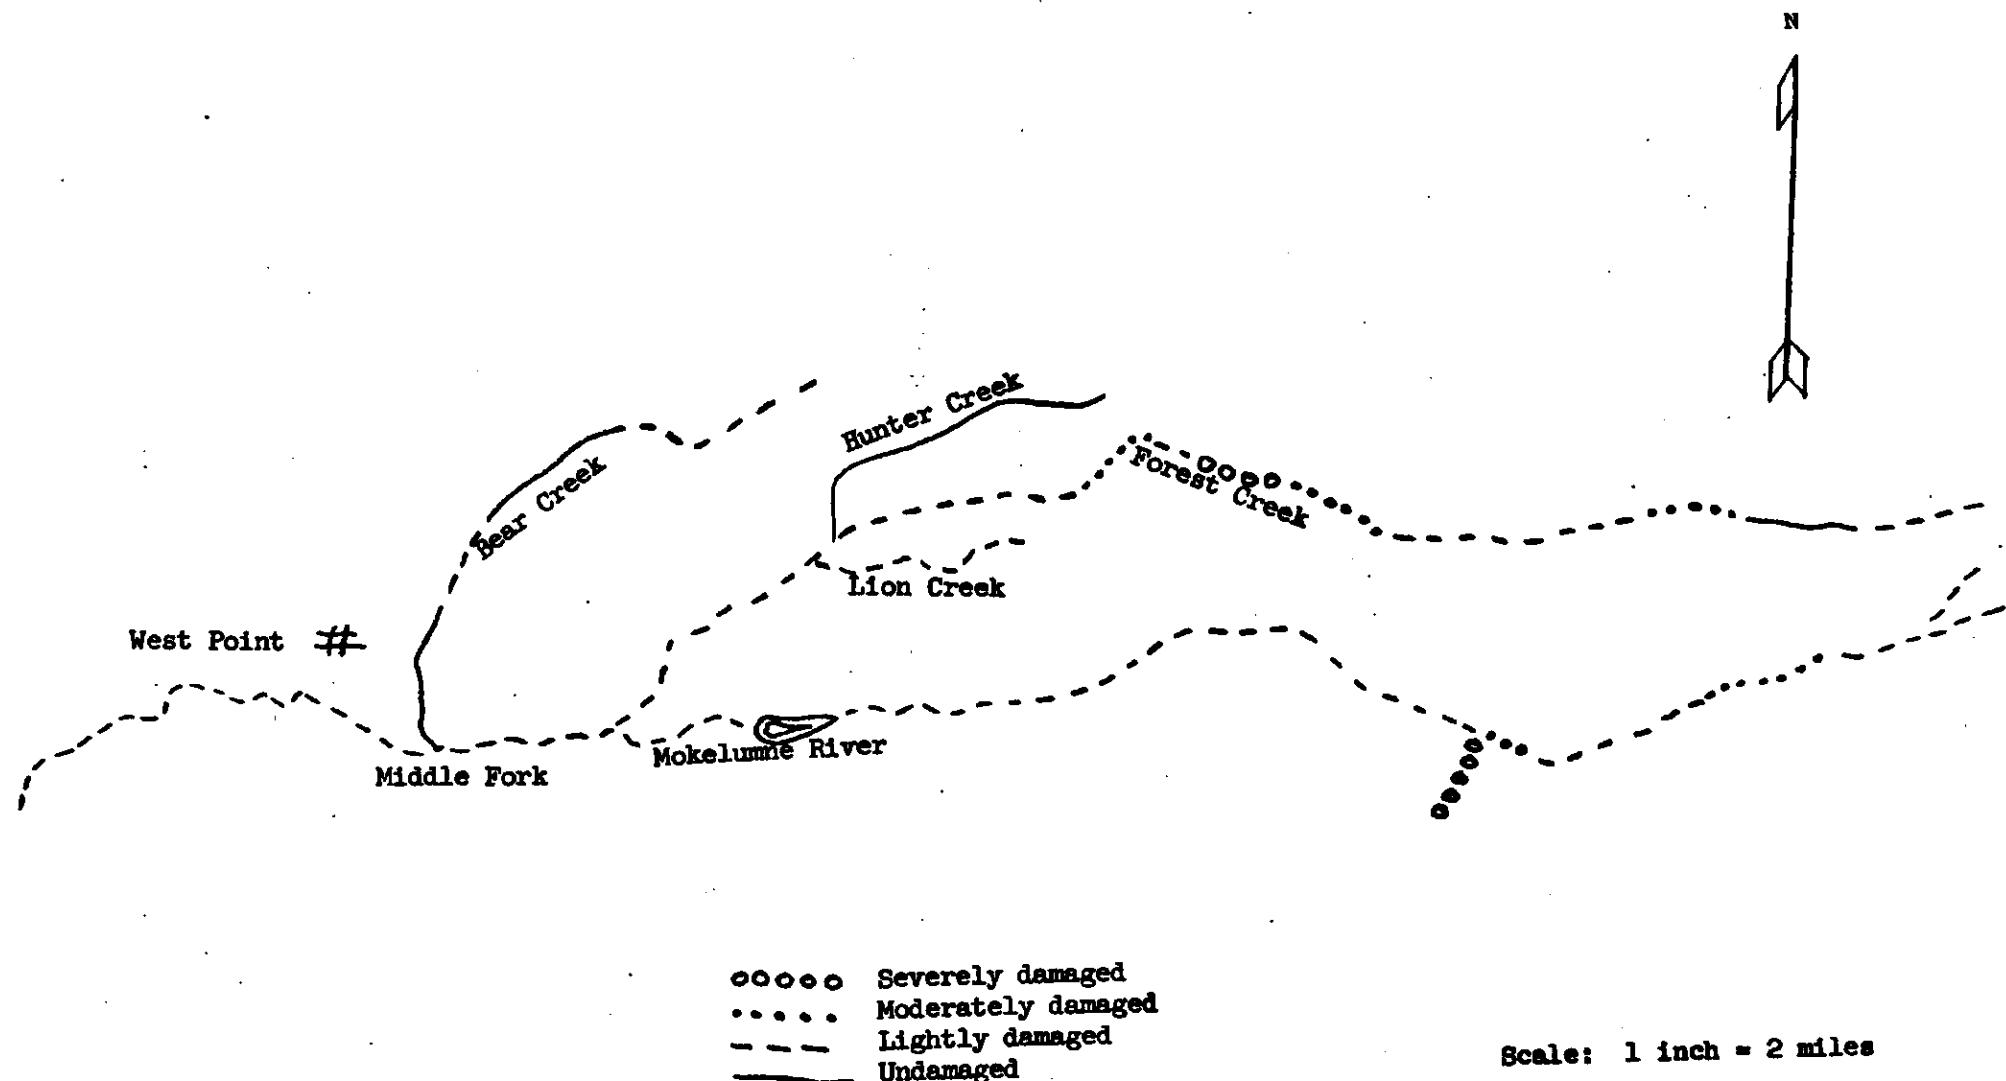
FIGURE 4. Middle Fork Mokelumne River, Calaveras County, stream damage.

Resident rainbow and brown trout are found in this drainage. Catchable-sized rainbow trout are also planted in several stream sections. All of the streams flowing through lands logged in the last 20 years have been damaged to some degree. Most of the damage has been caused by heavy equipment operations within the stream channels, and by removal of the streamside canopy. In this drainage, no stream disturbance other than siltation from upstream logging operations was noted on U. S. Forest Service lands.

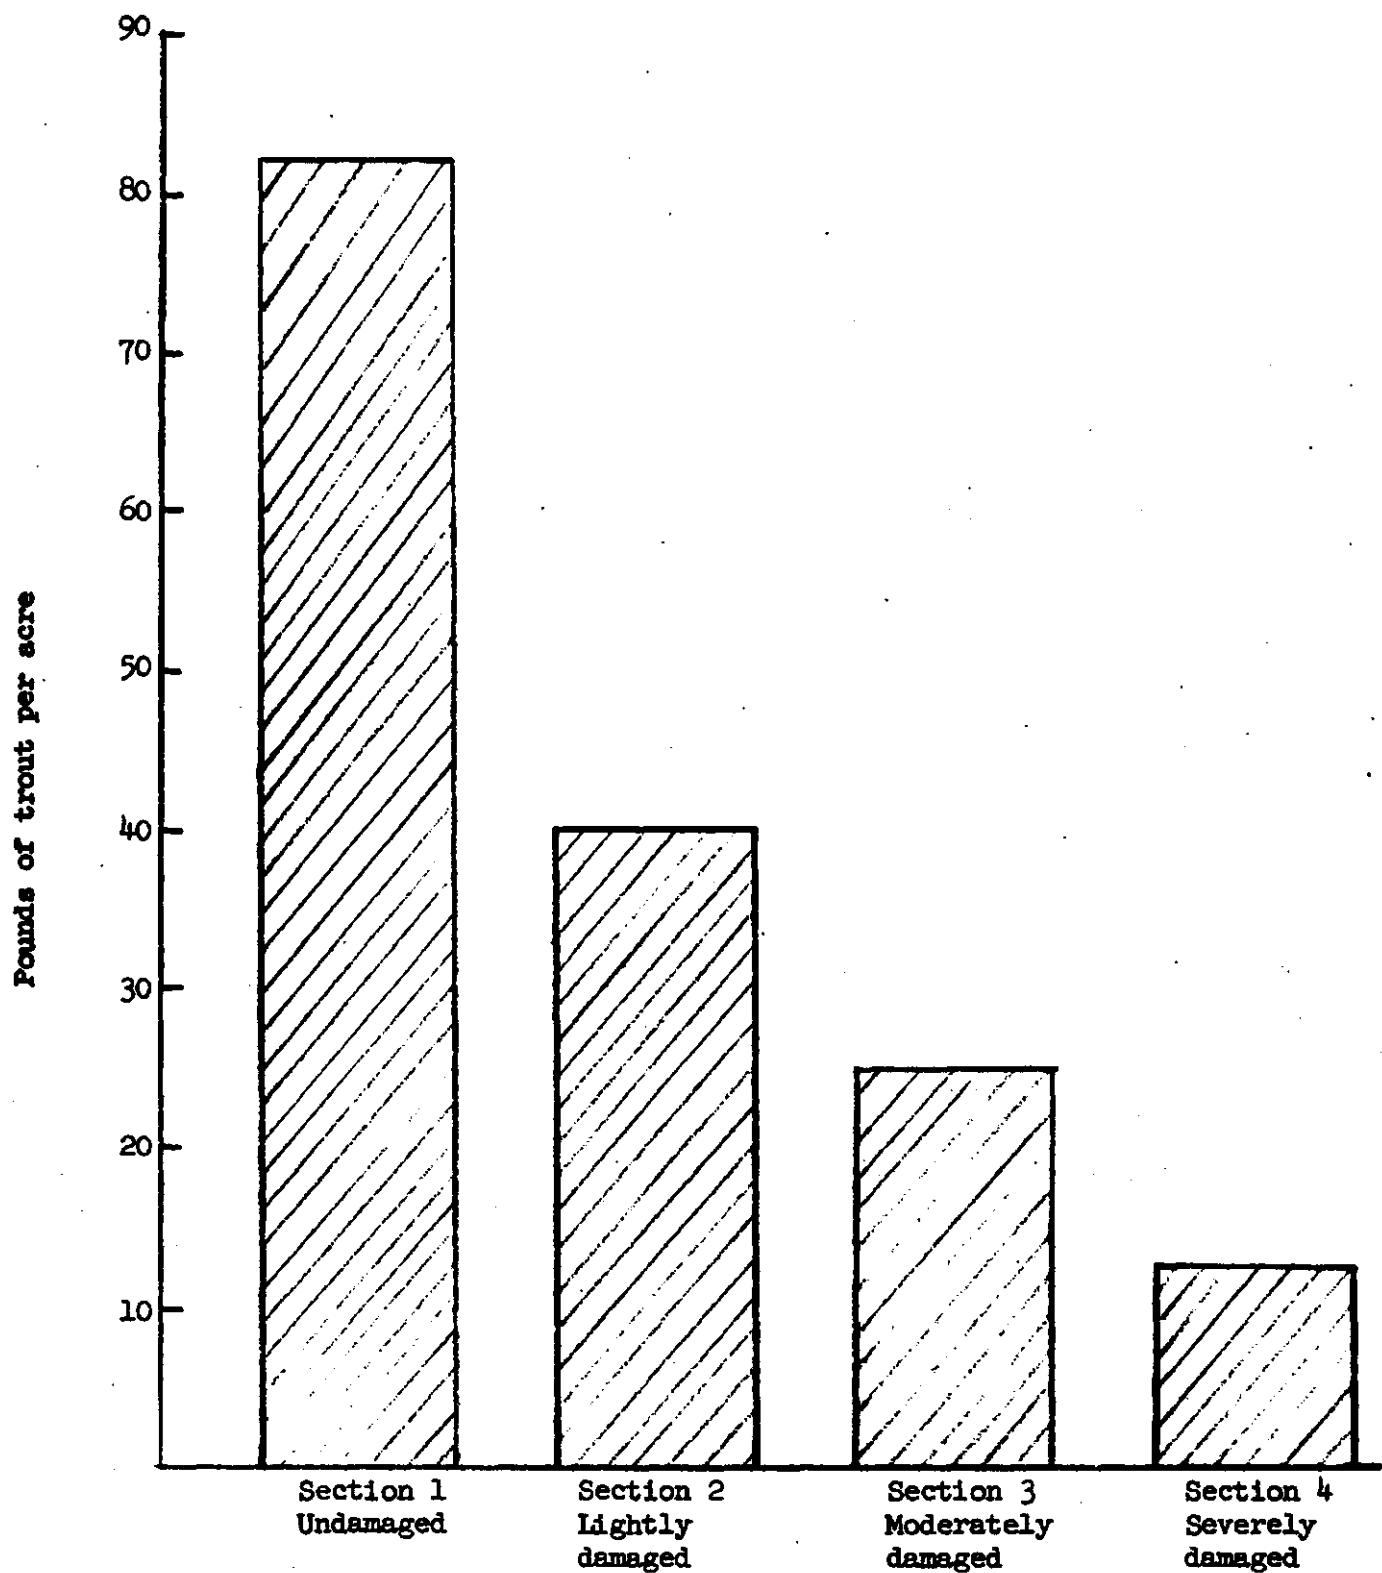
FIGURE 5. Trout populations from damaged sections of Forest Creek,
Calaveras County, July 25, 1965.

Fish populations were sampled in sections of the North Fork of Battle Creek and Forest Creek, tributary to the Middle Fork of Mokelumne River, to determine the numbers and weight of trout in undisturbed and in damaged sections of the streams. Results from both streams indicate approximately five times as much trout by weight, in undamaged streams as in severely damaged sections (Tables 2 and 3). Figure 5 portrays graphically the pounds of trout per acre in the various damaged sections of Forest Creek. Both streams were sampled with an electro-shocker in 200- or 300-foot sections.

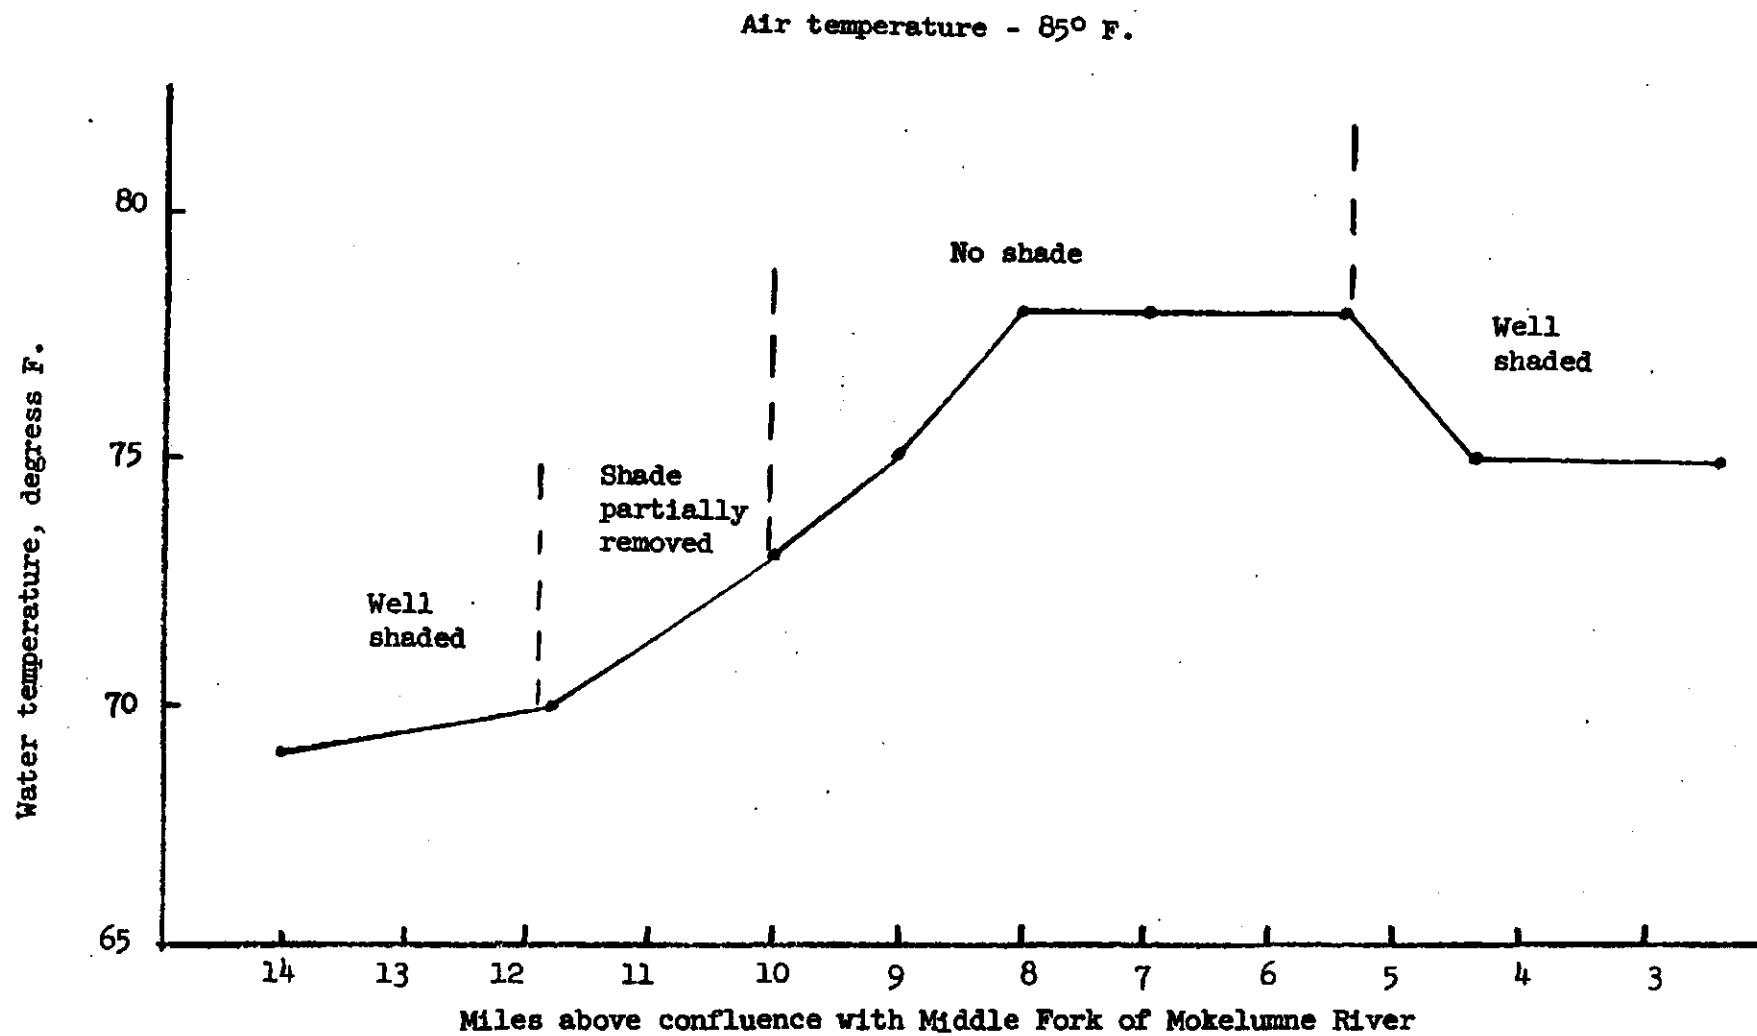
Temperatures increased about 0.5° F. per mile in shaded portions of the stream but increased from 1.5 to 2.0° F. per mile in the cleared or partially cleared areas. Figure 6 shows the results of a series of temperature measurements made in Forest Creek within a period of about one-half hour.

FIGURE 6. Relationship between stream canopy and stream temperatures,
Forest Creek, Calaveras County, August 2, 1966, 4:00 p.m.

The effect of removal of the streamside canopy on water temperatures was measured in Forest Creek, Calaveras County. Complete removal of shade resulted in undesirable temperatures. During the late July-early August period, water temperature ranged from 70 to 73° F. in shaded portions. In the unshaded portions, temperatures increased to 75 to 78° F.
